Fig. 114 FEBA: 5x5 ROD BUNDLE, TEST SERIES 2, TEST-No. 234

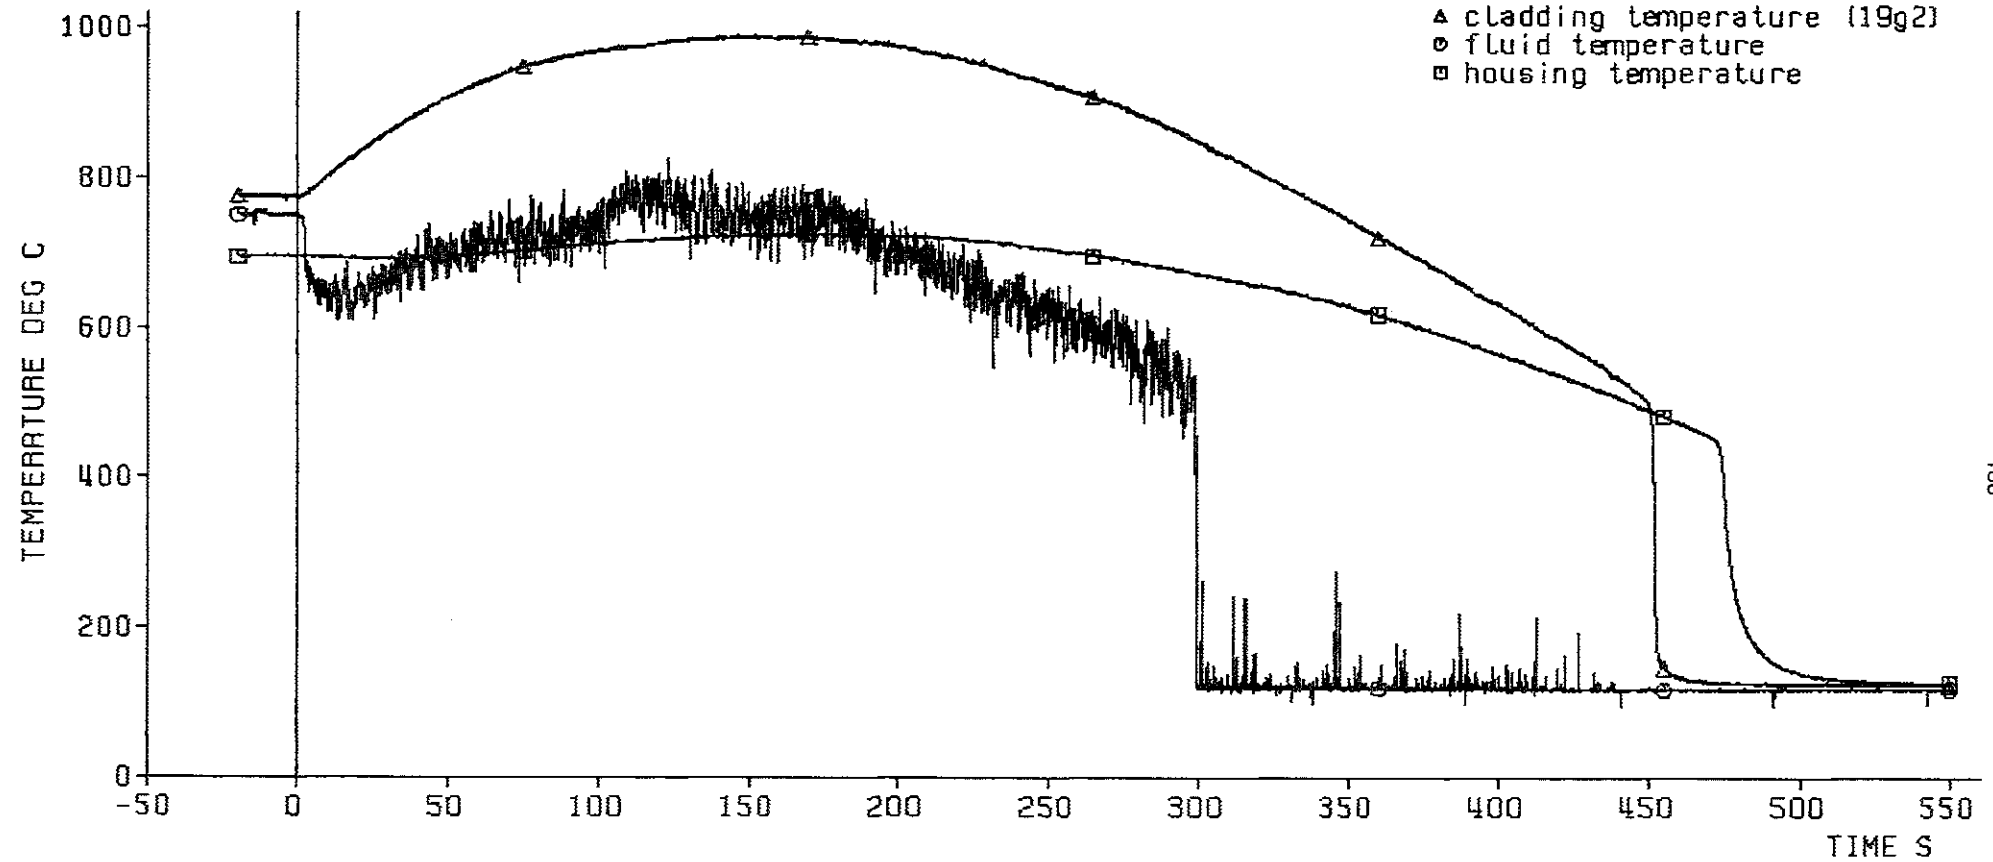
axial level: 1725 mm

△ cladding temperature (19g2)  
○ fluid temperature  
□ housing temperature

decay heat 120% RNS standard  
flooding rate (cold) 3.80 cm/s  
system pressure 2.02 bar  
feedwater temperature 40 deg C
