KfK
IRB

Fig. 150 FEBA: 5x5 ROD BUNDLE, TEST SERIES 2, TEST-No. 233

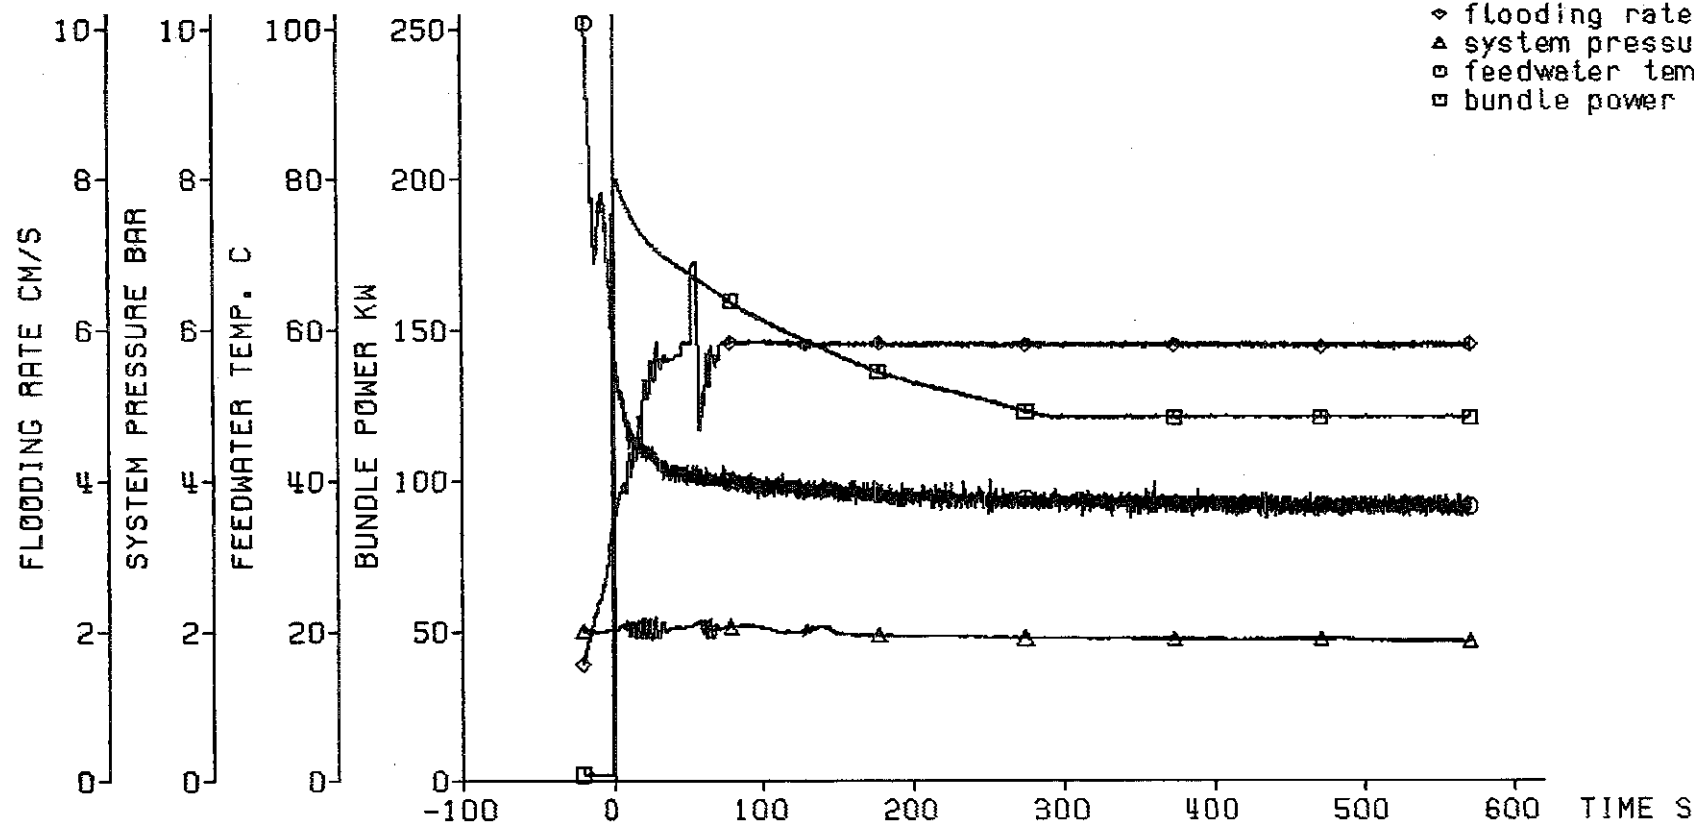
test parameters:

- ◇ flooding rate
- △ system pressure
- feedwater temperature
- bundle power

decay heat 120% ANS standard
 flooding rate (cold) 5.82 cm/s
 system pressure 1.99 bar
 feedwater temperature 40 deg C
