Fig. 174 FEBA: 5x5 ROD BUNDLE, TEST SERIES 2, TEST-No. 228

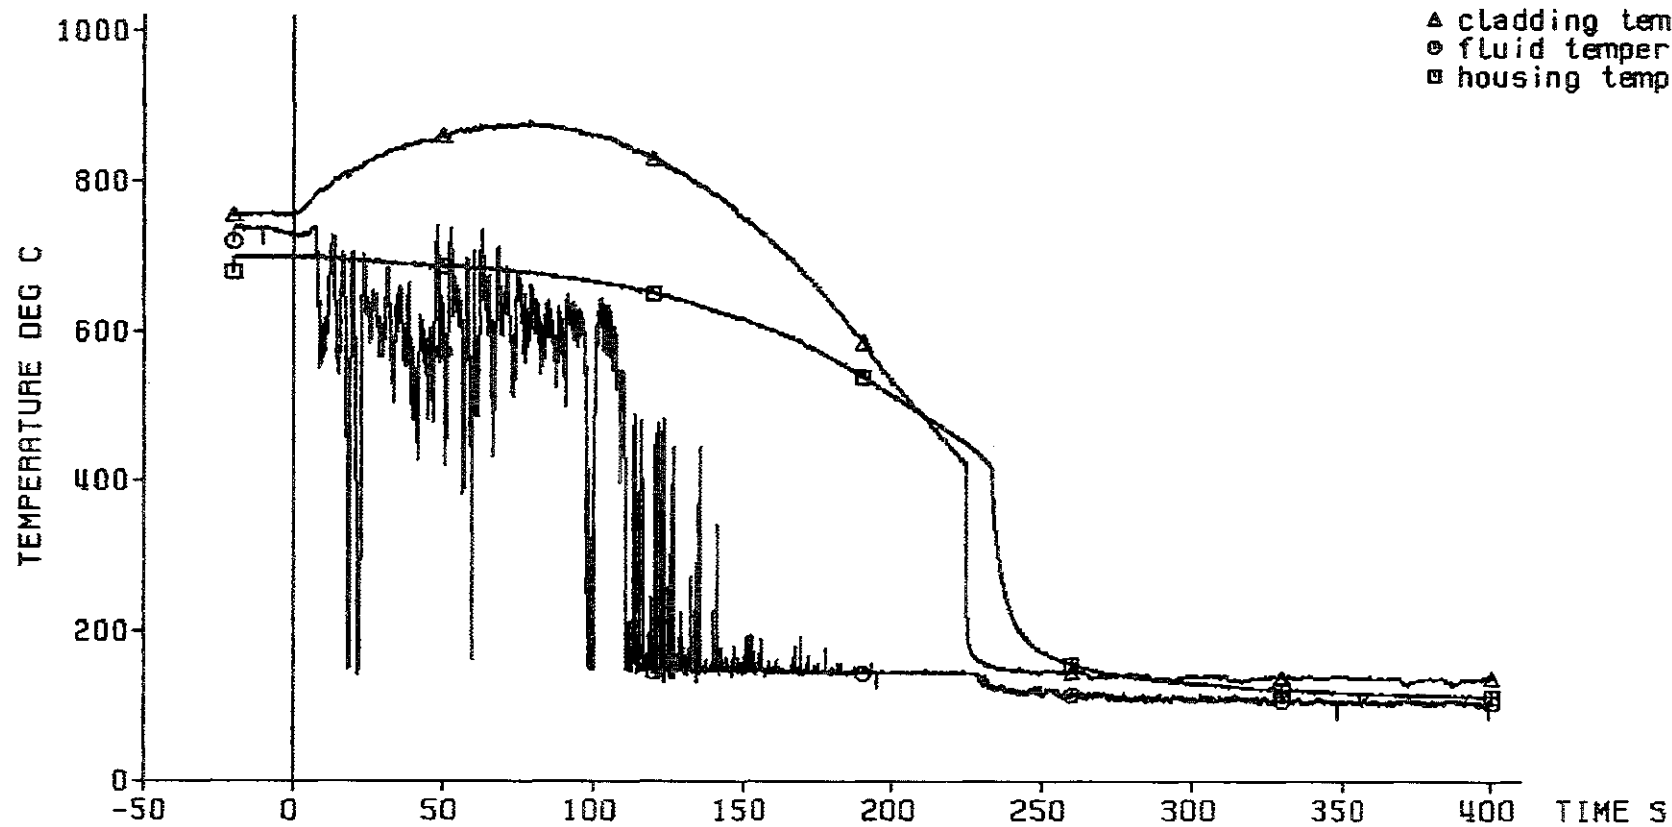
axial level: 1725 mm

decay heat
flooding rate (cold)
system pressure
feedwater temperature

120% ANS standard
5.72 cm/s
4.11 bar
40 deg C
