Fig. 160 FEBA: 5x5 ROD BUNDLE, TEST SERIES 2, TEST-No. 233

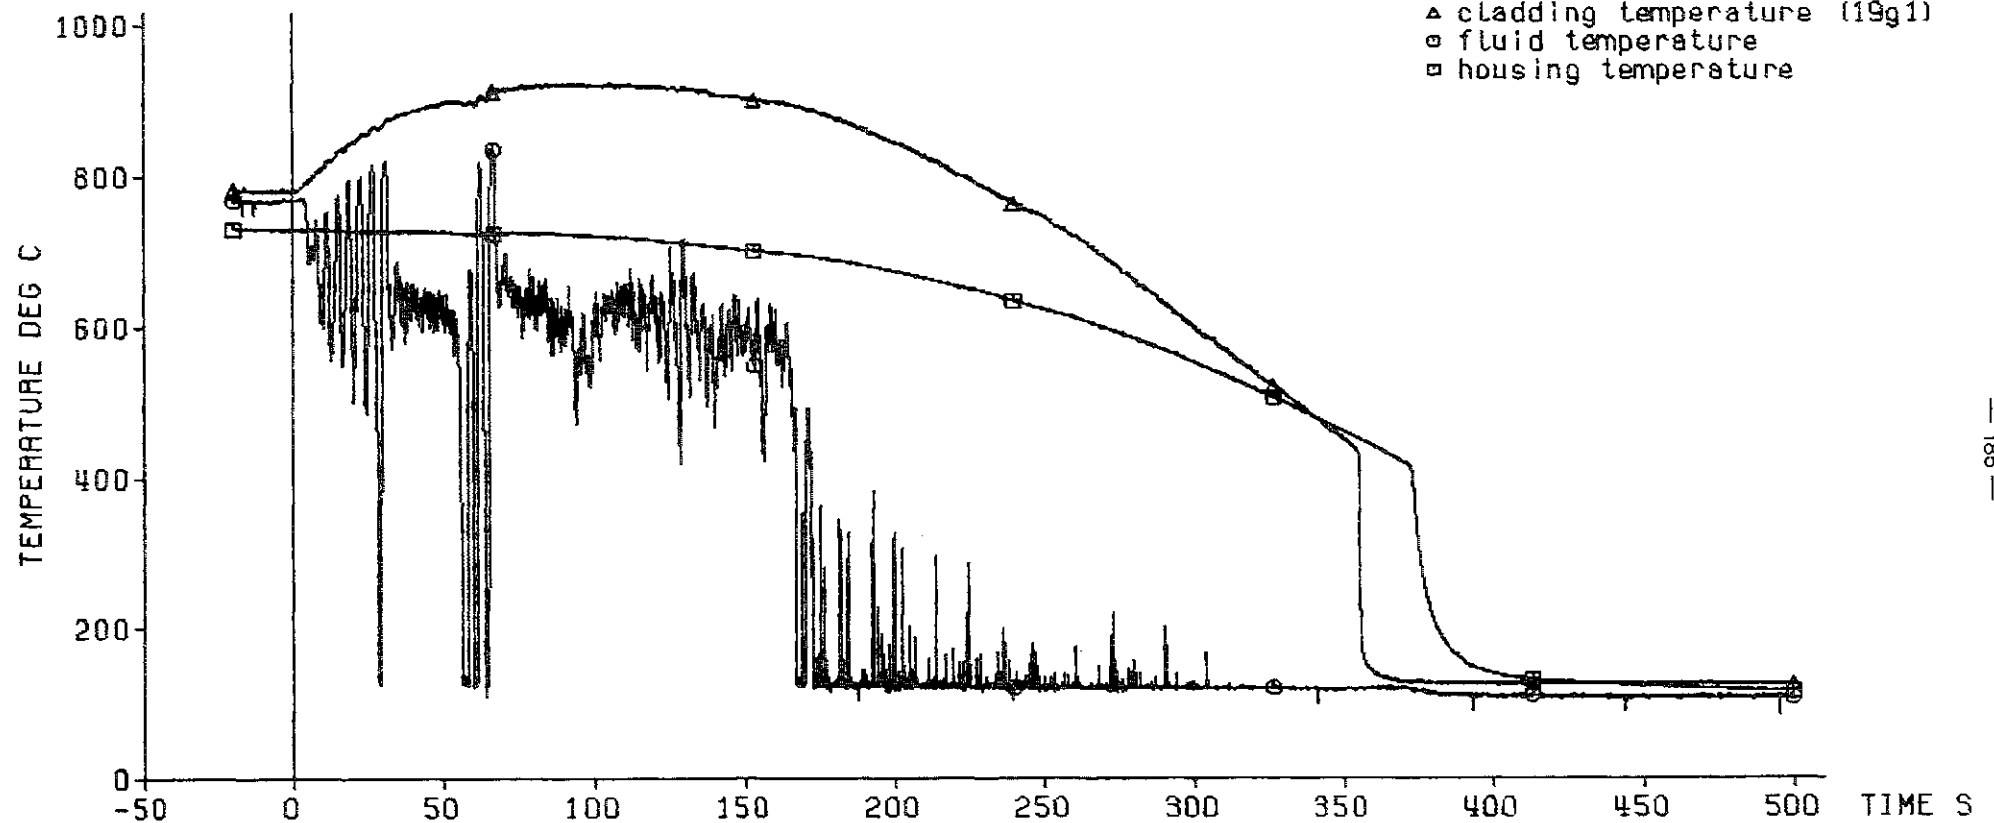
axial level: 1625 mm

△ cladding temperature (19g1)
○ fluid temperature
□ housing temperature

decay heat 120% ANS standard
flooding rate (cold) 5.82 cm/s
system pressure 1.99 bar
feedwater temperature 40 deg C
