Fig. 163 FEBA: 5x5 ROD BUNDLE
TEST SERIES 2, TEST-No. 233

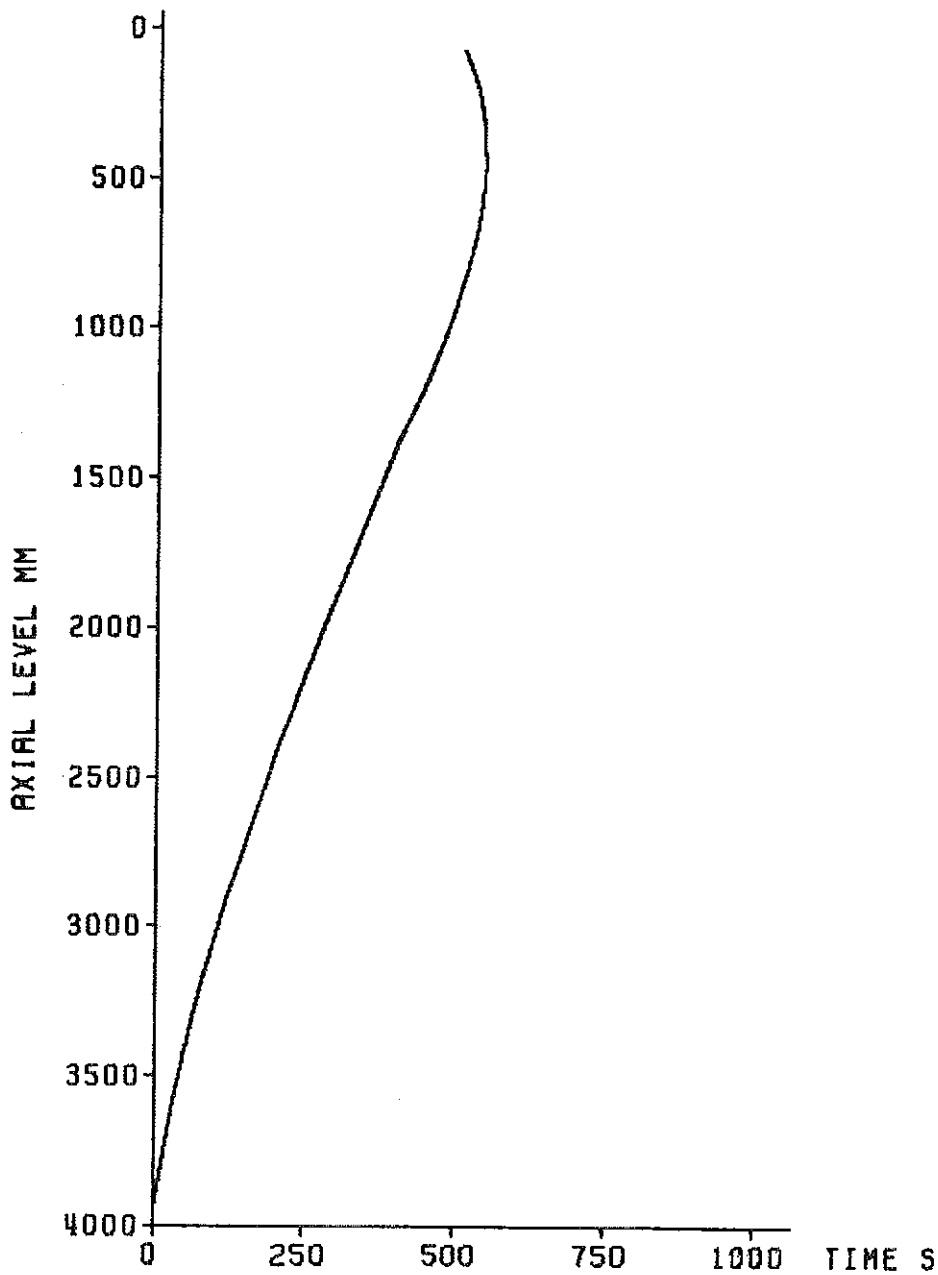
axial position of the quench front

decay heat	120% ANS standard
flooding rate (cold)	5.82 cm/s
system pressure	1.99 bar
feedwater temperature	40 deg C
