Fig. 190 FEBA: 5x5 ROD BUNDLE, TEST SERIES 2, TEST-No. 230

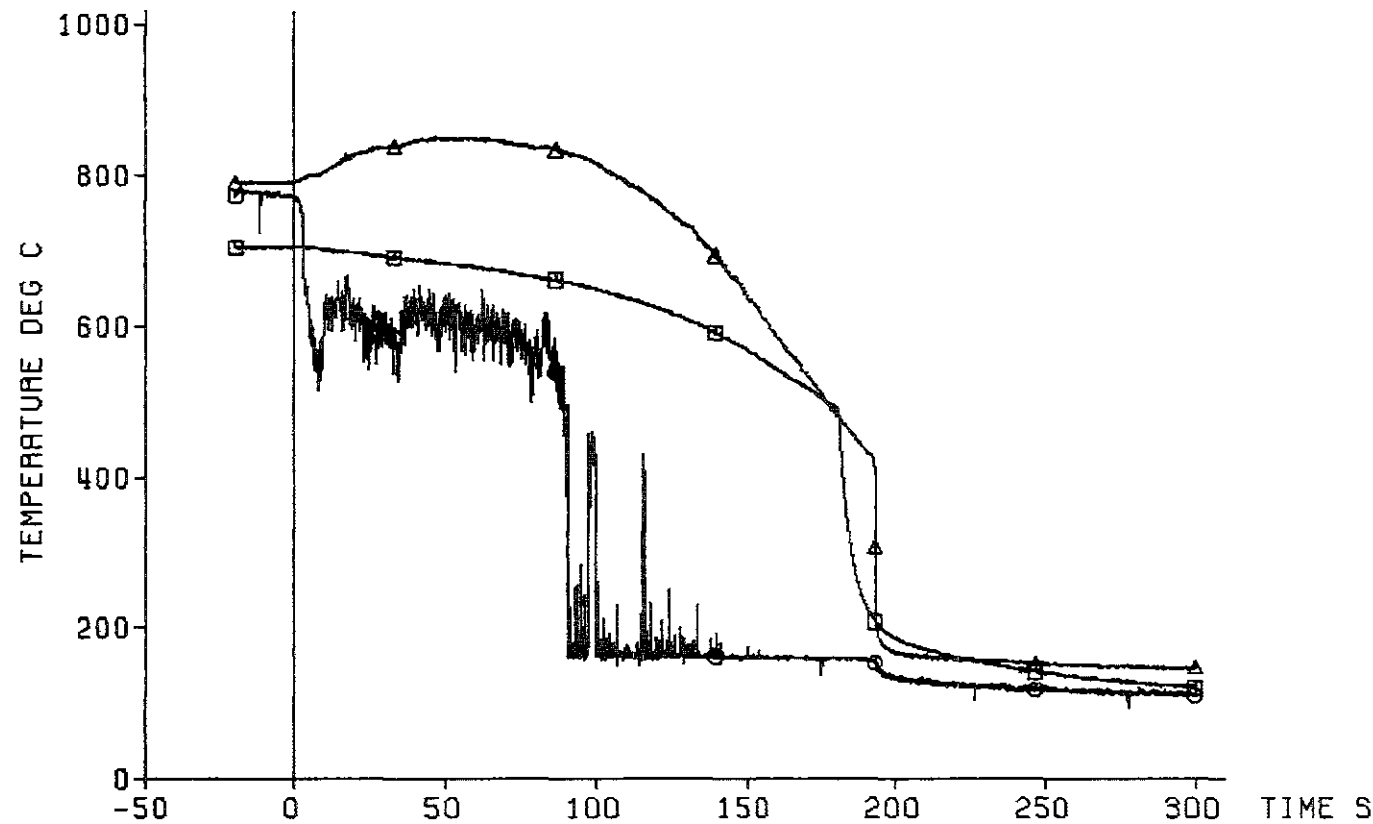
axial level: 1625 mm

decay heat
flooding rate (cold)
system pressure
feedwater temperature

120% ANS standard
5.77 cm/s
6.15 bar
40 deg C
