Ridgefield Levee Breach #2

LCR-95.0R

Strategy Objective: Exclusion : Prevent oil from travelling through breach in dike to Post Office Lake.

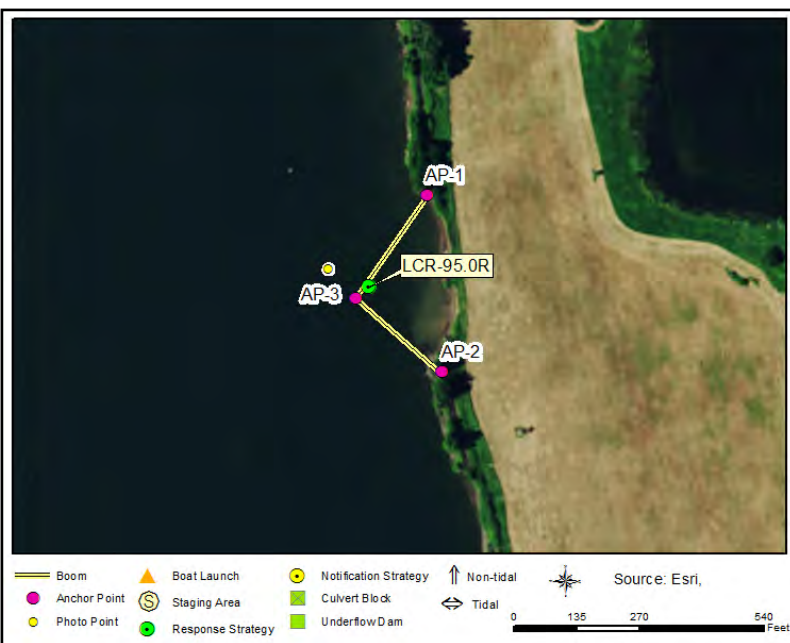
Implementation: From BL-LCR-97.7R, launch workboat to breach in dike at Ridgefield National Wildlife Refuge with 500ft. boom. Anchor to AP-1 and AP-2 using natural anchors, do not insert shoreside anchor posts. Anchor to AP-3 using Danforth or other acceptable anchor, and anchor every 100-150ft. along boom length or as appropriate for conditions. Notify Environmental Unit if deploying strategies in this area.

Field Notes: Site is decommissioned dike road at Ridgefield National Wildlife Refuge where drainage has eroded the road and dike to create breach that could open to Post Office Lake at high water.
