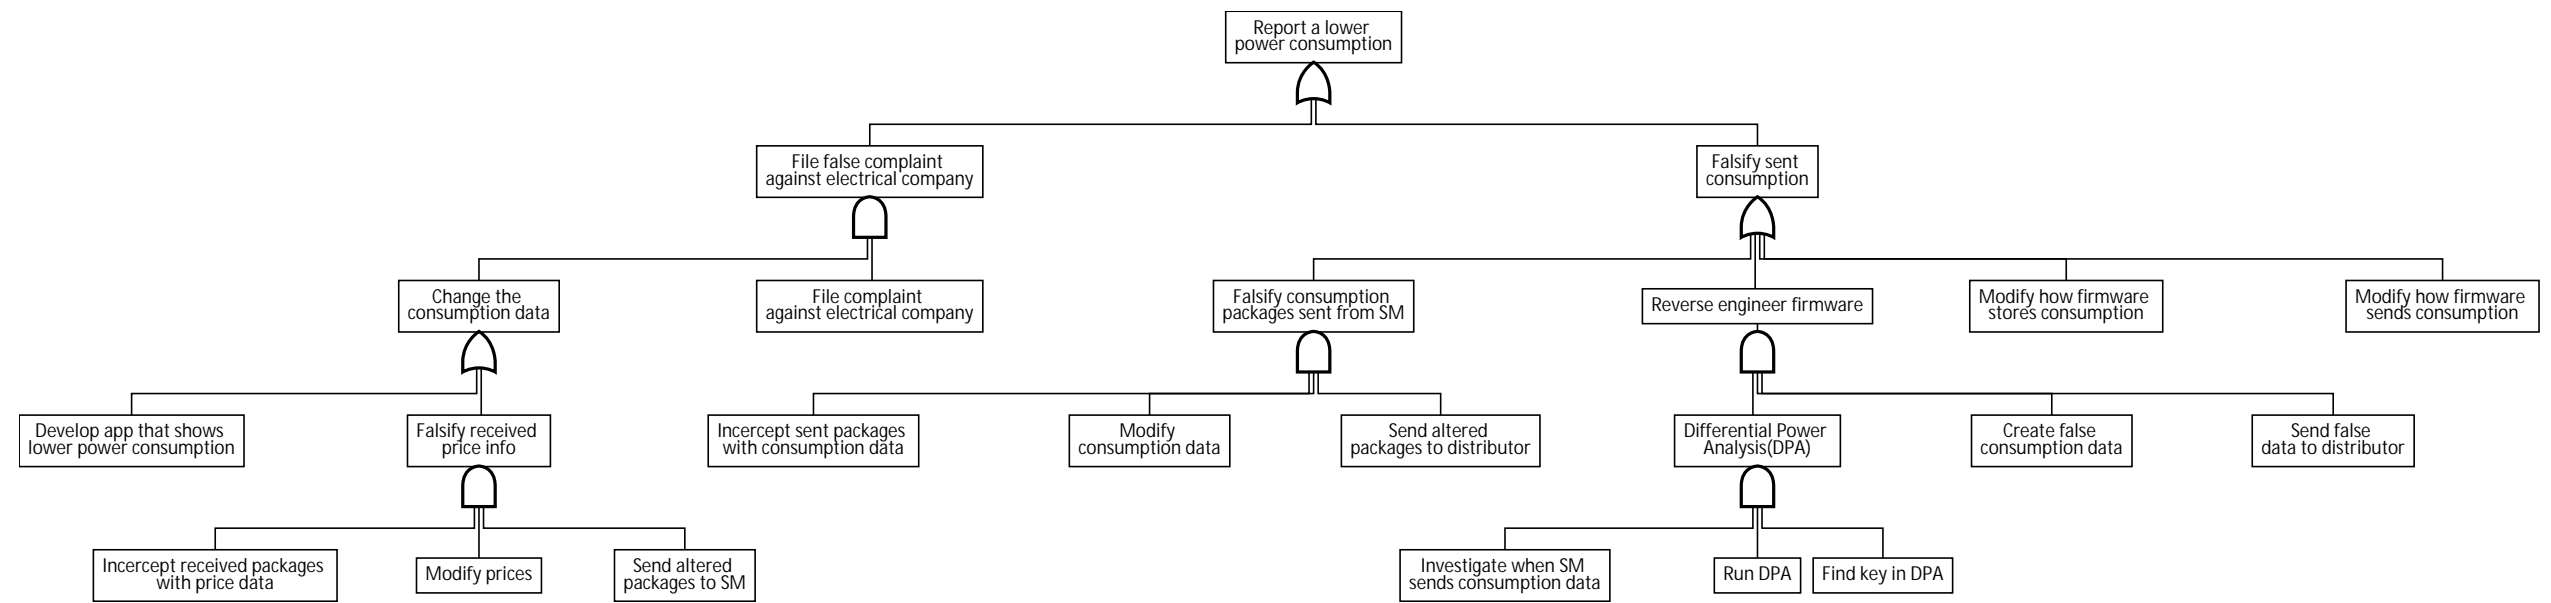
Figure 3.2: The consumer attacking the electrical company by reporting a lower consumption than measured by the smart meter.

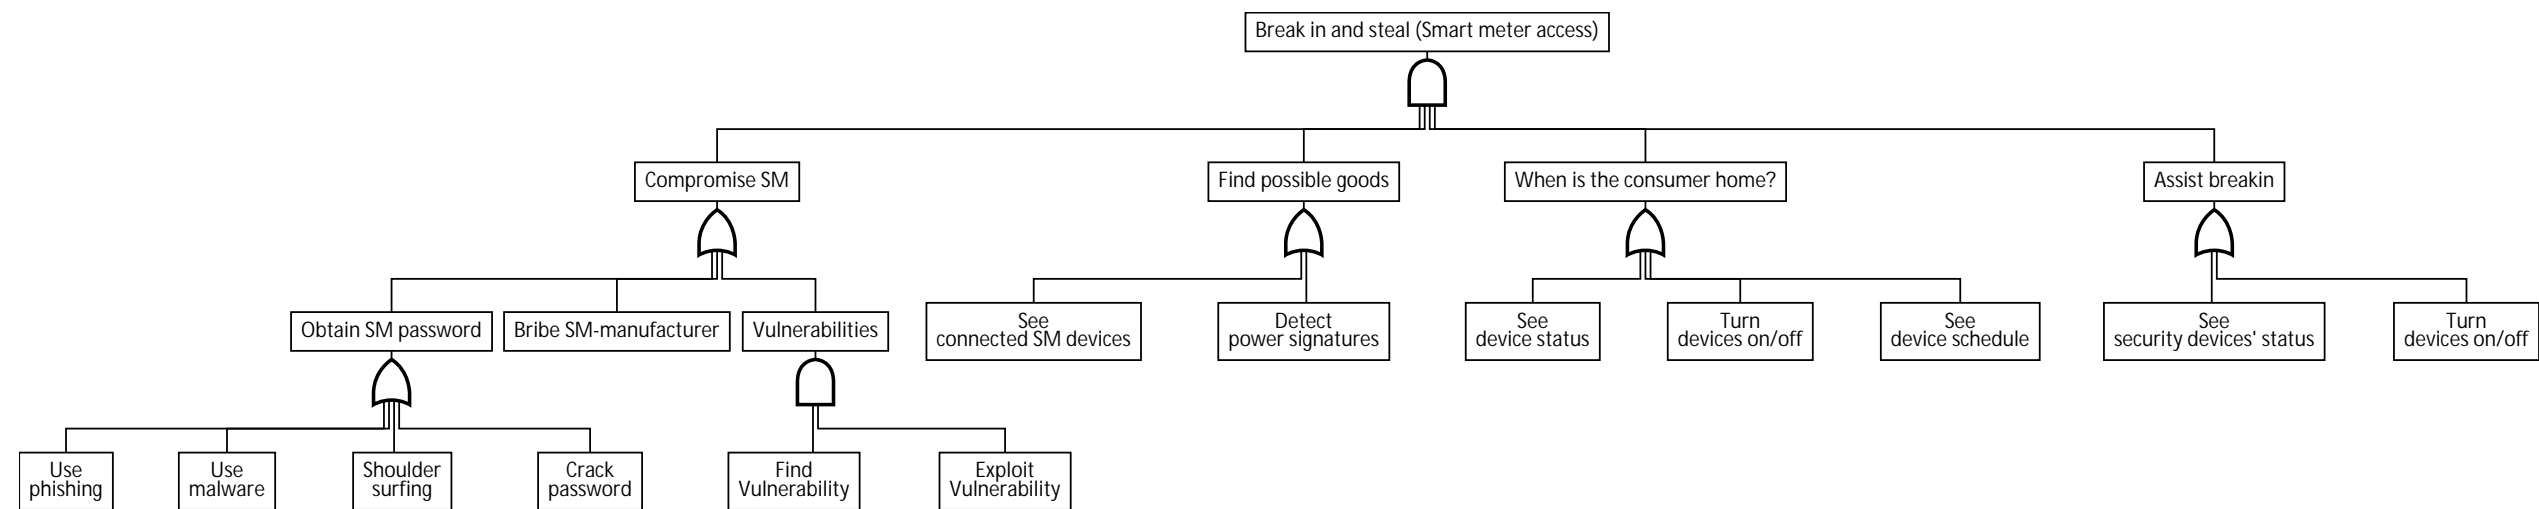
Figure 3.4: A burglar attacking the consumer using the smart meter.

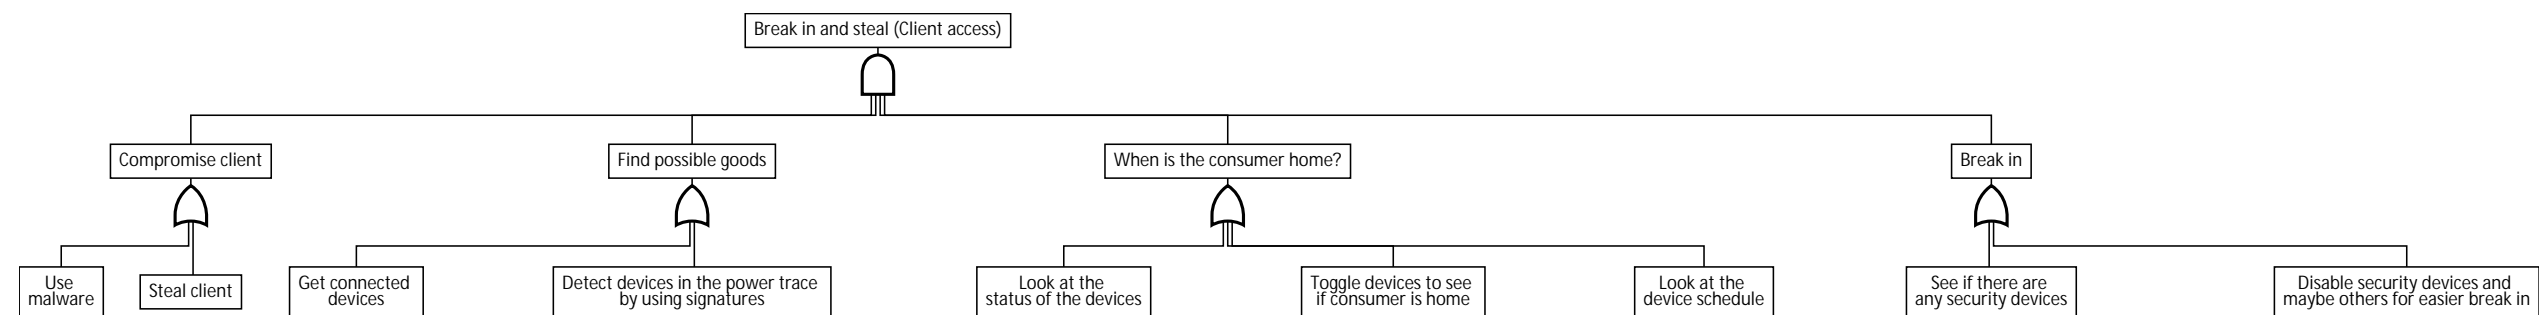
Figure 3.5: A burglar attacking the consumer using the consumers client.

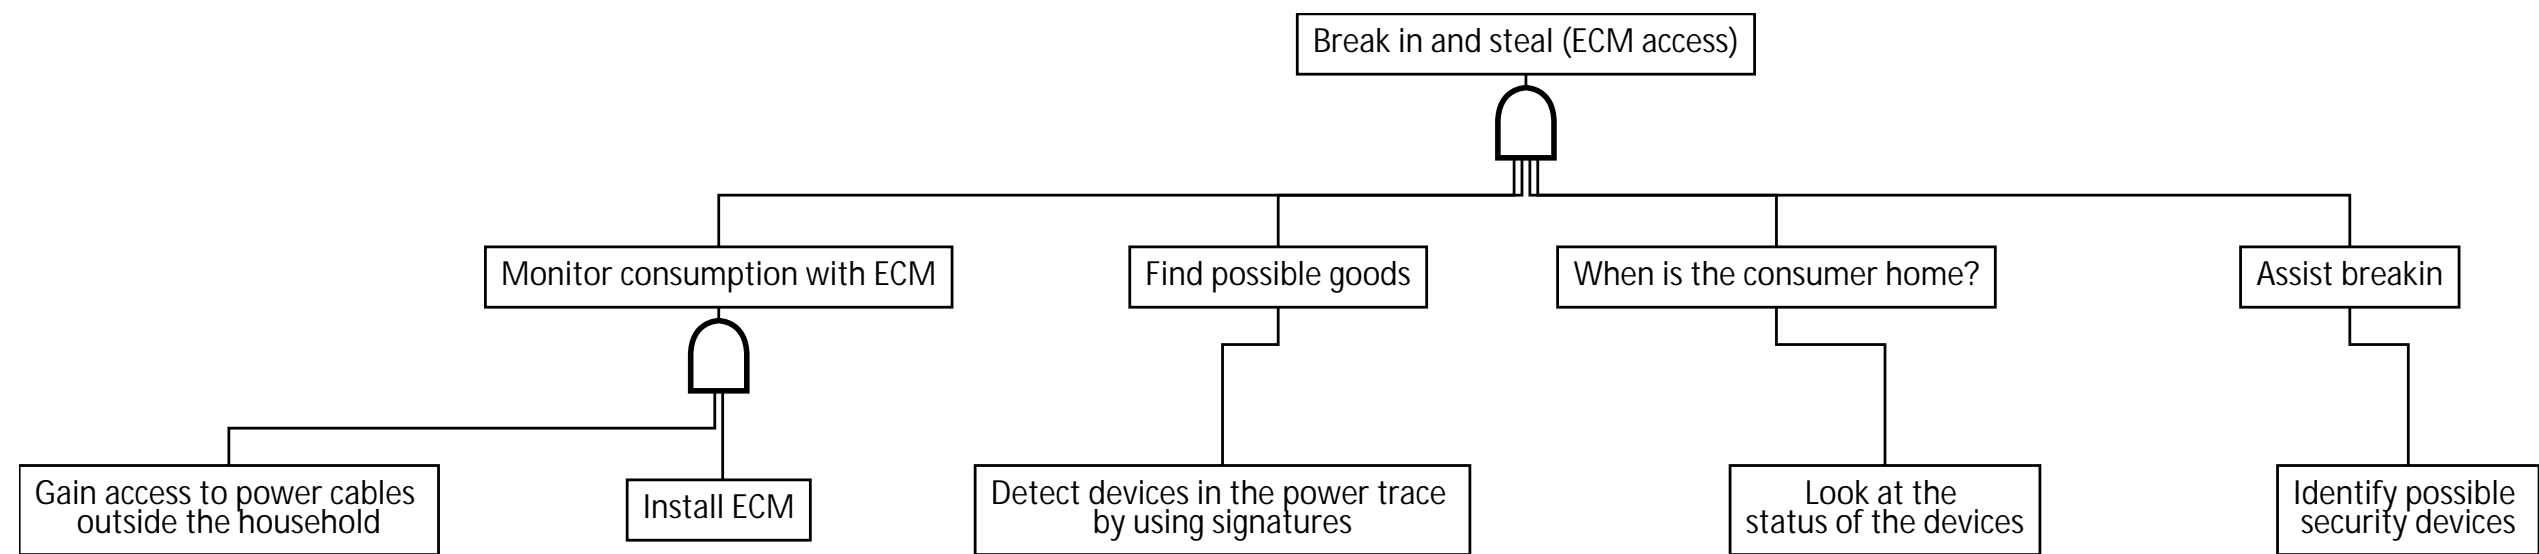
Figure 3.6: A burglar attacking the consumer using an ECM.

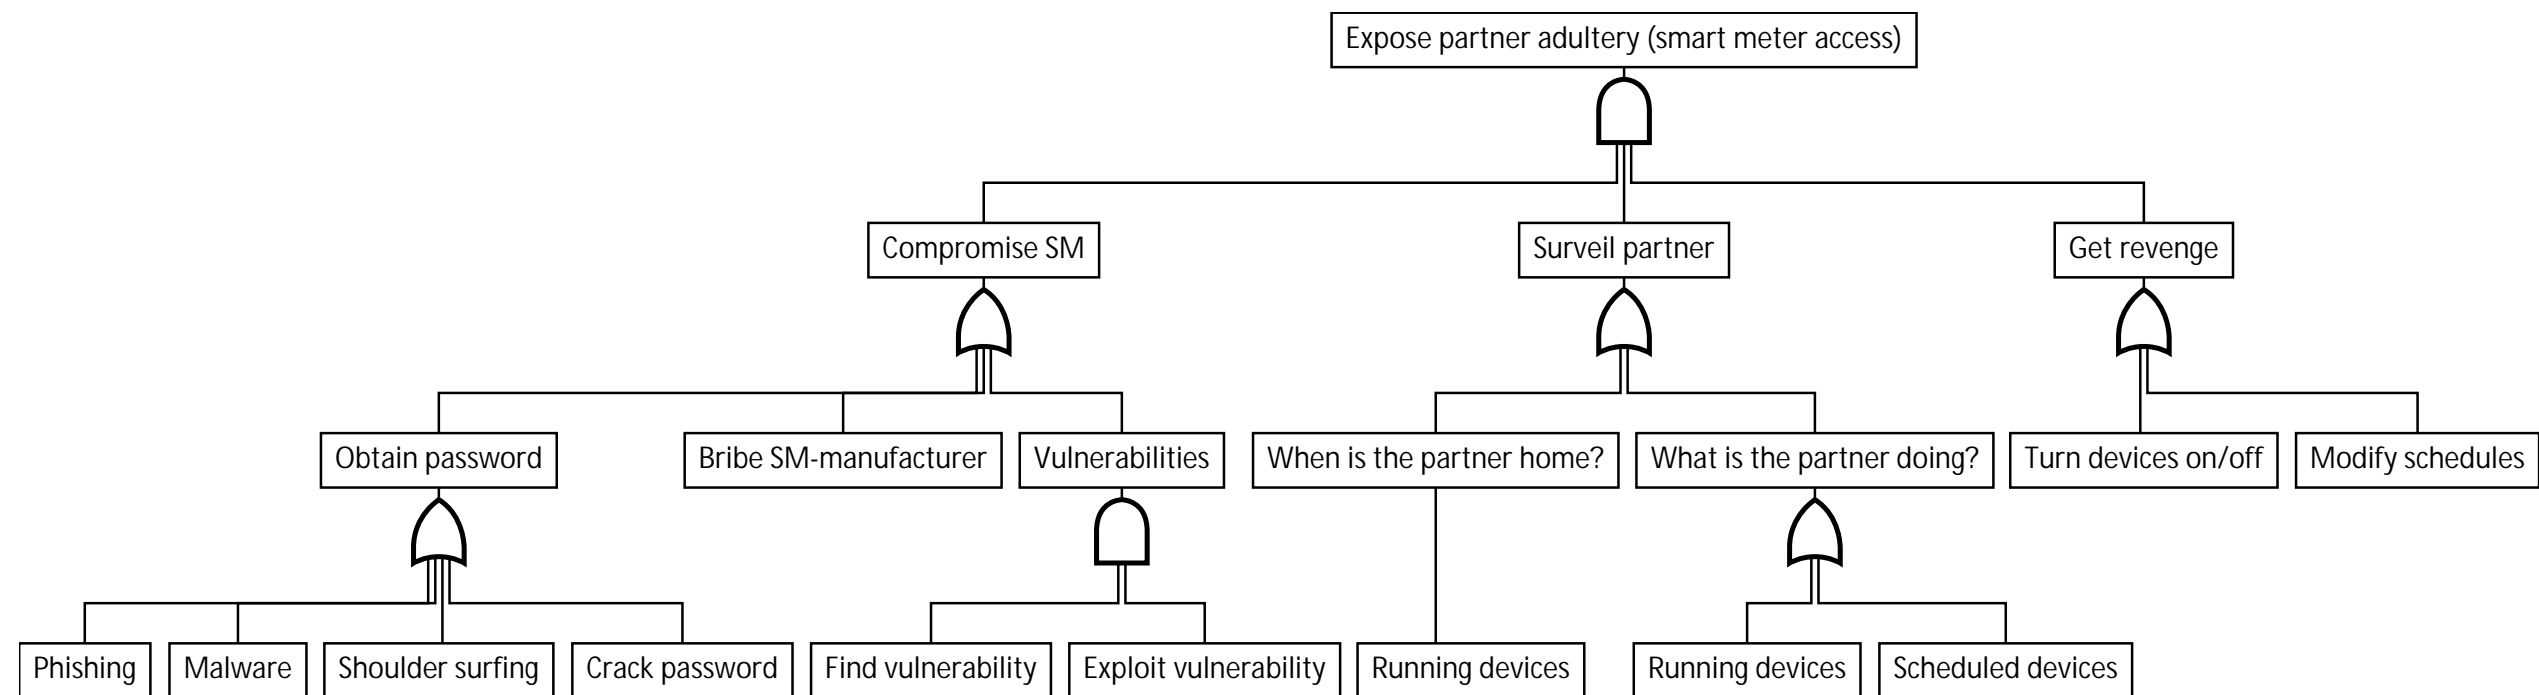
Figure 3.14: The Partner attacking the Consumer by compromising his smart meter.

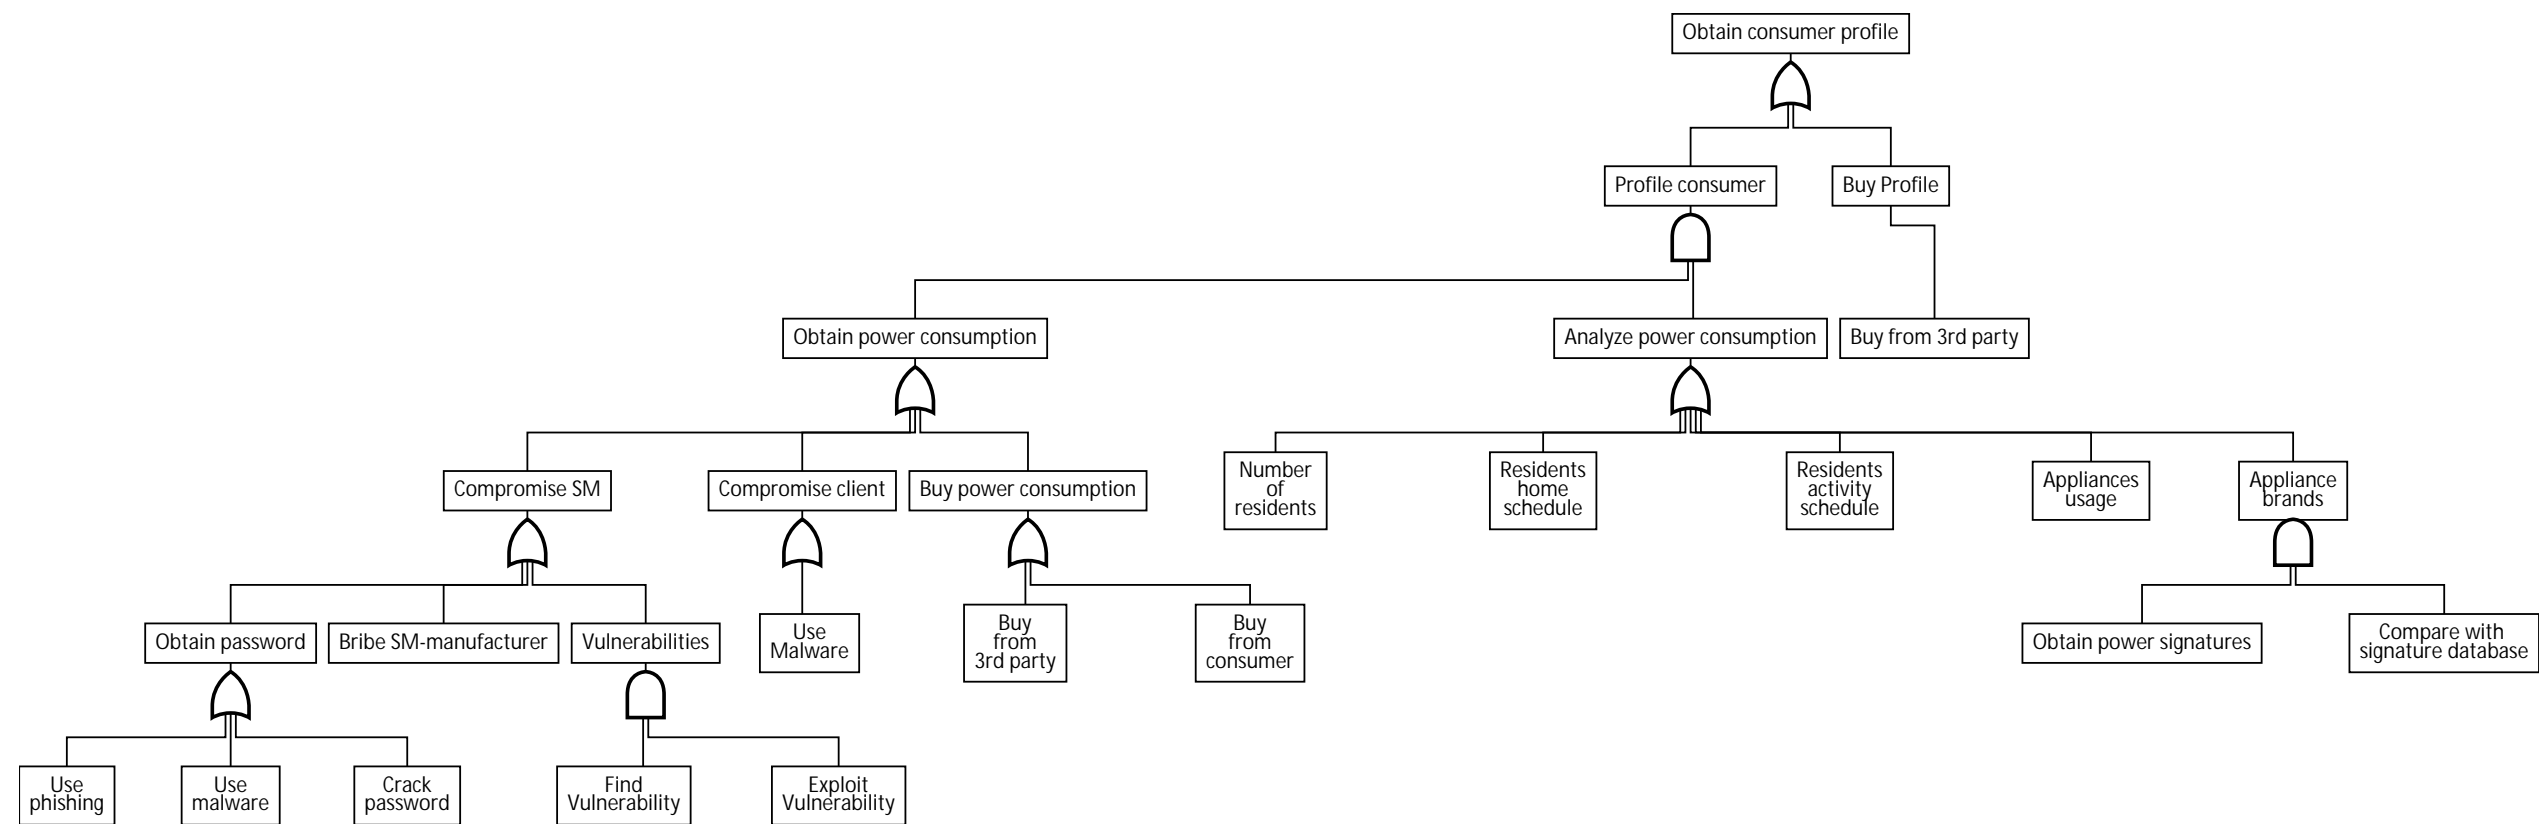
Figure 3.16: A information gatherer attacking the consumer by stealing his data.

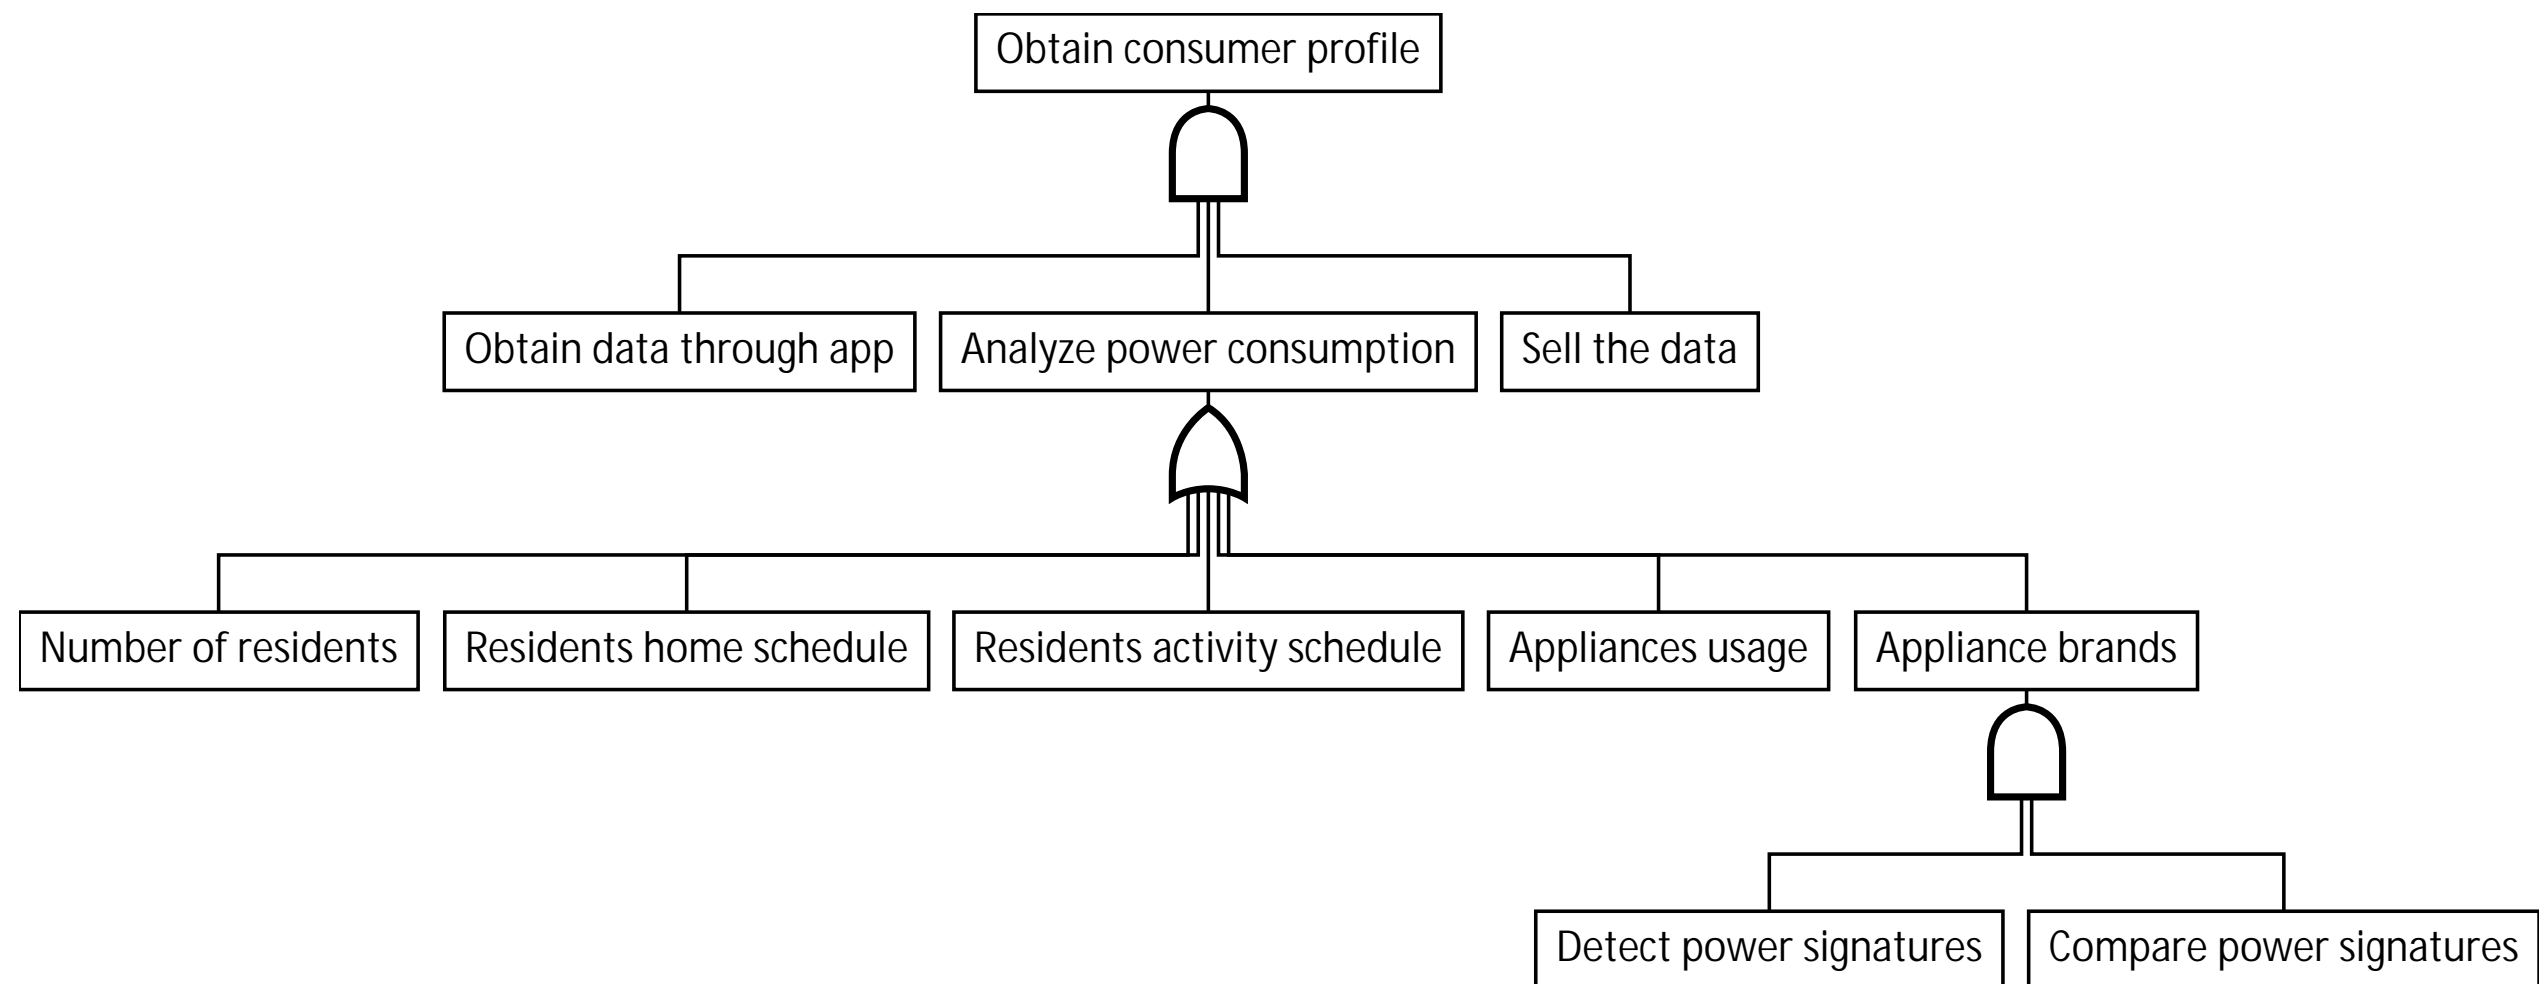
Figure 3.17: A 3rd party app developer attacking the consumer through their app.

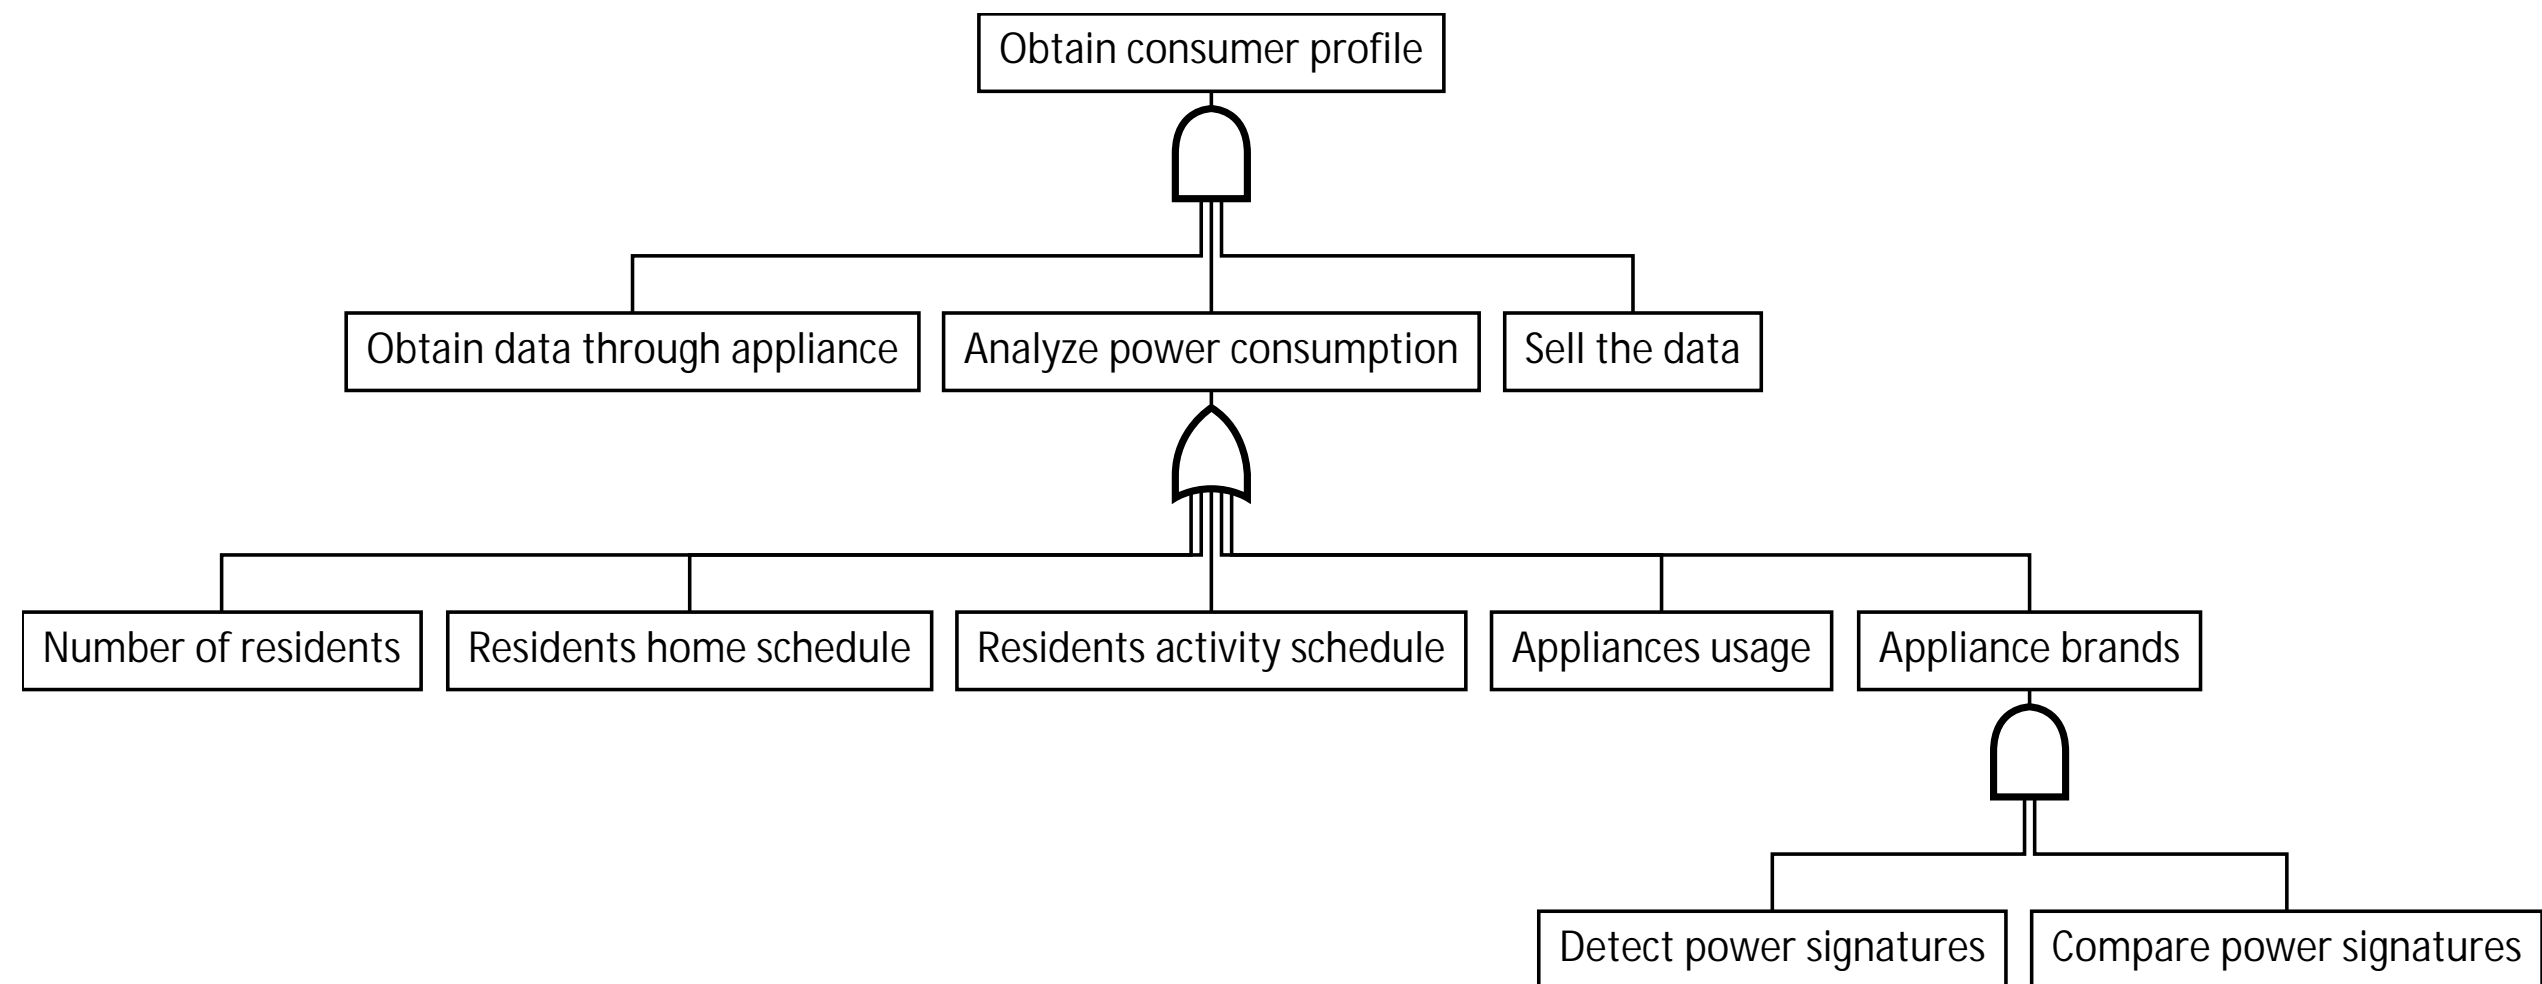
Figure 3.18: An appliance company attacking the consumer through their appliance.
