# Fact or Artifact in Two-Dimensional Echocardiography: Avoiding Misdiagnosis and Missed Diagnosis

Philippe B. Bertrand, MD, MSc, Robert A. Levine, MD, Eric M. Isselbacher, MD, MSc, and Pieter M. Vandervoort, MD, *Genk and Hasselt, Belgium; and Boston, Massachusetts*

Two-dimensional transthoracic echocardiography is the most widely used noninvasive imaging modality for the evaluation and diagnosis of cardiac pathology. However, because of the physical properties of ultrasound waves and specifics in ultrasound image reconstruction, cardiologists are often confronted with ultrasound image artifacts. It is particularly important to recognize such artifacts in order to avoid misdiagnosis of conditions ranging from aortic dissection to thrombosis and endocarditis. This overview article summarizes the most common image artifacts encountered in routine clinical practice, along with explanations of their physical mechanisms and guidance in avoiding their misinterpretation. (J Am Soc Echocardiogr 2016;29:381-91.)

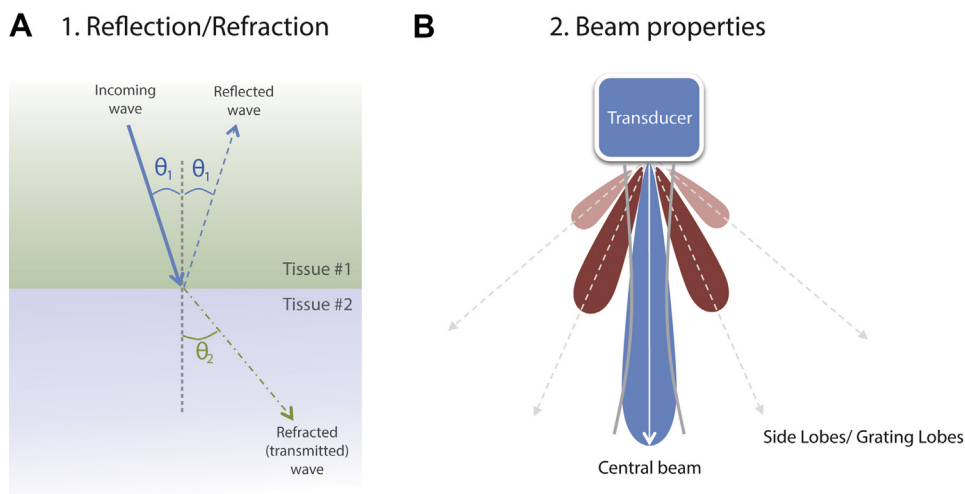
**Figure 1** Basic principles of ultrasound imaging. **(A)** Ultrasound waves obey the physical laws of reflection and refraction. The boundary of two tissues with different acoustic impedance acts as a specular reflector if significantly larger than the wavelength of the ultrasound waves. A portion of ultrasound wave energy will be reflected, with a reflection angle equal to the angle of incidence. Another portion will be transmitted, with a reflection angle dependent on the magnitude of difference in acoustic impedance between both tissues. **(B)** Ultrasound beam forming is associated with small parts of ultrasound energy traveling off axis in so-called side lobes or grating lobes.

The echocardiographic machine maps cardiac structures on the basis of the travel time and intensity of the ultrasound waves returning to the transducer from a given direction. These ultrasound waves are generated by a piezoelectric transducer in the form of an ultrasound beam.<sup>8</sup> Current phased-array transducers allow electronic steering and focusing of the beam by adjusting the timing of excitation of individual piezoelectric crystals.<sup>9</sup> These ultrasound beams have a finite (three-dimensional) beam width that is smallest in the region of focus and diverges in the far field. In addition, not all energy produced by the elements remains focused within a central beam. Smaller amounts of the emitted energy are directed to the sides of the central beam and may form so-called side lobes (or grating lobes in the case of array transducers) of ultrasound energy that propagate off axis<sup>8,10</sup> (Figure 1B).

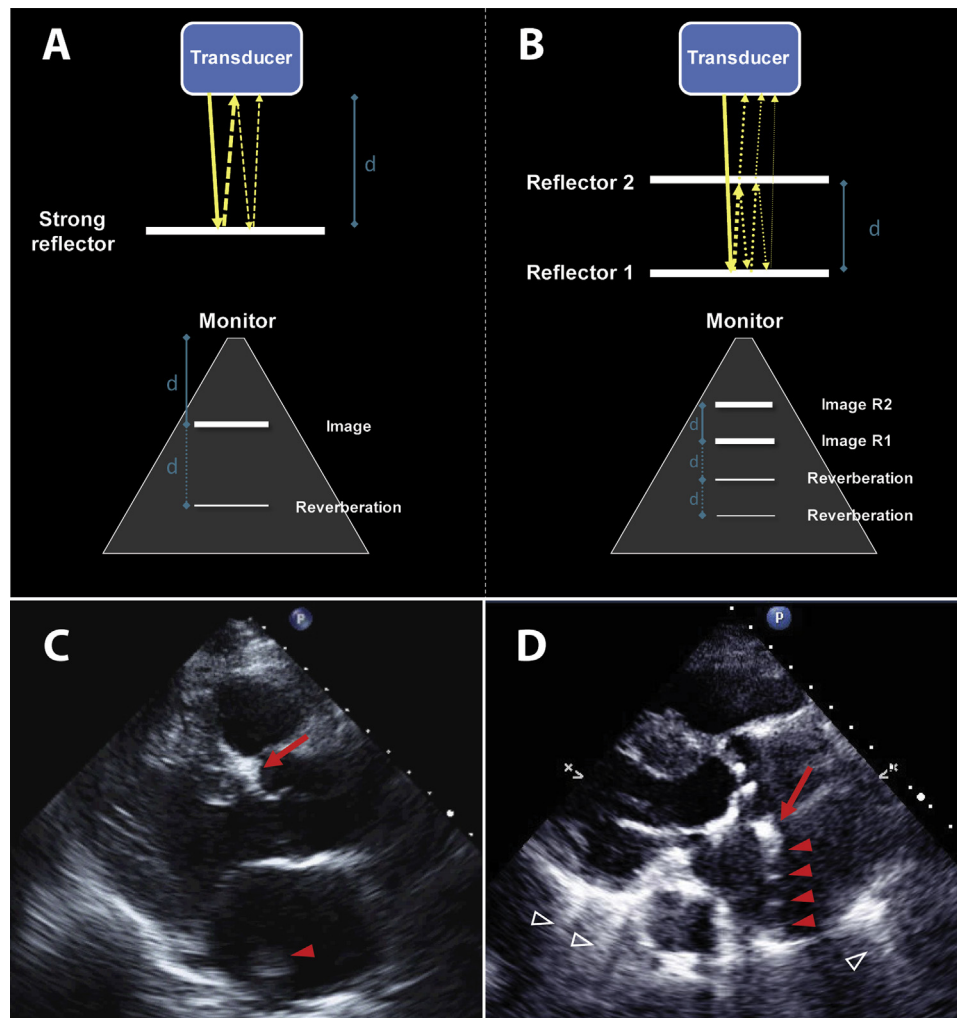
**Figure 2** Reverberation artifact. **(A,B)** The theoretical genesis of a reverberation artifact (animation in [Video 1](#); available at [www.onlinejase.com](http://www.onlinejase.com)). The second reflector can either be the transducer itself **(A)**, leading to a reverberation at twice the distance to the probe, or another strong reflector **(B)** located above the first reflector. **(C)** Reverberation artifact in the parasternal long-axis view mimicking a mass in the left atrium (arrowhead). Detailed analysis of the mass shows that it is a reverberation of the calcified aortic annulus (arrow), with the mass presenting at exactly twice the distance from the transducer ([Video 2](#); available at [www.onlinejase.com](http://www.onlinejase.com)). **(D)** Typical “stepladder” of reverberations (full arrowheads) below a “multilayered” aortic calcification (arrow) acting as the first and second reflectors ([Video 3](#); available at [www.onlinejase.com](http://www.onlinejase.com)). Comet-tail reverberations below a strongly reflecting pericardium can be observed as well (empty arrowheads).

#### Reverberation (Figure 2, Videos 1–3; available at [www.onlinejase.com](http://www.onlinejase.com))

A reflected ultrasound wave on its way back to the transducer can encounter a closer reflector in its path that reflects a portion of this returning energy back to the first reflector again. The portion of sound energy that was not interrupted by the closer reflector returns to the transducer as expected, and the first reflector’s structure is mapped accurately. However, the portion of sound energy that makes a second round trip to the first reflector and back to the transducer will have had a longer travel time. Because of the assumption of wave propagation, the transducer interprets this artifactual reflected structure as being at a further distance from the transducer because of the additional ultrasound travel time and thus maps a structure below the first reflector (at a distance below first reflector equal to the distance between first and second reflectors). This process can repeat itself each time the returning signal crosses a second reflector, causing multiple reflections between the two reflectors with progressively weaker signal intensity. This appears as a characteristic “stepladder” artifact in the echocardiographic image, with successive reverberations gradually diminishing in intensity; importantly, these reverberations do not respect anatomic boundaries. In clinical practice, the second reflector is often the ultrasound transducer itself, generating an artifact at a distance twice that of the first reflector. Other examples of strong reflectors in the near field include the walls of the aorta and pulmonary arteries, calcified structures, and implanted devices. During the cardiac cycle, the motion of the artifact parallels that of the true structure but with a greater (typically double) amplitude (Videos 2 and 15; available at [www.onlinejase.com](http://www.onlinejase.com)). Decreasing

gain and using alternative imaging planes are possible strategies for reducing, eliminating, and recognizing reverberation artifacts; the basic recognition comes from appreciating doubling of distances for single reverberations and the stepladder appearance of multiple reverberations.

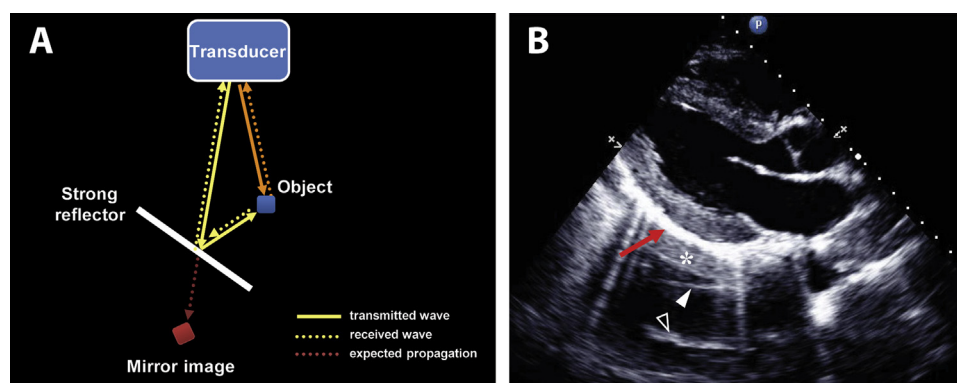
**Figure 3** Mirror artifact. **(A)** The theoretical genesis of a mirror artifact (animation in [Video 4](#); available at [www.onlinejase.com](http://www.onlinejase.com)). **(B)** Parasternal long-axis image showing a mirror artefact below the pericardium-lung interface (red arrow) (moving images in [Video 5](#); available at [www.onlinejase.com](http://www.onlinejase.com)). Notice the mirror image of the posterior myocardial tissue (asterisk), the posterior mitral leaflet (full arrowhead), and the anterior mitral leaflet (empty arrowhead). Comet-tail reverberations below the pericardium due to the strongly reflecting lung interface can be observed as well.

#### Mirror Artifact (Figure 3, Videos 4 and 5; available at [www.onlinejase.com](http://www.onlinejase.com))

A mirror artifact typically appears below a strong reflective surface that acts much as a mirror does with light, producing a duplicate image behind the mirror of the real structures in front of the mirror; the mirrored images move in the opposite direction from the mirror, as do the real structures.<sup>3,14</sup> The reflection mechanism is similar to that of a reverberation: ultrasound waves hitting a strong reflector are reflected (angle of reflection = angle of incidence) toward objects closer to the transducer than the reflector. These intervening objects reflect the waves back to the strong reflector, which in turn sends them back to the transducer. Because of the assumption of wave propagation (that all the returning sound comes from objects in the initial direction of the sound beam), the scanner displays these objects below the strong reflector, at a distance equal to the distance between strong reflector and the true intervening objects. The most common strong (specular) reflector that causes mirror

artifacts is the lung, best appreciated in the parasternal long-axis view (Figure 3B) and apical four-chamber view on transthoracic echocardiography and in the midesophageal view of the descending thoracic aorta on transesophageal echocardiography. Mirror artifacts are usually easy to identify in two-dimensional images as copies of structures located above a reflective surface. However, the three-dimensional shape of a reflective surface can sometimes mirror structures that are not located in the respective scanning plane, thereby complicating correct interpretation.<sup>15</sup>

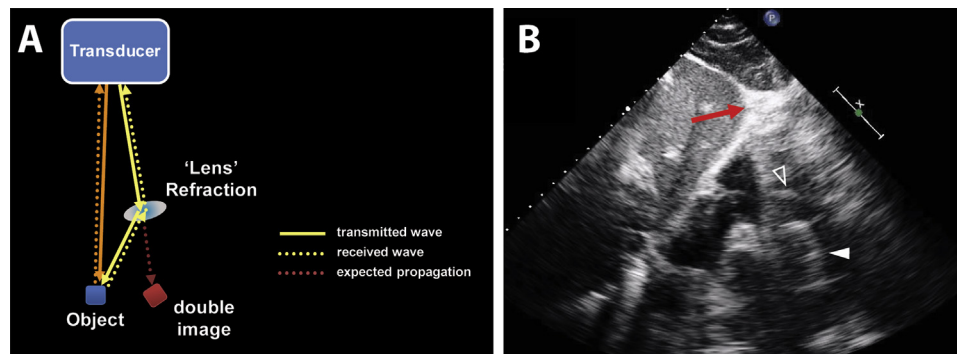
**Figure 4** Refraction artifact. **(A)** The theoretical genesis of a refraction artifact. Ultrasound waves directed through a “lens” are refracted toward the respective cardiac object and back, resulting in a duplicate of this object in the initial beam direction (animation in [Video 6](#); available at [www.onlinejase.com](http://www.onlinejase.com)). **(B)** Double image of the aorta (*full arrowhead*) in a subcostal short-axis image of the heart, due to refraction of the ultrasound beam at perihepatic fatty tissue (*arrow*). A Swan-Ganz catheter in the right ventricular outflow tract is doubled as well (*empty arrowhead*). Moving images in [Video 7](#) (available at [www.onlinejase.com](http://www.onlinejase.com)).

#### Refraction Artifact or Double Image (Figure 4, Videos 6 and 7; available at [www.onlinejase.com](http://www.onlinejase.com))

A refraction artifact, also called a “lens artifact,” is the false duplication of an object behind a structure that acts as a wave refractor and thus behaves as a lens.<sup>20</sup> Ultrasound waves directed through the “lens” are refracted toward the respective cardiac object and then re-refracted back to the original direction of transmission on the return acoustic path, resulting in a duplicate image of this object but in the original direction of the beam. These artifacts occur mostly in subcostal and parasternal imaging planes, with costal cartilage, fascial structures and fat, and pleural and pericardial surfaces acting as the medium inducing refraction of the ultrasound beam.<sup>21,22</sup> Structures behind an ultrasound lens may not be visible in that plane, because the sound beam never reaches them, and instead they are overwritten by the duplicate image of a nearby structure. Adjusting the probe to avoid the lens and using alternative imaging windows are strategies to avoid the double image and assess the structures that were shadowed.

In routine clinical practice, refraction artifacts are typically recognizable because they create impossible anatomic relations, such as intersecting duplicated images of the mitral valve in long-axis imaging<sup>22</sup> or the aortic root and left ventricle in short-axis imaging (Figure 4).<sup>21</sup> However in apical long-axis images, more subtle doubling of the ventricular wall can occur because of refraction at the apex (pericardium, fat), complicating the assessment of left ventricular dimensions and ejection fraction. Adjusting the image settings and changing the probe angulation are possible strategies to avoid refraction in such cases.<sup>7</sup>

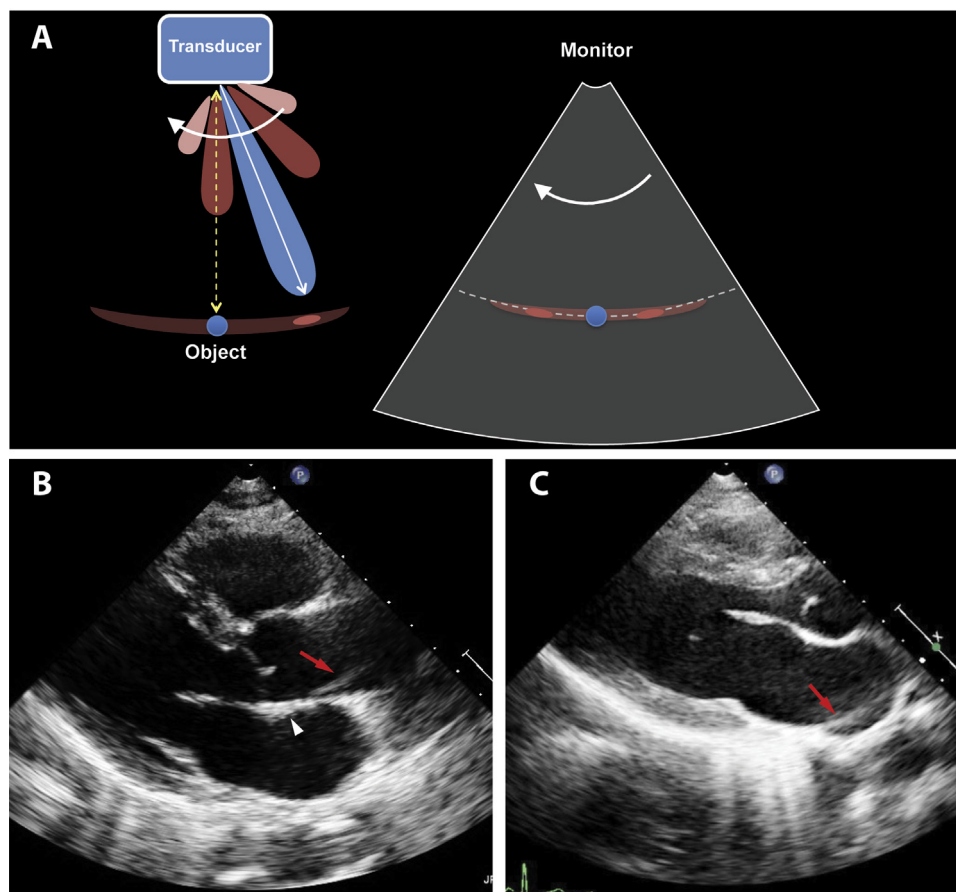
**Figure 5** Side-lobe artifact. **(A)** The genesis of a side-lobe artifact. While “interrogating” the imaging plane in a radial direction, side-lobe energy can encounter a strong reflector. Reflections of side-lobe energy are interpreted as if originating from the direction in which the transducer is “looking.” Ultimately, this leads to a linear “arc-like” artifact at both sides of the strong reflector (short animation in [Video 8](#); available at [www.onlinejase.com](http://www.onlinejase.com)). **(B)** Parasternal long-axis view with linear side-lobe artifact (arrow) in the aorta ascendens due to a calcified sinotubular junction (arrowhead). This artifact can sometime be misinterpreted as a dissection flap. **(C)** Parasternal long-axis view of a healthy patient with strongly reflecting pericardium, causing a side-lobe artifact in the left atrium (arrow). In moving images ([Video 9](#); available at [www.onlinejase.com](http://www.onlinejase.com)), comet-tail reverberations, acoustic shadowing, near-field clutter, and a mirror image of the mitral valve leaflets can be observed as well.

##### Side-Lobe Artifact (Figure 5, Videos 8 and 9; available at [www.onlinejase.com](http://www.onlinejase.com))

The small portions of ultrasound energy emitted in “side lobes” are mostly dissipated in the tissue, without relevant reflections. However, when this side-lobe energy is reflected by a strong reflector (wires, calcifications, pericardium) in its path, these reflections are interpreted by the scanner as originating from the central beam.<sup>10</sup> As the transducer scans the imaging window by sweeping in a radial direction, numerous side-lobe artifacts can be generated

on both sides of the true reflector. When the true reflector is bright and wide, these multiple side-lobe images can overlap and visually merge, producing a linear arc-like artifact at a radial distance of the transducer.<sup>2,23</sup>

Clinical recognition is important to avoid misdiagnosis of thrombi or vegetations generated by side-lobe artifacts from highly reflective annular or prosthetic interfaces. In addition, side-lobe artifacts from highly reflective aortic sinotubular junctions could be mistaken for aortic dissection flaps (Figure 5B).

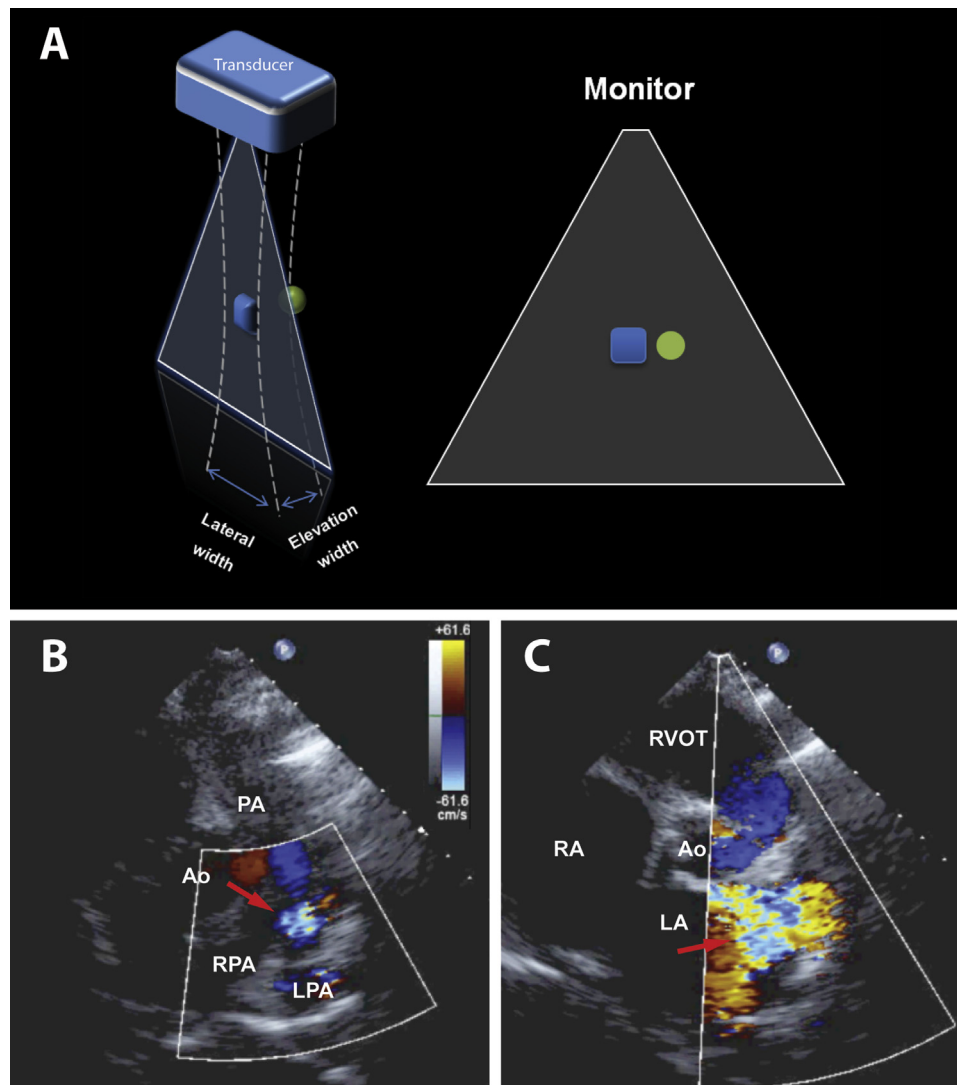
**Figure 6** Beam-width artifact. **(A)** The lateral width and elevation width of the ultrasound beam, respectively, cause a decrease in lateral resolution and the occurrence of beam-width artifacts. The blue square object within the scanning plane is correctly identified in the center of the beam. However, because of the elevation width of the beam, the green circular object outside of the imaging plane is incorrectly positioned within the scanning plane. **(B)** Parasternal short-axis image of pulmonary arteries showing unexplained turbulent flow into the left pulmonary artery (LPA; arrow), without evidence of shunting or stenosis. **(C)** Tilting of the probe out of the scanning plane reveals massive MR into the left atrium (LA) picked up by the beam as if occurring in the pulmonary artery (PA). Ao, Aorta; RA, right atrium; RPA, right pulmonary artery; RVOT, right ventricular outflow tract.

##### Beam-Width Artifact (Figure 6)

In most current machines and transducers, the ultrasound beam is able to focus only over a limited distance and increasingly diverges beyond from the focal zone.<sup>8</sup> Within the imaging plane, the wider the beam is, the poorer the lateral resolution (i.e., the minimal lateral distance needed between two objects to be identified as two separate objects by the transducer). However, the finite beam width is even more problematic in the perpendicular direction (“elevation width”) out of the scanning plane, because it is less evident to the interpreter. Objects or blood flow out of the imaging plane but within the elevation width of the beam are interpreted as if located in the imaging plane, sometimes leading to diagnostic dilemmas and enigmas.<sup>24-26</sup>

In clinical practice, beam-width artifacts from highly reflective annular or prosthetic interfaces could be confused for thrombi or vegetations (similar to side-lobe artifacts). Furthermore, it is important to recognize out-of-plane artifacts displaying strong Doppler signals in adjacent structures, for example, disturbed LVOT flow in patients with aortic stenosis, producing apparent tricuspid regurgitation (without typical direction or vena contracta) or prominent MR eccentrically directed toward the LAA, producing apparently disturbed systolic flow in the pulmonary artery (Figures 6B and 6C).

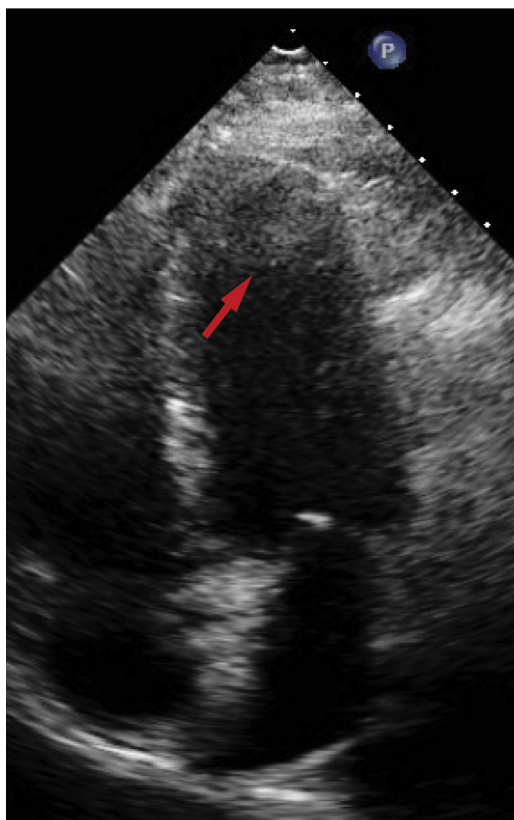
**Figure 7** Near-field clutter (arrow) in apical four-chamber view, mimicking apical thrombus. Moving images (Video 10; available at [www.onlinejase.com](http://www.onlinejase.com)) show normal apical myocardial kinetics and no relationship between clutter and myocardial motion.

Structures in the near field are sometimes obscured because of the high amplitude of oscillations by the transducer itself, causing so-called near-field clutter.<sup>7</sup> This is especially relevant in case an apical ventricular thrombus is suspected (Figure 7, Video 10; available at [www.onlinejase.com](http://www.onlinejase.com)). The introduction of harmonic imaging and the technologic advances in transducer design have already reduced the occurrence of this type of artifact. In contrast to a thrombus, clutter is unaffected by ventricular wall motion and appears to pass

through the wall. When uncertain, one can apply color Doppler and reduce the scale in order to demonstrate blood flow through the apex, thus refuting the possible thrombus; alternatively, one can switch to other (parasternal or subcostal) imaging planes or use contrast echocardiography to confirm or refute the presence of an apical thrombus.

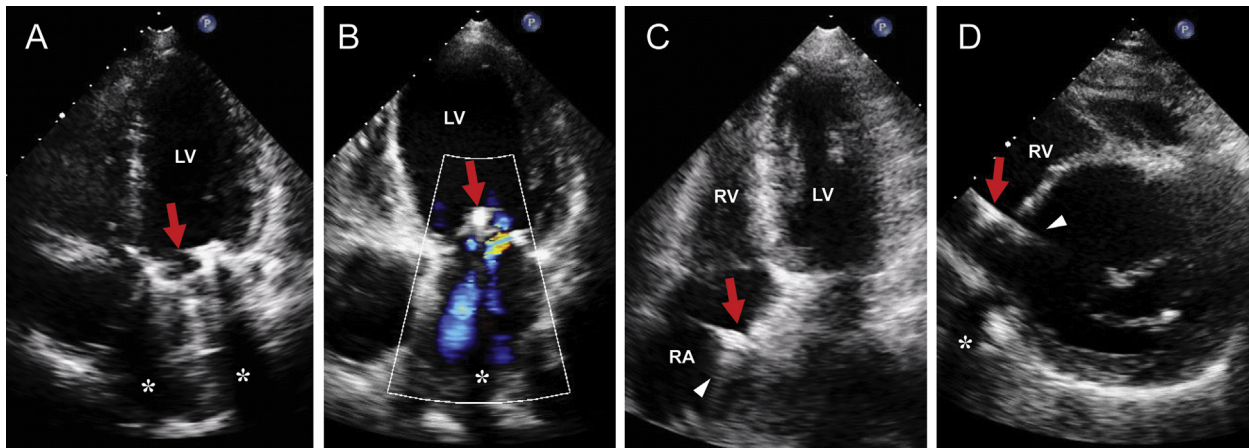
**Figure 8** Cardiac devices as sources of image artifacts. **(A)** Mechanical mitral valve prosthesis causing multiple reverberations and comet tails below the prosthesis (arrow) as well as two acoustic shadowing regions below the prosthesis frame (asterisk) (Video 11; available at [www.onlinejase.com](http://www.onlinejase.com)). **(B)** Acoustic shadowing (asterisk) distal from an implanted MitraClip device (arrow). Notice the shadowing of the color flow signal as well, potentially leading to underestimation of residual MR after clip placement. **(C)** Pacemaker wire in the right atrium (RA) (arrow) with linear comet-tail reverberation (arrowhead) below the wire and side-lobe artifact extending in the radial direction. **(D)** Defibrillator wire in the right ventricle (RV) (arrow) with linear arc-like side-lobe artifact crossing the anatomic borders (interventricular septum). This should not be misinterpreted as a dislocated (perforated) wire into the left ventricular cavity (Video 12; available at [www.onlinejase.com](http://www.onlinejase.com)). LV, Left ventricle.

Implantable cardiac devices, such as pacemaker and implantable cardioverter-defibrillator leads, catheters, mechanical circulatory support devices, and valve prostheses, typically represent strong reflectors that are prone to the aforementioned reflection-related artifacts (reverberations or comet tails, shadowing, and mirroring) as well as side-lobe and beam-width artifacts.<sup>27,28</sup> Cardiac devices therefore complicate the interpretation of echocardiographic images ([Figure 8](#)) and demand careful examination of the devices and surrounding structures from different imaging views.

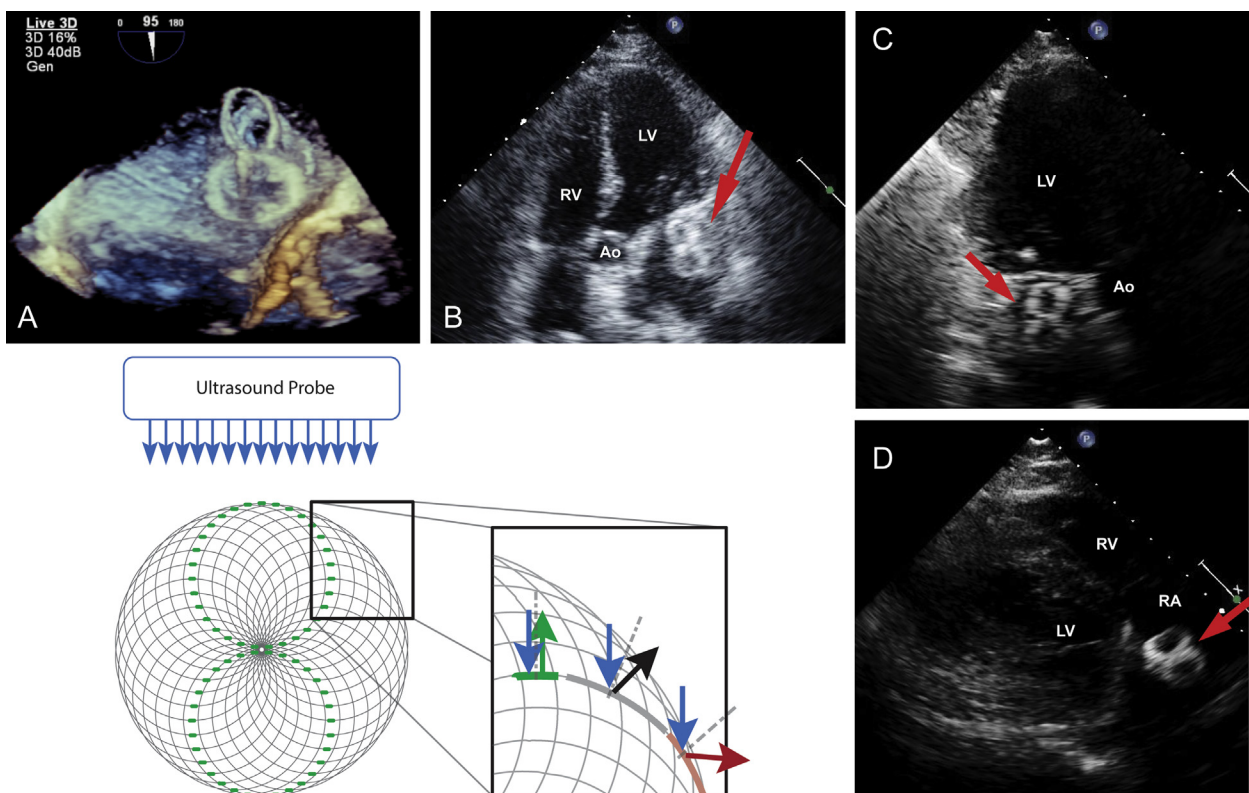
**Figure 9** Figure-of-eight artifact in the echocardiographic assessment of disk occluders. **(A)** Three-dimensional echocardiography of an Amplatzer Cardiac Plug after successful implantation in LAA. **(B)** Apical five-chamber view in the same patient, with an Amplatzer Cardiac Plug in the correct position presenting as a figure-of-eight (Video 13; available at [www.onlinejase.com](http://www.onlinejase.com)). **(C)** Apical three-chamber view (slightly off axis) in a patient following LAA occlusion. **(D)** A patent foramen ovale (PFO) occluder device in a parasternal off-axis image of the interatrial septum in a patient a few years after PFO occlusion (Video 14; available at [www.onlinejase.com](http://www.onlinejase.com)). Central image: because of the epitrochoidal mesh geometry of the disk occluders, sound is reflected back to the probe only by the small segments of mesh with fibers orthogonal to the beam direction. These align in a figure of eight (as shown by the green lines on the figure). Adapted from Bertrand *et al.*<sup>29</sup> with permission. Ao, Aorta; LV, left ventricle; RA, right atrium; RV, right ventricle.

mind the physical principle that for a specular reflector, the angle of reflection equals the angle of incidence. The figure-of-eight artifact ([Figure 9](#)) obtained when imaging a percutaneous disk occluder is a typical example of such a device-specific artifact based on the physics of ultrasound reflection. This artifact occurs in disk occluders (e.g., patent foramen ovale occluders, atrial septum defect occluders, the Amplatzer Cardiac Plug LAA occluder, and similar devices) with a specific epitrochoidal mesh configuration, when imaged from an imaging plane that is coronal relative to the device.<sup>29</sup> Because of the characteristic direction of the nitinol mesh fibers that act as strong specular reflectors, ultrasound waves are mostly reflected or deflected away from the transducer, except where the mesh fibers lie orthogonal to the beam direction. Our mathematical analysis previously demonstrated that those locations constitute a figure of eight, explaining the artifact that is frequently seen in apical five-chamber view after LAA closure using the Amplatzer Cardiac Plug,<sup>29,30</sup> but also in off-axis parasternal long-axis views following atrial septal defect or patent foramen ovale closure procedures.<sup>31</sup> In contrast, three-dimensional echocardiographic imaging with the beam propagating perpendicular to the plane of the device (frontal probe position) will correctly display the rounded extent of the occluder.<sup>29</sup>

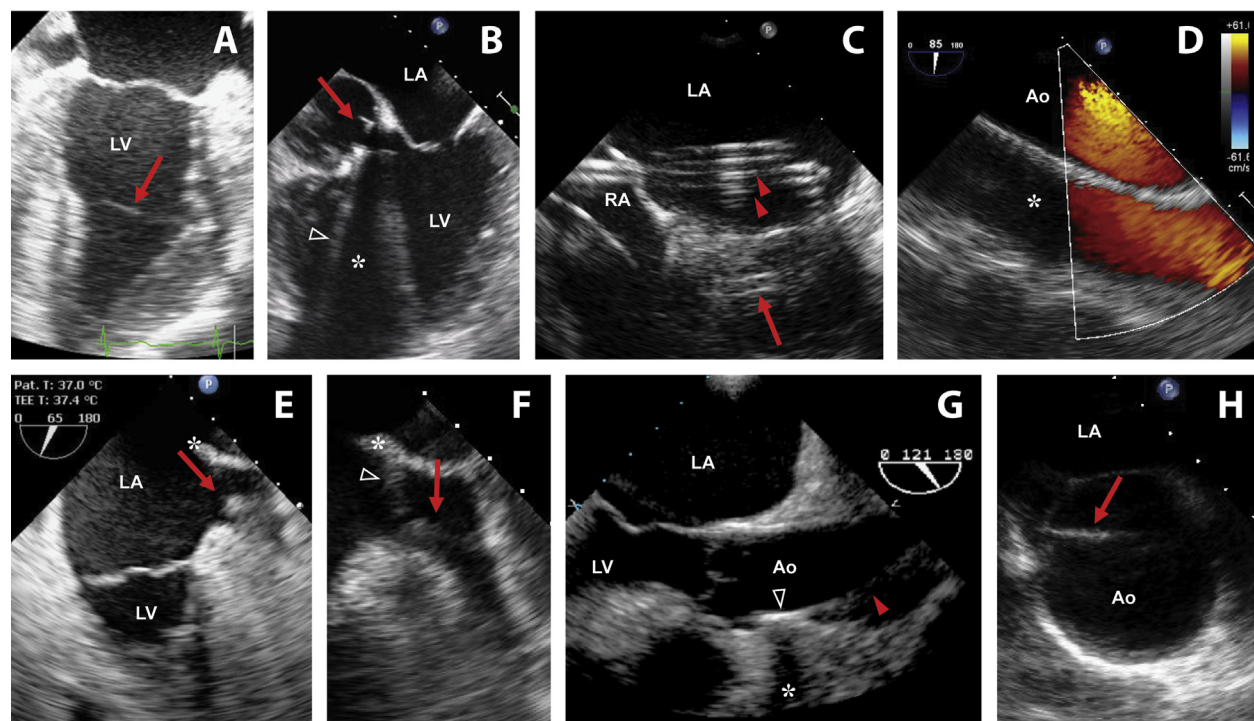
**Figure 10** Transesophageal image artifacts. **(A)** Reverberation artifact of mitral valve leaflet at exactly twice the distance from the probe, presenting as a wire in the left ventricular cavity (Video 15; available at [www.onlinejase.com](http://www.onlinejase.com)). **(B)** Mechanical aortic valve casting an acoustic shadow over the majority of the right ventricle (RV) (asterisk) and a reverberation (comet tail) to the side (arrowhead) (Video 16; available at [www.onlinejase.com](http://www.onlinejase.com)). **(C)** Transseptal guiding catheter during pulmonary vein isolation procedure presenting with a series of closely spaced reverberations (arrowheads) due to reflections at the upper and lower side of the (hollow) catheter and one reverberation at twice the distance to the probe due to reflection at the transducer itself. **(D)** Mirror artifact (asterisk) of the ascending aorta (Ao) mimicking two parallel aortas. Notice the mirroring of the color flow in the mirror image as well, the mechanism being similar (i.e., the assumption of wave propagation) (Video 17; available at [www.onlinejase.com](http://www.onlinejase.com)). **(E)** Reverberation artifact in the LAA mimicking thrombus. Detailed analysis from multiple angles **(F)** and applying color flow imaging in the respective region confirms the presence of a reverberation from the warfarin ridge (asterisk) rather than true thrombus (Videos 18–20; available at [www.onlinejase.com](http://www.onlinejase.com)). **(G)** Side-lobe artifact (arrow) from a calcified sinotubular junction (arrowhead) extending in the ascending aorta (Video 21; available at [www.onlinejase.com](http://www.onlinejase.com)) should not be misinterpreted as a dissection flap. **(H)** Similarly, a reverberation in the ascending aorta might be misinterpreted as being a dissection flap. LA, Left atrium; LV, left ventricle; RA, right atrium.

Although this overview article is focused mainly on routine transthoracic echocardiography, the aforementioned artifacts are frequently encountered in transesophageal echocardiography as well.<sup>4,23,39-41</sup> Figure 10 displays a selection of common artifacts in transesophageal echocardiography. The most relevant clinical situations in this respect are (1) excluding thrombus in the LAA (Figures 10E and 10F) and (2) excluding aortic dissection<sup>42</sup> (Figures 10G and 10H). Reverberations,

mirror artifacts, and side-lobe artifacts in particular play an important role in these settings because of the often linear aspect of the artifact, resembling a dissection flap in the ascending or descending aorta,<sup>43-47</sup> or mimicking a thrombus in the LAA.<sup>48,49</sup> Historically, lack of recognition of artifacts in transesophageal echocardiography for aortic dissection created the impression that echocardiography lacked specificity for the diagnosis relative to other modalities such as magnetic resonance imaging,<sup>50</sup> a misimpression that can be eliminated by understanding the nature of artifacts. Furthermore, in the early years of transesophageal imaging, occasional patients were being operated on because of artifacts now largely eliminated by our understanding. Even so, to date patients are still receiving anticoagulation rather than undergoing immediate cardioversion for atrial fibrillation because of image artifacts. This again shows the importance of understanding the physics of ultrasound reflection, refraction, and beam formation, a practical consequence of that knowledge.
