Report

26 Windsor Gardens

Whitley Bay

Woodworm suspected to: **Damp & Woodworm Survey**

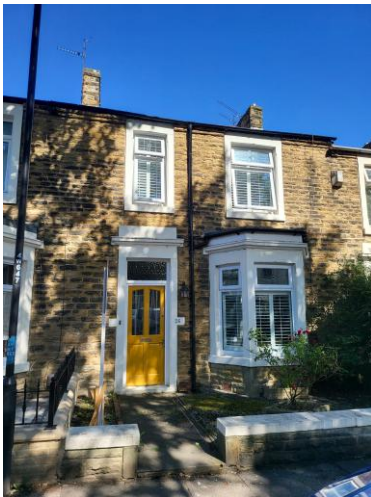
Front Elevation

The property is a: Mid terrace

The property is constructed of : Brick Stone and slate

The property was built approximately : 1900s

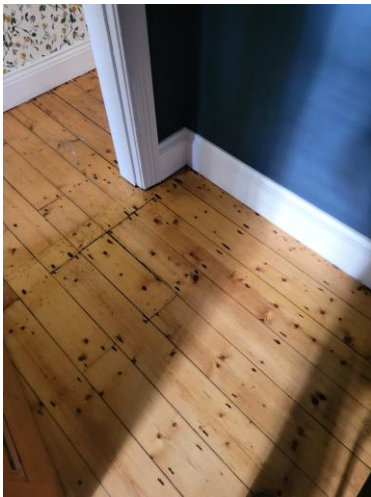
Hallway

Movement - vibration in corner of room

- Create discrete openings as required to facilitate treatment.
- Carry out treatment for woodboring insects using our environmentally friendly (water based with no solvents or propellants) micro biocidal fluid fogging system.
- Carry out repair to section of floor vibration movement was noted (see diagram)

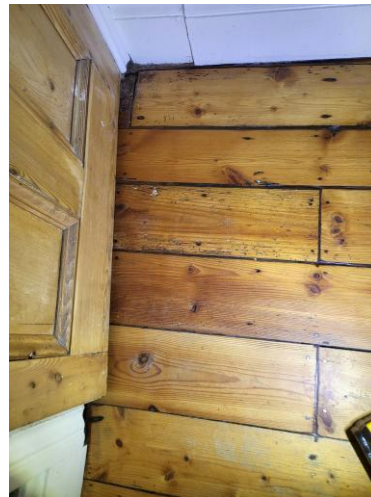
Our inspection confirmed an active infestation of common furniture beetle (*anobium punctatum* - picture below).

Woodworm noted to floorboards

We will apply new generation, Microtec woodworm treatment chemicals using our specialist Electronic aerosol micro spray system. This system allows the work to be carried out with minimum disruption. Treatment by electro-aerosol allows the chemical to permeate all connected voids with extremely high surface coverage even to remote areas.

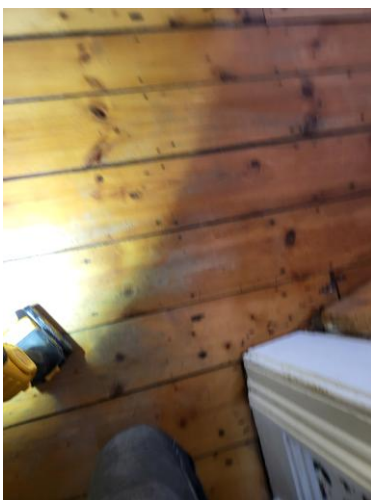
Woodworm noted to floorboards

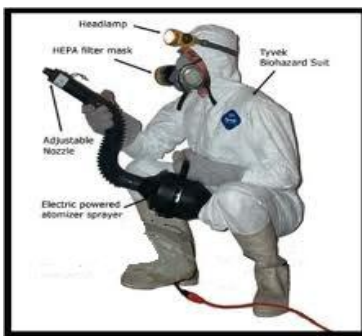
Electro-aerosol applicator

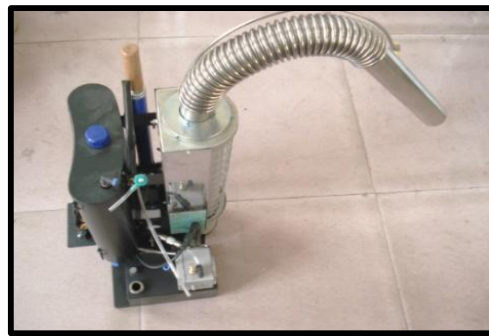
Atomised micro-spray fogging

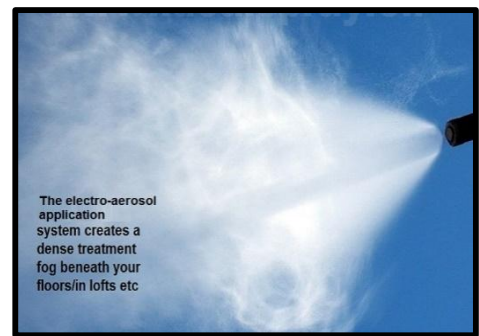
Exclusion Zone

There will be no permitted entry to the areas of treatment, during the treatment and for 1 hour after completion of treatment works. Exclusion will be to the whole of all rooms treated and if communal areas such as halls, landings are treated we advise vacating the whole property. This applies to humans and all animals/pets.
