# Geomorphology of thermo-erosion gullies – case study from Bylot Island, Nunavut, Canada

Godin Etienne, Fortier Daniel

Département de Géographie – Université de Montréal, Montréal, Québec, Canada

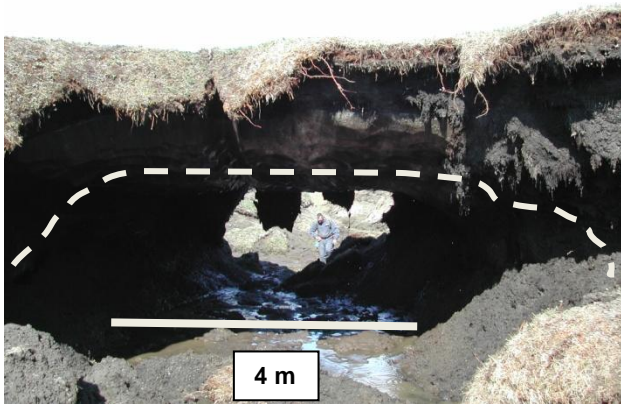
Figure 7 : Exposed tunnel in permafrost. The broken line indicates the ceiling of the tunnel.

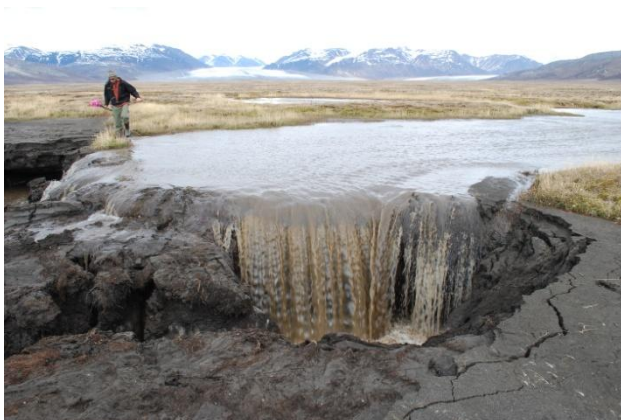
Figure 8 : Gully head in ice wedge polygons forming falls, (person for scale).

Gully head were points of active thermo-erosion where water penetrated in the gully network by way of waterfalls (Figure 8). Gully heads were essentially present in the high-erosion activity zone and to a lesser extent in the intermediate-erosion activity zone. They were absent from the low-activity zone downstream. Gully heads were deactivated during the summer when runoff became insignificant.

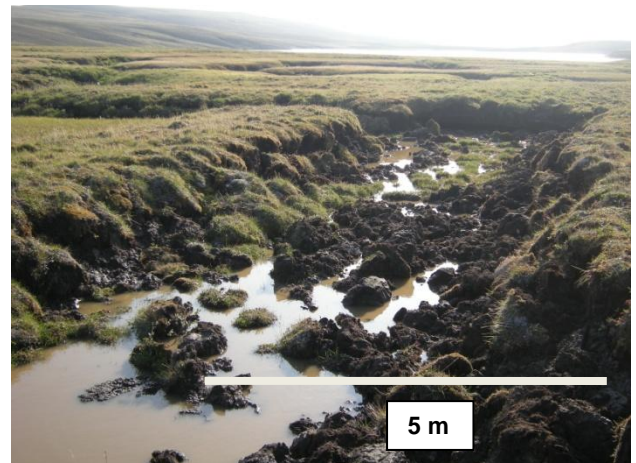
Figure 11 : A fresh collapse following thermo-erosion of ice wedge polygons.

Tunnel collapse and associated active layer slumps were observed essentially in the intermediate-erosion activity zone and to a lesser extent in the low-erosion activity zone (Figure 11). Collapses create baydjarakhs which became better developed with time in the low thermo-erosion activity zone.
