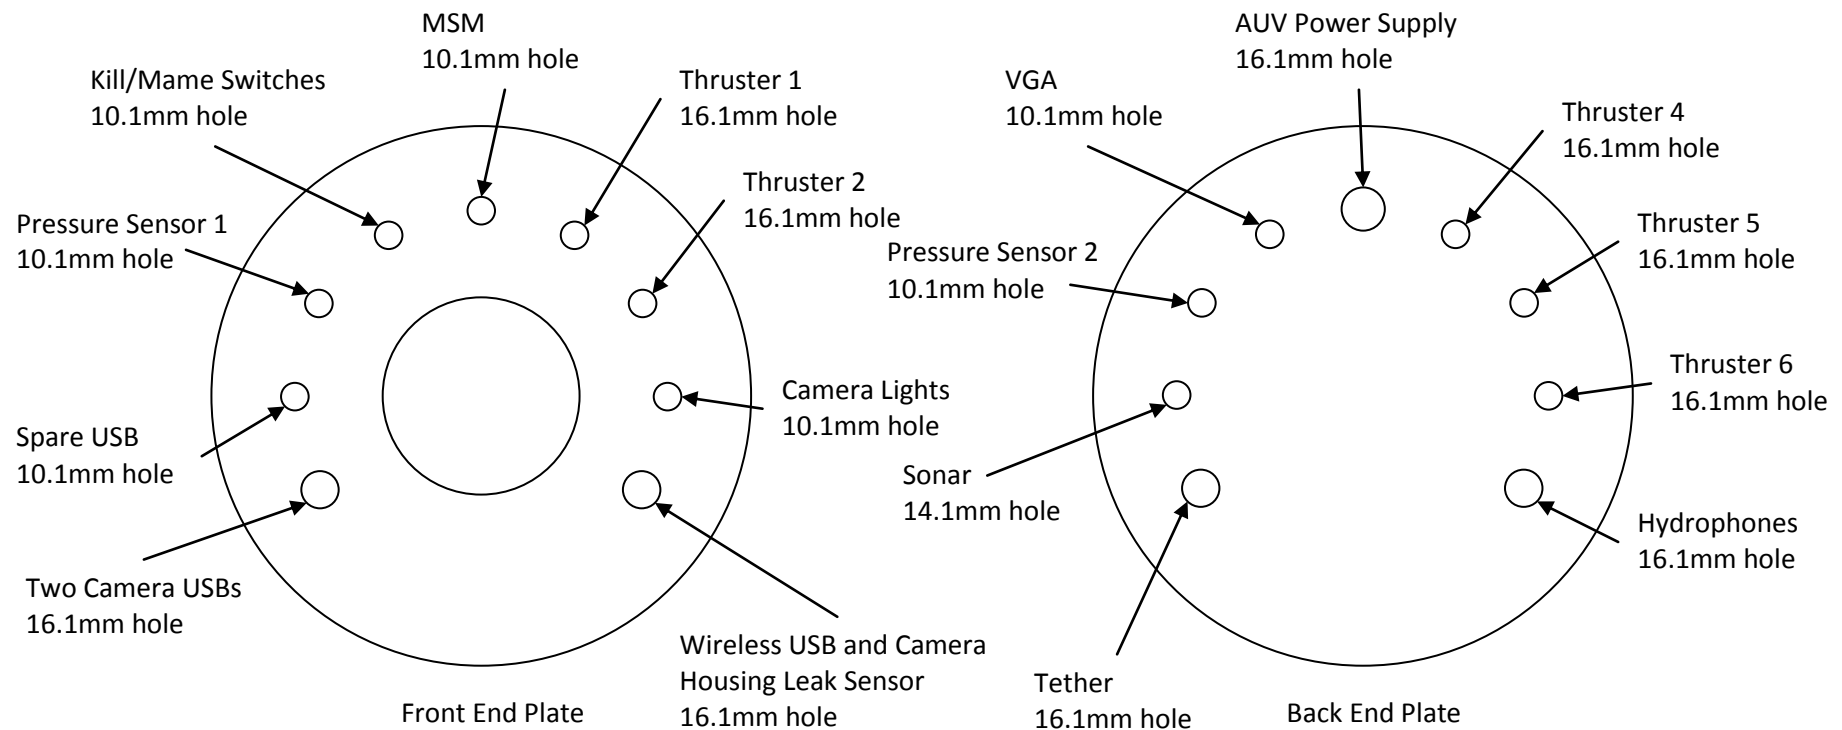
Note: The tether hole is wider than it needs to be because the waterjet cut the hole too big so it has been made larger so it will fit a connector well

Note: Both end plates are being viewed from the outside of the vehicle
