(wafer1,0,0,-1,-1,2,2) Characteristics

- **Cell Size:** 10um
- **Times Accessed:** 27
- **Last Measurement:** 2022/February/28 at 05:01PM

Summary

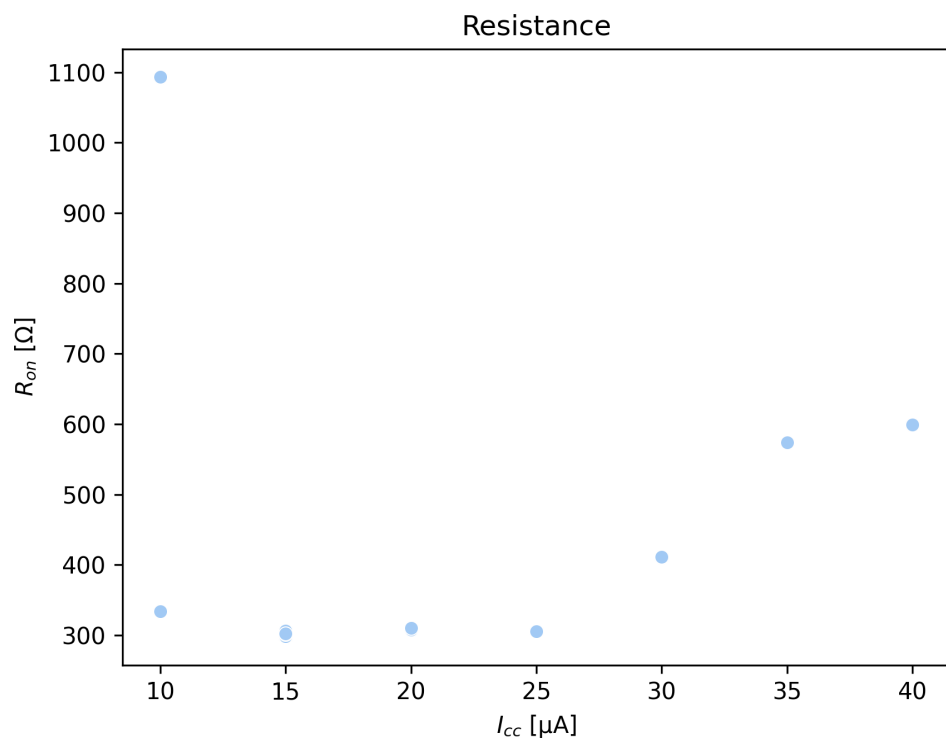
Cycle #	Set Icc (μ A)	Set Voltage (V)	R_on (Ω)	R2
1	10.0	2.80	333.83	1.000
2	10.0	2.80	96753327.60	0.194
3	20.0	4.15	309.44	1.000
4	20.0	4.15	308.05	1.000
5	20.0	4.15	310.35	1.000
6	25.0	4.35	305.26	1.000
7	30.0	4.55	411.54	1.000
8	35.0	4.50	574.24	0.998
9	40.0	4.40	599.46	0.998
10	10.0	2.20	1093.37	1.000
11	15.0	4.55	306.12	1.000
12	15.0	4.55	297.47	1.000
13	15.0	4.55	297.90	1.000
14	15.0	4.55	298.43	1.000
15	15.0	4.55	301.28	1.000
16	15.0	4.55	302.05	1.000

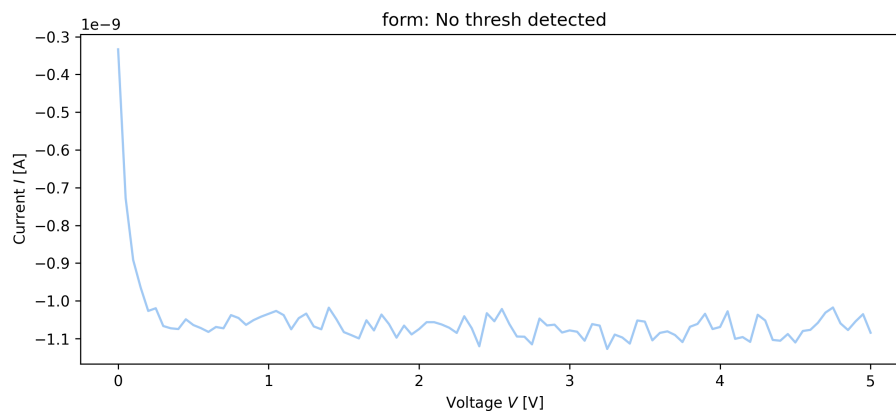
form

- **Time:** 04:16:09PM
- **Icc:** 10.0uA
- **Voltage Range:** 0V \rightarrow 5V
- **Target Ramp Rate:** 1V/s
- **True Ramp Rate:** 1.069 V/s*
- **Cycle:** 1
- **Error:** Set failed

Failure to form. Bad probe to pad contact. A: Copper, B: Platinum.

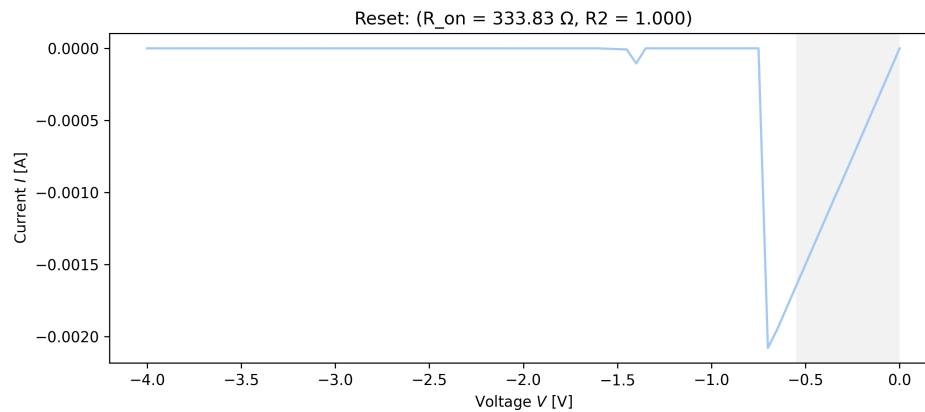
reset

- **Time:** 04:19PM
- **I_{cc}:** 5.0mA
- **Voltage Range:** 0V → -4V
- **Target Ramp Rate:** 1V/s
- **True Ramp Rate:** -1.342 V/s*
- **Cycle:** 1
- **Resistance:** 333.83 Ω
- **Linear Fit R2:** 1.000

Success. AV column missing, copied from run 2202281620. This run was a near perfect reset. A: Copper, B: Platinum.

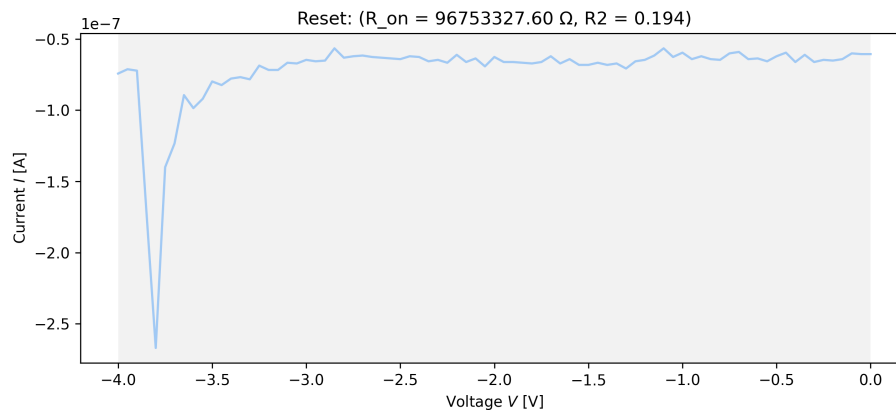
reset

- **Time:** 04:20PM
- **I_{cc}:** 5.0mA
- **Voltage Range:** 0V → -4V
- **Target Ramp Rate:** 1V/s
- **True Ramp Rate:** -1.068 V/s*
- **Cycle:** 2
- **Resistance:** 96753327.60 Ω
- **Linear Fit R2:** 0.194

Retry and observation from run 2202281619 due to missing AV column. A: Copper, B: Platinum.

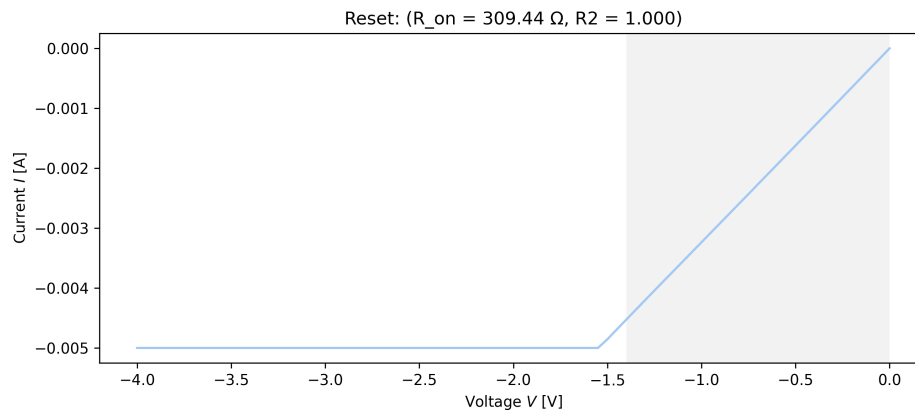
reset

- **Time:** 04:29PM
- **I_{cc}:** 5.0mA
- **Voltage Range:** 0V → -4V
- **Target Ramp Rate:** 1V/s
- **True Ramp Rate:** -1.609 V/s*
- **Cycle:** 3
- **Resistance:** 309.44 Ω
- **Linear Fit R²:** 1.000

Failure to reset. A: Copper, B: Platinum.

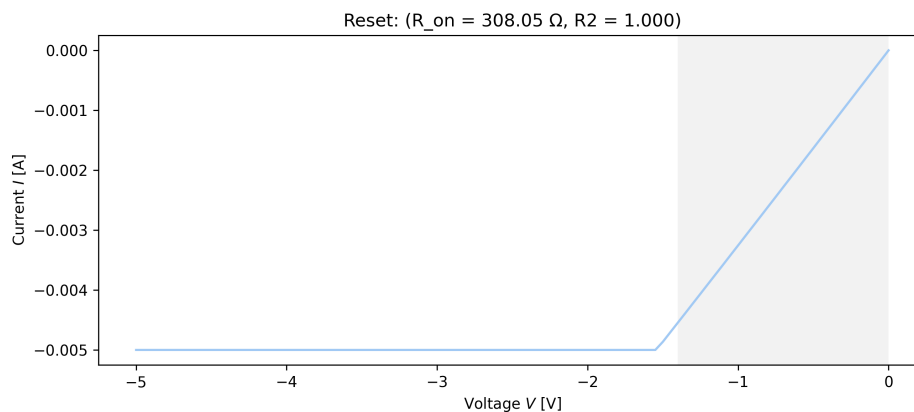
reset

- **Time:** 04:30PM
- **I_{cc}:** 5.0mA
- **Voltage Range:** 0V → -5V
- **Target Ramp Rate:** 1V/s
- **True Ramp Rate:** -1.609 V/s*
- **Cycle:** 4
- **Resistance:** 308.05 Ω
- **Linear Fit R²:** 1.000

Reset failure. A: Copper, B: Platinum

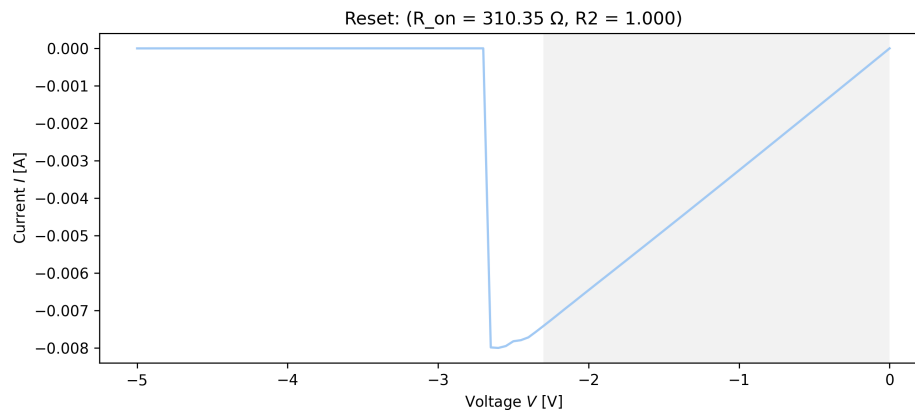
reset

- **Time:** 04:31PM
- **I_{cc}:** 8.0mA
- **Voltage Range:** 0V → -5V
- **Target Ramp Rate:** 1V/s
- **True Ramp Rate:** -1.608 V/s*
- **Cycle:** 5
- **Resistance:** 310.35 Ω
- **Linear Fit R²:** 1.000

Reset success. A: Copper, B: Platinum.

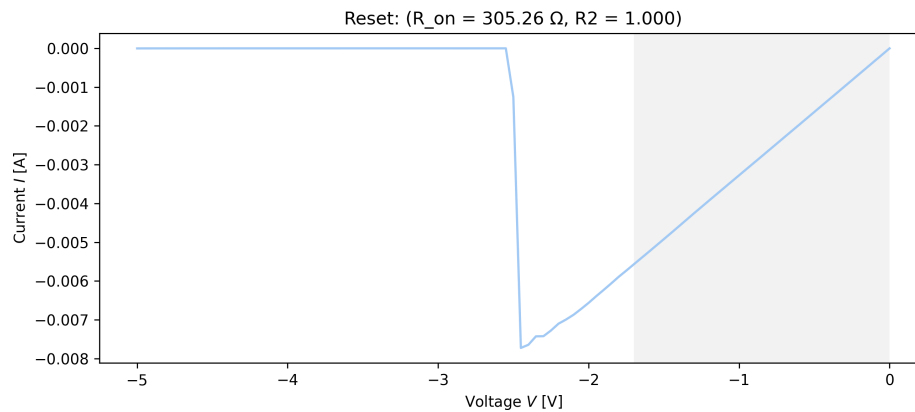
reset

- **Time:** 04:36PM
- **I_{cc}:** 8.0mA
- **Voltage Range:** 0V → -5V
- **Target Ramp Rate:** 1V/s
- **True Ramp Rate:** -1.609 V/s*
- **Cycle:** 6
- **Resistance:** 305.26 Ω
- **Linear Fit R²:** 1.000

Successful reset. A: Copper, B: Platinum.

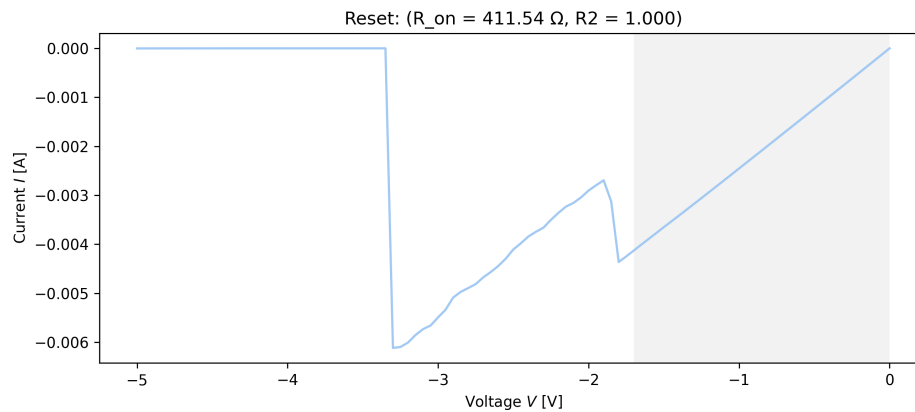
reset

- **Time:** 04:38PM
- **I_{cc}:** 8.0mA
- **Voltage Range:** 0V → -5V
- **Target Ramp Rate:** 1V/s
- **True Ramp Rate:** -1.514 V/s*
- **Cycle:** 7
- **Resistance:** 411.54 Ω
- **Linear Fit R2:** 1.000

Reset success. But not smooth. A: Copper, B: Platinum.

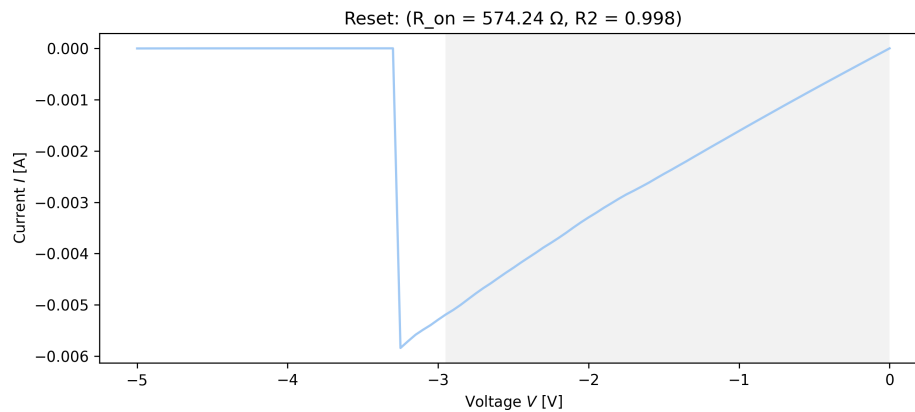
reset

- **Time:** 04:41PM
- **I_{cc}:** 8.0mA
- **Voltage Range:** 0V → -5V
- **Target Ramp Rate:** 1V/s
- **True Ramp Rate:** -1.352 V/s*
- **Cycle:** 8
- **Resistance:** 574.24 Ω
- **Linear Fit R²:** 0.998

Successful reset, very smooth. A: Copper, B: Platinum.

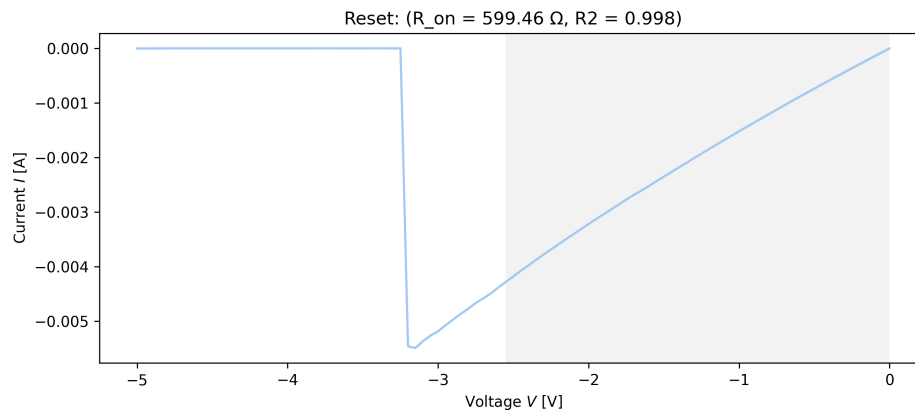
reset

- **Time:** 04:45:54PM
- **I_{cc}:** 8.0mA
- **Voltage Range:** 0V → -5V
- **Target Ramp Rate:** 1V/s
- **True Ramp Rate:** -1.351 V/s*
- **Cycle:** 9
- **Resistance:** 599.46 Ω
- **Linear Fit R²:** 0.998

Successful reset. A: Copper, B: Platinum

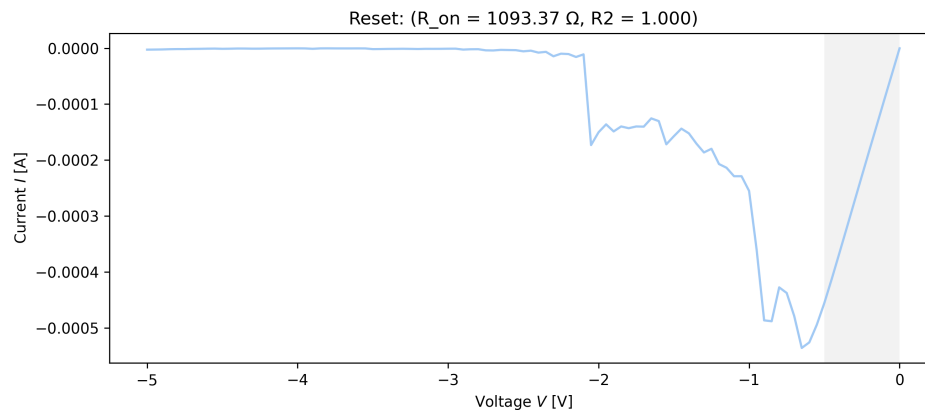
reset

- **Time:** 04:48PM
- **I_{cc}:** 8.0mA
- **Voltage Range:** 0V → -5V
- **Target Ramp Rate:** 1V/s
- **True Ramp Rate:** -1.091 V/s*
- **Cycle:** 10
- **Resistance:** 1093.37 Ω
- **Linear Fit R²:** 1.000

Successful reset, but very janky. A: Copper, B: Platinum.

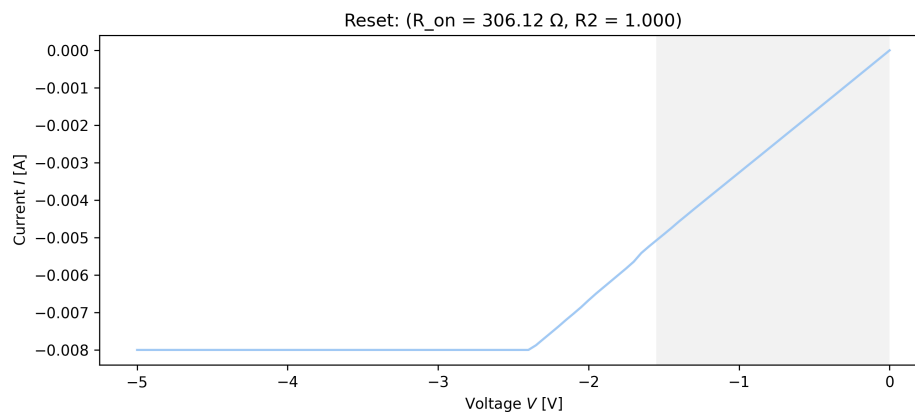
reset

- **Time:** 04:54PM
- **I_{cc}:** 8.0mA
- **Voltage Range:** 0V → -5V
- **Target Ramp Rate:** 1V/s
- **True Ramp Rate:** -1.609 V/s*
- **Cycle:** 11
- **Resistance:** 306.12 Ω
- **Linear Fit R²:** 1.000

Reset failed. A: Copper, B: Platinum

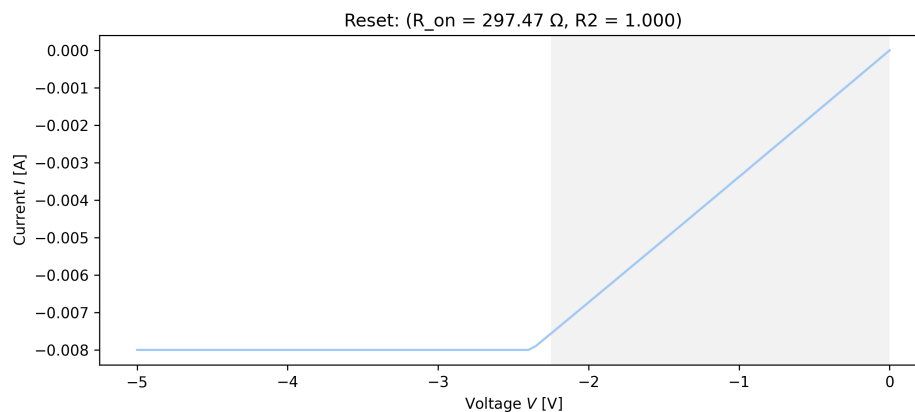
reset

- **Time:** 04:55:04PM
- **I_{cc}:** 8.0mA
- **Voltage Range:** 0V → -5V
- **Target Ramp Rate:** 1V/s
- **True Ramp Rate:** -1.609 V/s*
- **Cycle:** 12
- **Resistance:** 297.47 Ω
- **Linear Fit R2:** 1.000

Reset failed. A: Copper, B: Platinum.

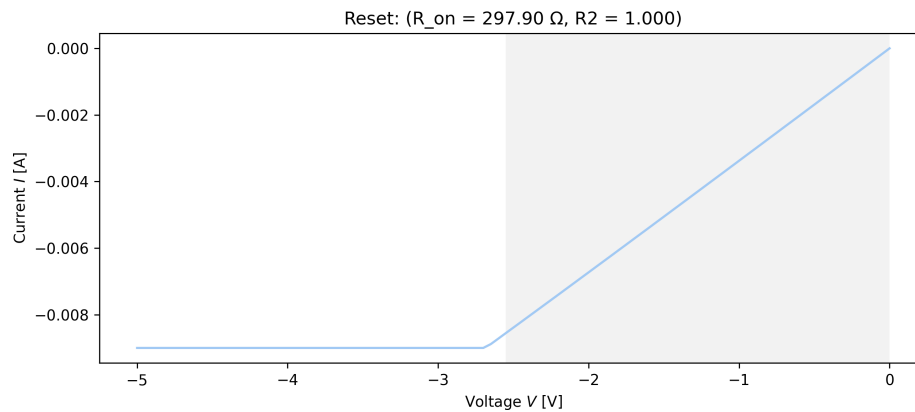
reset

- **Time:** 04:55:32PM
- **I_{cc}:** 9.0mA
- **Voltage Range:** 0V → -5V
- **Target Ramp Rate:** 1V/s
- **True Ramp Rate:** -1.609 V/s*
- **Cycle:** 13
- **Resistance:** 297.90 Ω
- **Linear Fit R²:** 1.000

Reset failed. Something wrong, cell is possibly burnt out (i.e. too strong of a filament. A: Copper, B: Platinum).

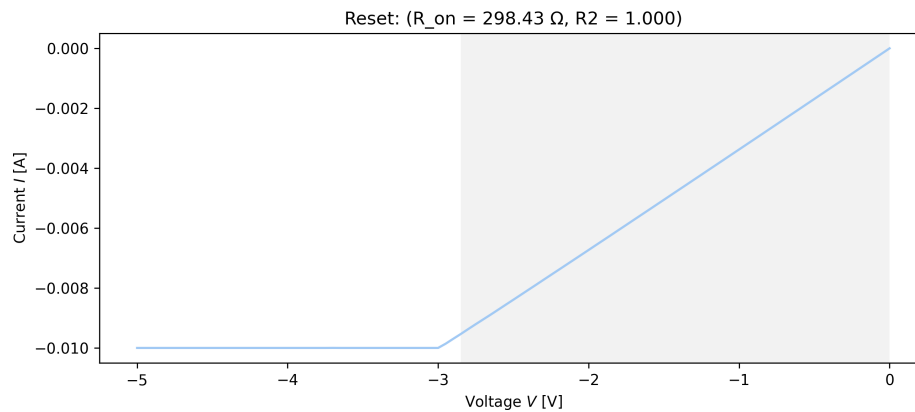
reset

- **Time:** 04:57PM
- **Icc:** 10.0mA
- **Voltage Range:** 0V \rightarrow -5V
- **Target Ramp Rate:** 1V/s
- **True Ramp Rate:** -1.610 V/s*
- **Cycle:** 14
- **Resistance:** 298.43 Ω
- **Linear Fit R2:** 1.000

Reset failed. A: Copper, B: Platinum

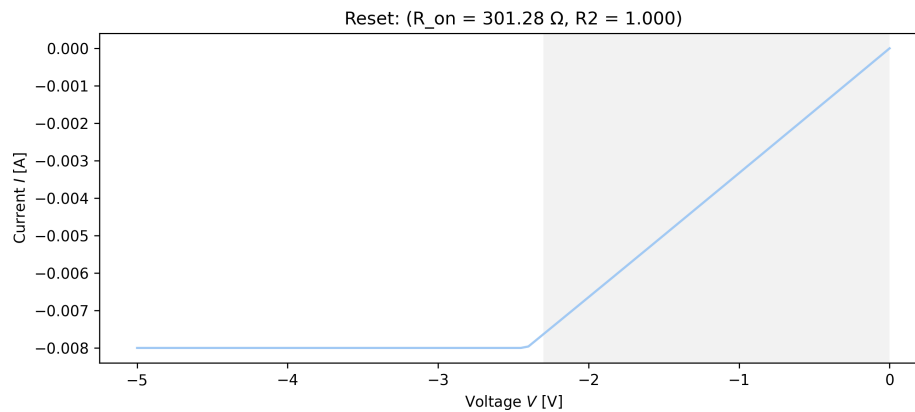
- **Time:** 04:59:04PM
- **I_{cc}:** 8.0mA
- **Voltage Range:** 0V → -5V
- **Target Ramp Rate:** 1V/s
- **True Ramp Rate:** -1.610 V/s*
- **Cycle:** 15
- **Resistance:** 301.28 Ω
- **Linear Fit R²:** 1.000

Failed reset again. A: Copper, B: Platinum.

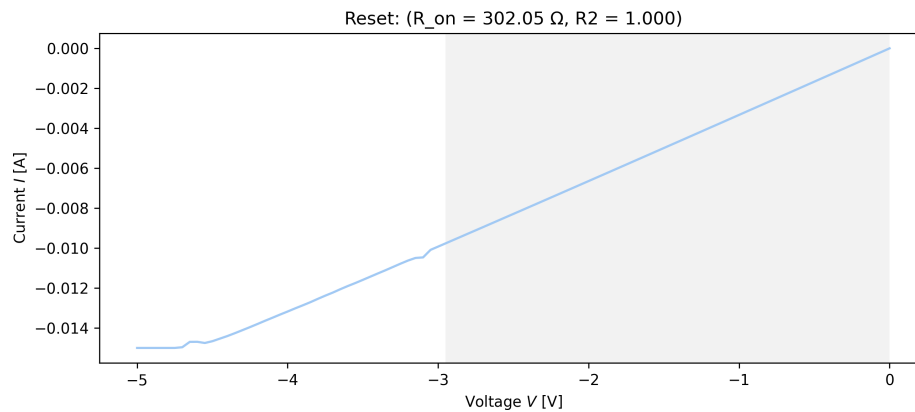
reset

- **Time:** 04:59:43PM
- **Icc:** 15.0mA
- **Voltage Range:** 0V \rightarrow -5V
- **Target Ramp Rate:** 1V/s
- **True Ramp Rate:** -1.087 V/s*
- **Cycle:** 16
- **Resistance:** 302.05 Ω
- **Linear Fit R2:** 1.000

Reset fail. Cell damage confirmed. A: Copper, B: Platinum.
