(wafer2,0,1,-1,-1,1,1) Characteristics

- **Cell Size:** 10um
- **Times Accessed:** 3
- **Last Measurement:** 2022/March/17 at 03:54:56PM

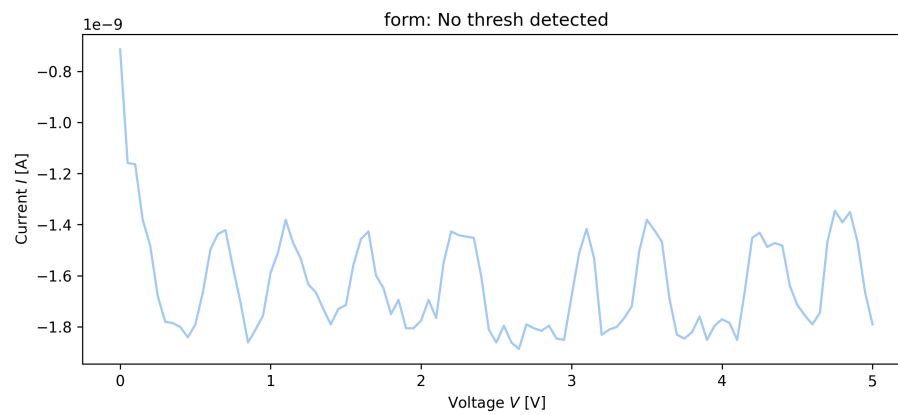
form

- **Time:** 03:53:44PM
- **Icc:** 20.0uA
- **Voltage Range:** 0V \rightarrow 5V
- **Target Ramp Rate:** 1V/s
- **True Ramp Rate:** 1.069 V/s*
- **Cycle:** 1
- **Error:** Set failed

Not conducting

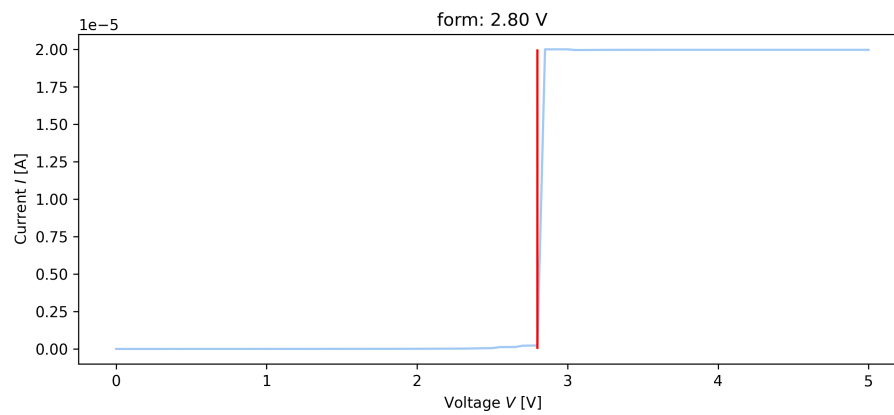
form

- **Time:** 03:54:56PM
- **Icc:** 20.0uA
- **Voltage Range:** 0V \rightarrow 5V
- **Target Ramp Rate:** 1V/s
- **True Ramp Rate:** 1.069 V/s*
- **Cycle:** 1
- **Set Voltage:** 2.80 V

Formed at 2.85
