# (wafer2,2,0,-1,-1,0,2) Characteristics

- **Cell Size:** 15um
- **Times Accessed:** 14
- **Last Measurement:** 2022/March/23 at 03:57:19PM

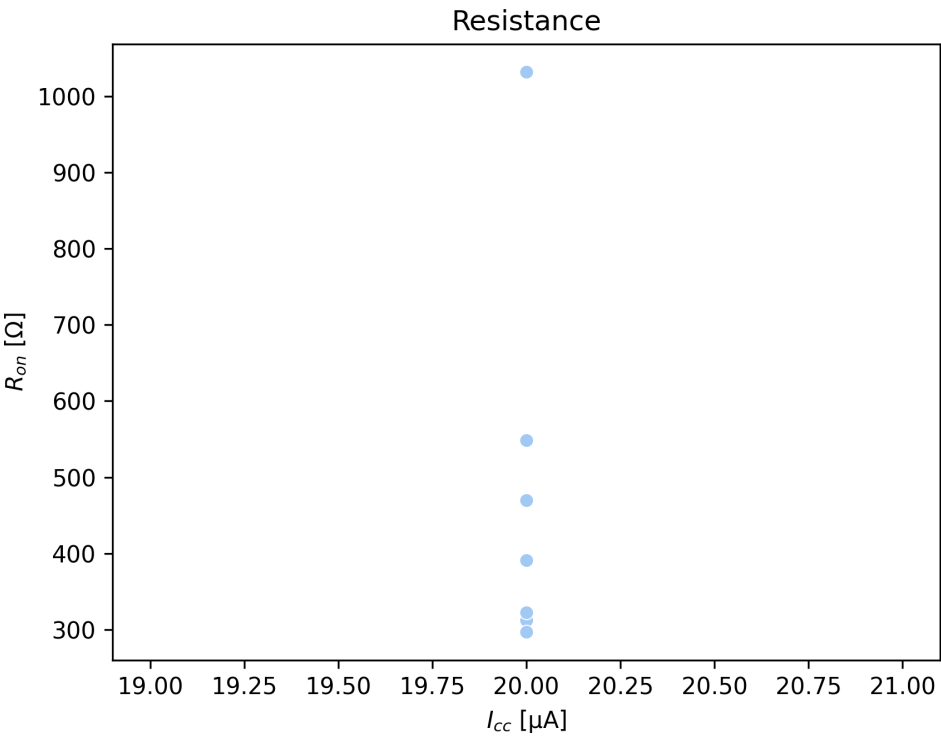
## Summary

Cycle #	Set Icc (μA)	Set Voltage (V)	R_on (Ω)	R2
1	20.0	1.50	548.23	1.000
2	20.0	1.60	469.53	1.000
3	20.0	1.60	298.30	1.000
4	20.0	1.60	1031.86	1.000
5	20.0	1.60	312.89	1.000
6	20.0	1.65	166608.91	0.699
7	20.0	1.65	390.81	1.000
8	20.0	1.65	312.25	1.000
9	20.0	1.65	322.49	1.000
10	20.0	1.65	296.82	1.000

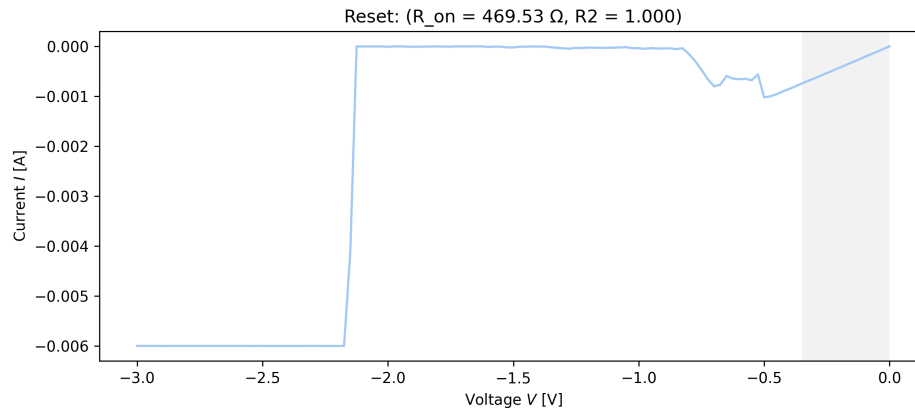
## reset

- **Time:** 03:45:57PM
- **I<sub>cc</sub>:** 6.0mA
- **Voltage Range:** 0V → -3V
- **Target Ramp Rate:** 1V/s
- **True Ramp Rate:** -0.596 V/s\*
- **Cycle:** 2
- **Resistance:** 469.53 Ω
- **Linear Fit R2:** 1.000

reset fail.

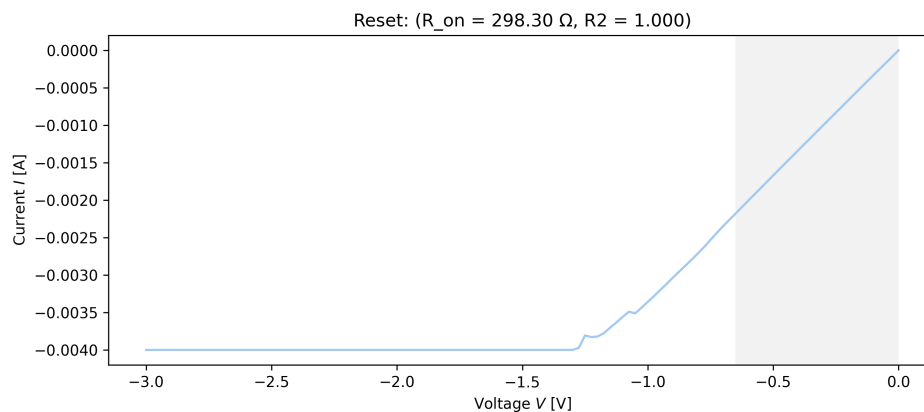
## reset

- **Time:** 03:47:07PM
- **I<sub>cc</sub>:** 4.0mA
- **Voltage Range:** 0V → -3V
- **Target Ramp Rate:** 1V/s
- **True Ramp Rate:** -0.826 V/s\*
- **Cycle:** 3
- **Resistance:** 298.30 Ω
- **Linear Fit R<sup>2</sup>:** 1.000

reset fail.

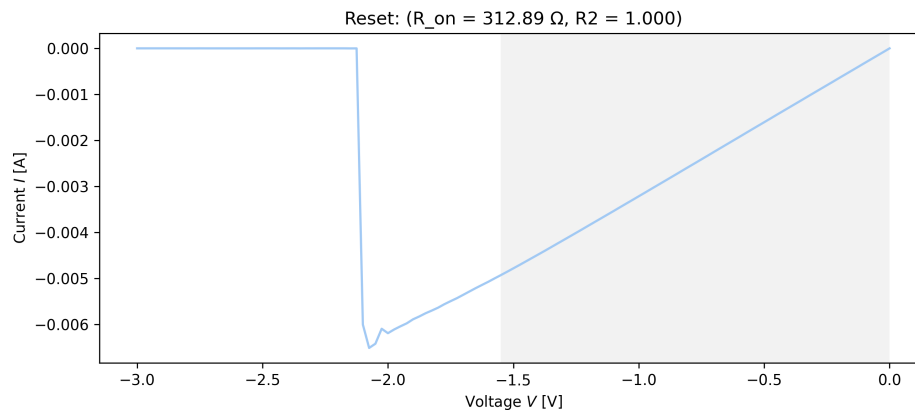
## reset

- **Time:** 03:48:37PM
- **I<sub>cc</sub>:** 8.0mA
- **Voltage Range:** 0V → -3V
- **Target Ramp Rate:** 1V/s
- **True Ramp Rate:** -0.826 V/s\*
- **Cycle:** 5
- **Resistance:** 312.89 Ω
- **Linear Fit R<sup>2</sup>:** 1.000

reset success, but took about 6.5mA. Looking good.

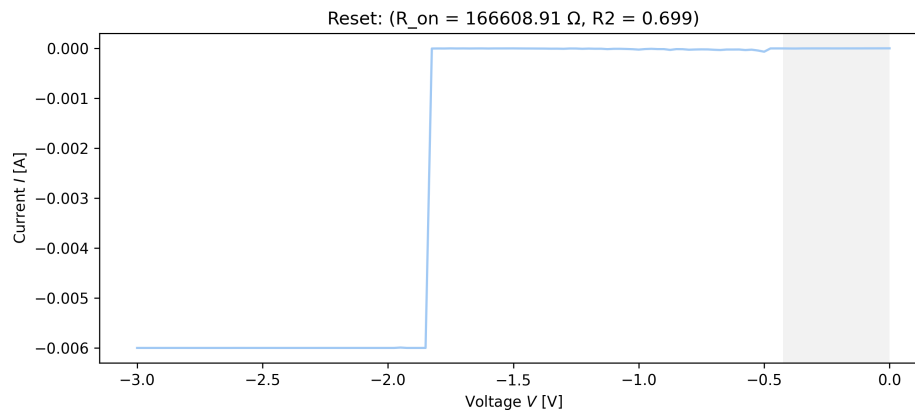
## reset

- **Time:** 03:53:42PM
- **Icc:** 6.0mA
- **Voltage Range:** 0V  $\rightarrow$  -3V
- **Target Ramp Rate:** 1V/s
- **True Ramp Rate:** -0.548 V/s\*
- **Cycle:** 6
- **Resistance:** 166608.91  $\Omega$
- **Linear Fit R2:** 0.699

reset fail.

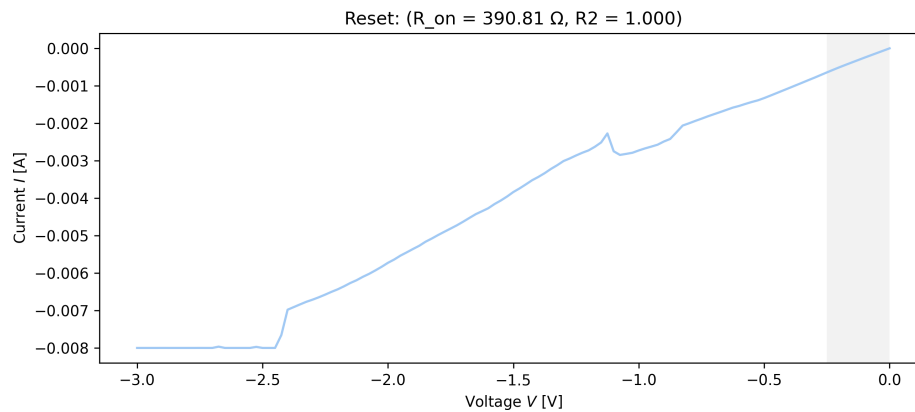
## reset

- **Time:** 03:54:40PM
- **I<sub>cc</sub>:** 8.0mA
- **Voltage Range:** 0V → -3V
- **Target Ramp Rate:** 1V/s
- **True Ramp Rate:** -0.788 V/s\*
- **Cycle:** 7
- **Resistance:** 390.81 Ω
- **Linear Fit R2:** 1.000

reset fail.

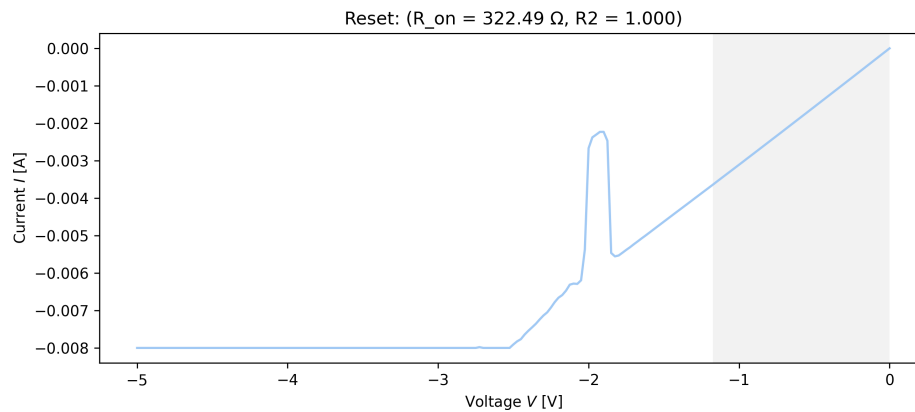
## reset

- **Time:** 03:56:15PM
- **Icc:** 8.0mA
- **Voltage Range:** 0V  $\rightarrow$  -5V
- **Target Ramp Rate:** 1V/s
- **True Ramp Rate:** -0.813 V/s\*
- **Cycle:** 9
- **Resistance:** 322.49  $\Omega$
- **Linear Fit R2:** 1.000

reset fail, but weird bump in between.

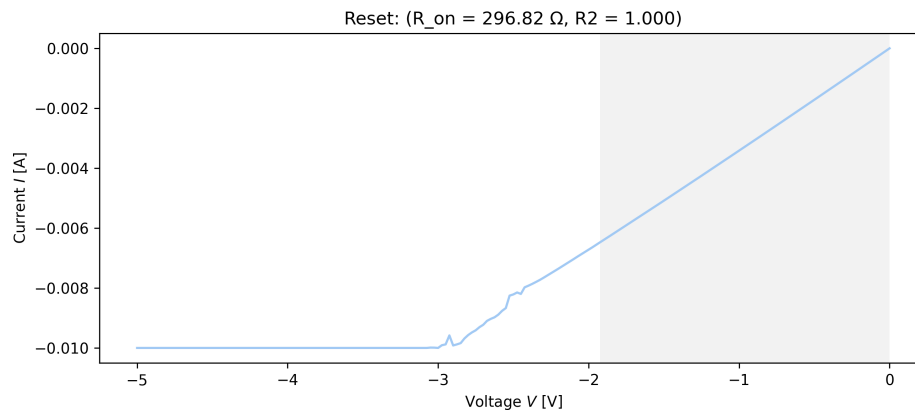
## reset

- **Time:** 03:57:19PM
- **I<sub>cc</sub>:** 10.0mA
- **Voltage Range:** 0V → -5V
- **Target Ramp Rate:** 1V/s
- **True Ramp Rate:** -0.826 V/s\*
- **Cycle:** 10
- **Resistance:** 296.82 Ω
- **Linear Fit R<sup>2</sup>:** 1.000

reset fail. giving up on this cell.
