Figure 62-13. Ultrasonic Equipment Display

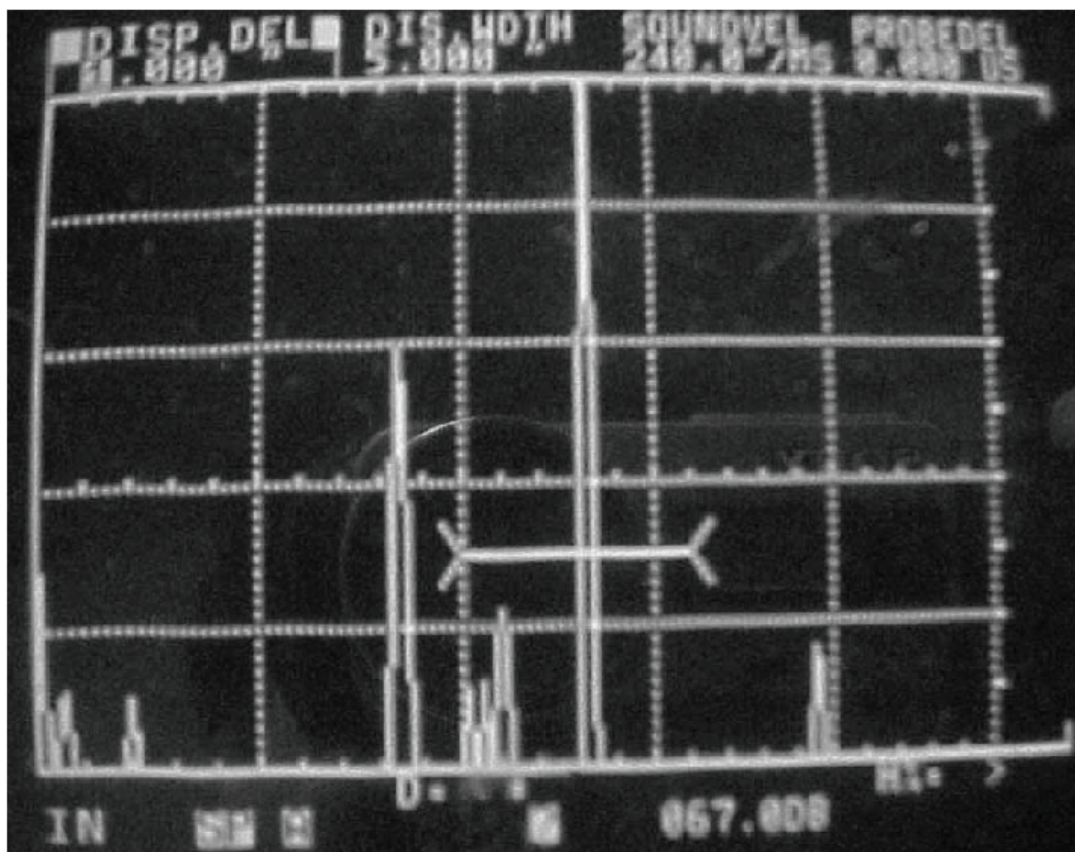
1. Any response similar to that shown above that is within the GATE is cause for rejection.
2. The signal that appears to the left of the GATE will be displayed throughout the inspection; it is not considered relevant.
