20. January 2010, [hb9pit@uska.ch](mailto:hb9pit@uska.ch)

## MC-60A RFI Modification

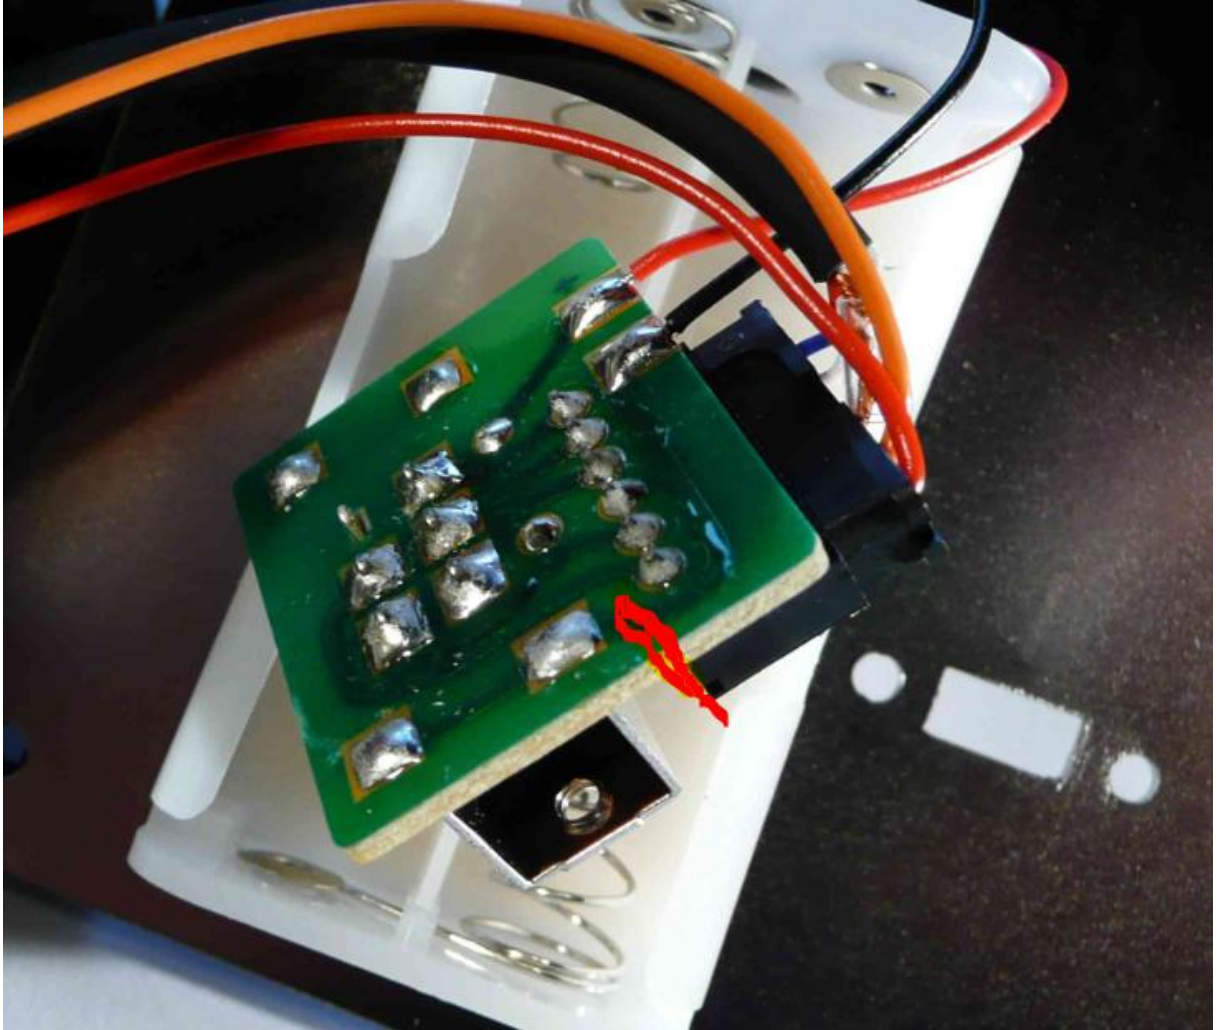
Just switching off the preamp is not a solution when you have RFI problems with that fine Kenwood mic. Then the mic level is too low for VOX operation. But it is so easy to fix the problem. Just open the mic and unscrew the switch at the bottom plate. Then cut the copper foil of the PC switch-board between the switch housing and the black wire. That can be done with a knife. Many hams did that modification with success.
