HISTORIC AMERICAN TIMBER-FRAMED STEEPLES

I. Middlebury, Vermont

This article is first in a series to discuss the form, function and joinery of selected historic American timber-framed steeples. The series was developed from original research under a grant from the National Park Service and the National Center for Preservation Technology and Training. Its contents are solely the responsibility of the authors and do not represent the official position of the NPS or the NCPTT.

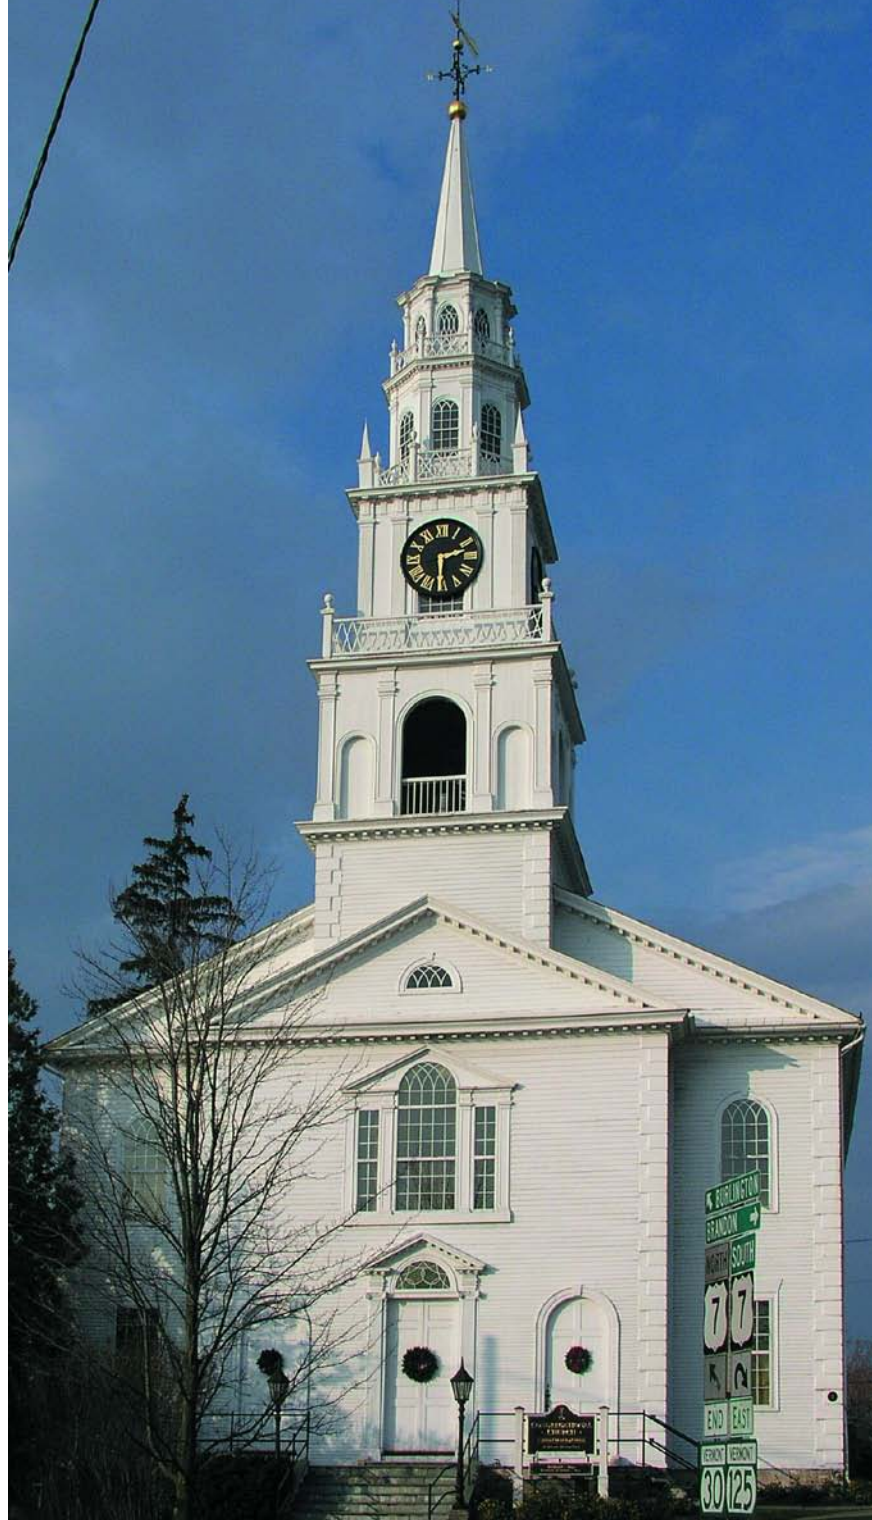
A square lantern of somewhat smaller footprint rises next, with ranked, fluted pilasters and large clock faces, added in 1853, that unfortunately interrupt the original design of ascending arched windows. Above that, the first octagonal lantern emerges and then a shorter octagonal lantern above that with elliptical fenestration. This second lantern is surmounted by a spire, ball and vane, of which the comet-form arrow is itself 6 ft. long. The overall height to the top of the vane is 135 ft., but the church's position at the crest of a hill above the center of the village makes it appear taller (Fig. 1).

Fig. 1. Middlebury Congregational Church (1806-1809), designed by Lavius Fillmore, stands at the top of a hill at an important road junction. Fig. 2, below, post at left rear rises through vaulting to help support a roof truss carrying back wall of steeple.

Clock stage. The third stage, the clock stage, is still square in plan but smaller than the tower and belfry stages, though architecturally similar. Since 1853 it has displayed the clock, perhaps enhancing the timeliness of the citizens, but interrupting the graceful vertical development of Fillmore's design by almost entirely occluding the arched windows behind the clock faces (Figs. 1 and 3).

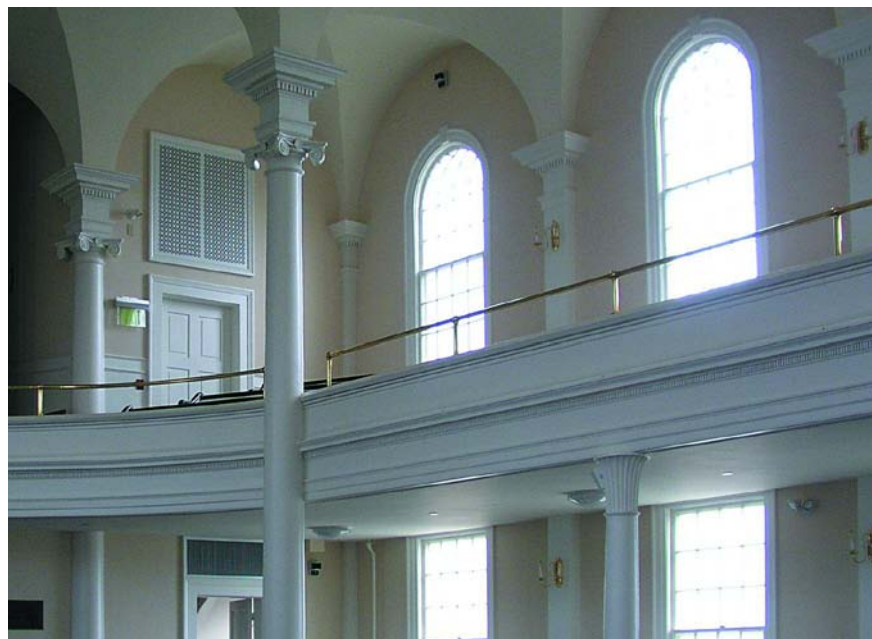
THE STRUCTURAL FOUNDATION. Middlebury's weighty steeple is integrated with the exterior and interior design of the church. The front of the tower appears to rise from the front wall of the portico, although the two front tower columns disappear from sight descending inside the portico wall, dropping ultimately to the sill and limestone foundation at grade, a feature shared with Brown's First Baptist of Providence. Longitudinal 12x14 main sleepers tenoned into these front posts right above the interrupted portico plate cross the 11x13 front wall plate of the church 5 ft. inward, and then the fully supported vestibule wall 12 ft. farther inward, ultimately terminating over the lower chord of the second interior kingpost truss. This truss is in turn propped by colossal columns rising through the audience room, supporting the galleries, passing through two levels of decorative capitals and tenoning into the truss several feet to the outside of the sleeper (Fig. 2).

The rear columns of the first stage of the tower rise from these main sleepers slightly forward of where the latter cross the first interior truss. As is common in steeple framing, these posts are treated as queenposts in a truss to help carry the steeple load, but in this case the main braces rising to the tower queenposts are slightly out of plane, originating as they do on the truss chord centered 1 ft. behind the centerline of the posts on the sleepers. This combination of support systems for the steeple—portico plate, front wall, sleepers, vestibule wall, queenpost trussing of the rear columns and colossal columns assisting both the first and second interior trusses—apparently was not enough to stop some rearward lean of the steeple. The evidence is open (and now filled) joinery shoulders on the slack side, and the presence of later-added timber bracing on the compression side, the latter rising from the sleepers and first and second interior truss chords to the rear tower posts.

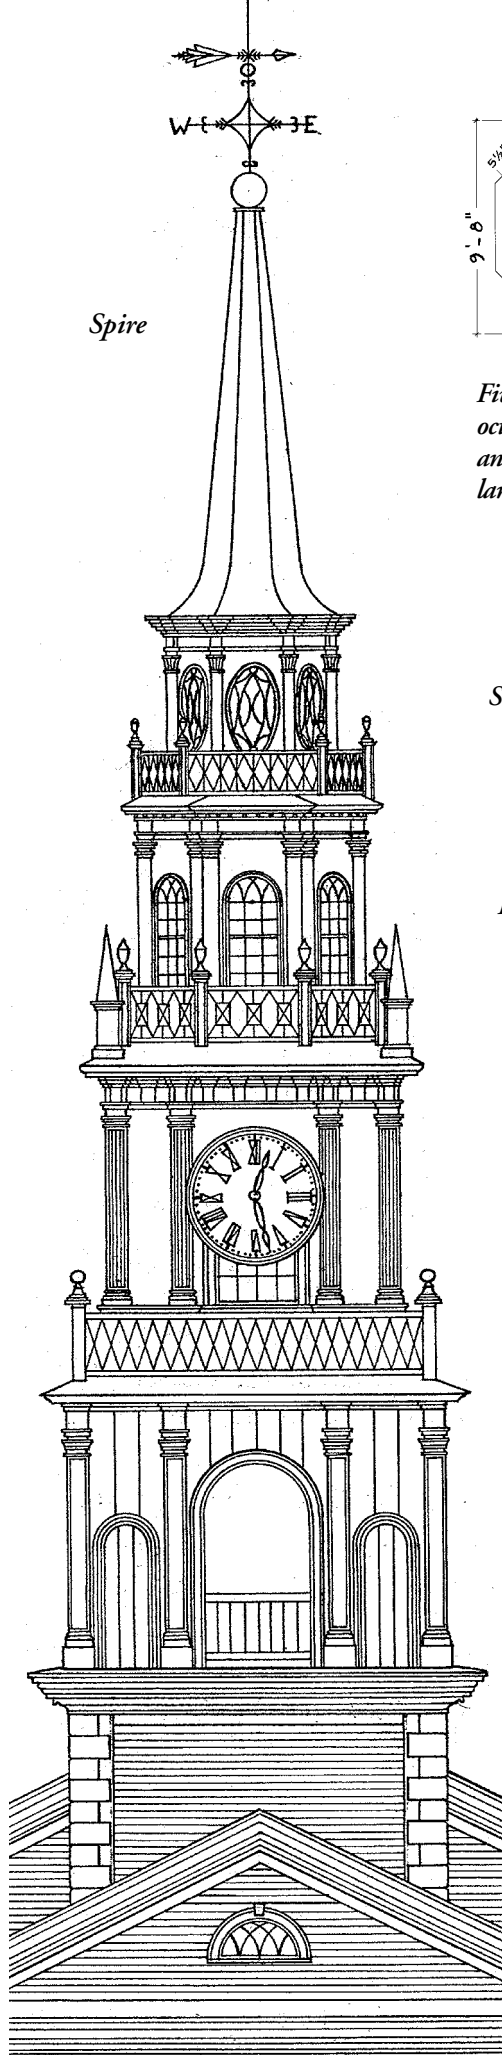
Fig. 3. Historic American Buildings Survey drawing V-11 of Middlebury, detail from sheet 3, front elevation.

Five-sided post sections, octagonal mast section and upper and lower lantern dimensions.

The six stages of the Middlebury Congregational Church steeple comprise three square frames, two octagonal frames (the upper and lower lanterns) and a culminating tapered octagonal spire (Figs. 3 and 4).

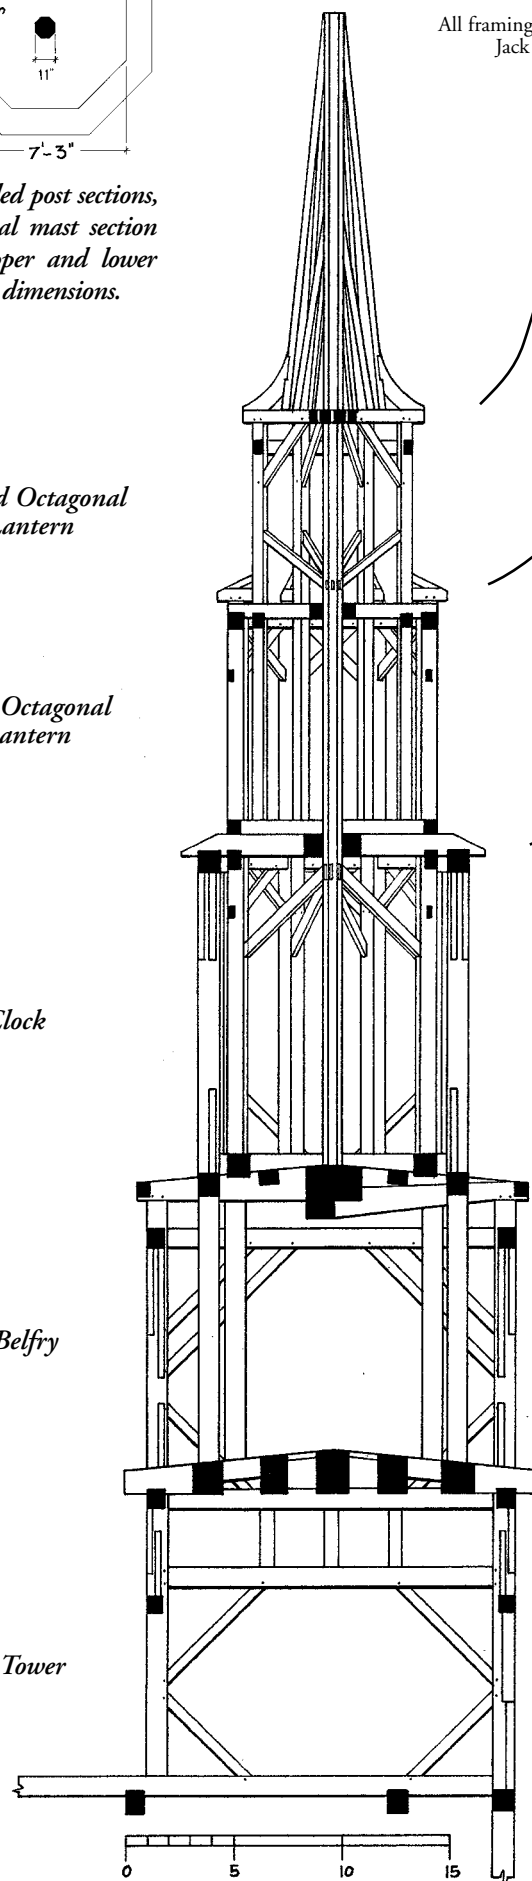
Fig. 4. Steeple frame side elevation, cut away to show original mast. Mast is now refooted one stage higher, at top of clock stage.

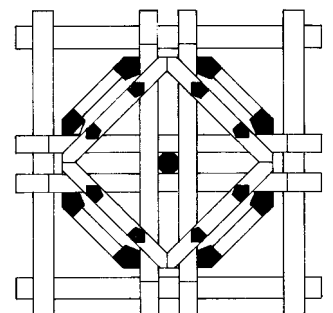
Fig. 7. Base of first octagon (partners).

The four pairs of columns terminate in a 12x12 plate at the top of the clock stage. At this level, 10x12 mast partner timbers lap into and over this plate, two on each side. These partners clasp the mast at their middle and also lap over connecting girts within the fourth stage framing, the first octagonal lantern frame, already telescoped within the clock stage at this point. To add complexity to this junction, the crib timbers for the *fifth* stage, the second lantern, bear upon these partners, locking the lap joints with thousands of pounds of superimposed weight from the stage, spire and vane above (Fig. 7).

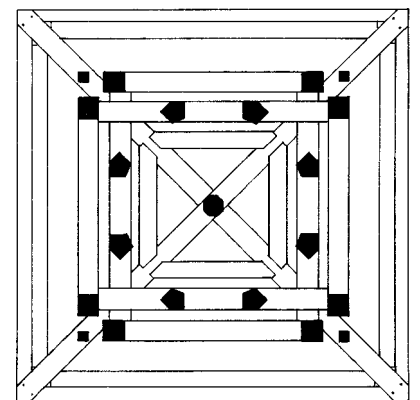
Fig. 6. Base of clock stage, with mast foot.

At the top of the belfry, the tops of the four corner columns of the tower are joined diagonally by the immense lapped double-cambered ties of the original mast base, which sit upon the post tenons. Girt timbers 10x10 tenon into these posts slightly below their tops and are double-braced by two different lengths of parallel 4x6 bracing (Fig. 6).

The eight 12x12x28 columns flanking the corners of this stage began approximately 14 ft. lower at the bell deck sleepers, rose hidden within the belfry interior sheathing, and now emerge to view as the visible steeple frame for another 14 ft. (Fig. 21). As these paired columns emerged from the belfry roof, they clasped the immense diagonal double-cambered ties of the original mast foot (Figs. 6 and 11).

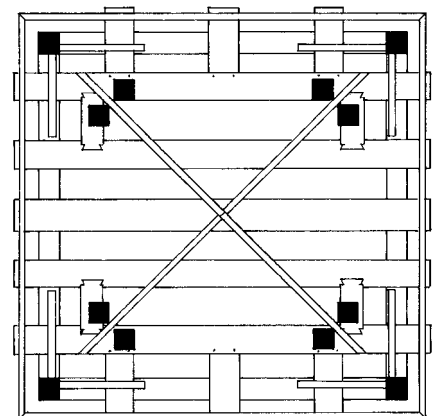
Fig. 5. Base of belfry.

Tower and belfry. The first and second stages, respectively the tower plinth and belfry, although visually separated on the exterior by a large cornice and distinct architectural detail (Fig. 3), are supported by the same tower frame: 12x12x60 tower posts rising from the sill at the front and 12x12x30 rear tower posts rising from the main sleepers and complex framing. Where tower plinth becomes belfry at the top of the first stage, the immense bell deck sleepers are lodged on two levels of 10x12 girts joined by short struts and supported by long 4x6 oak braces (Fig. 5).

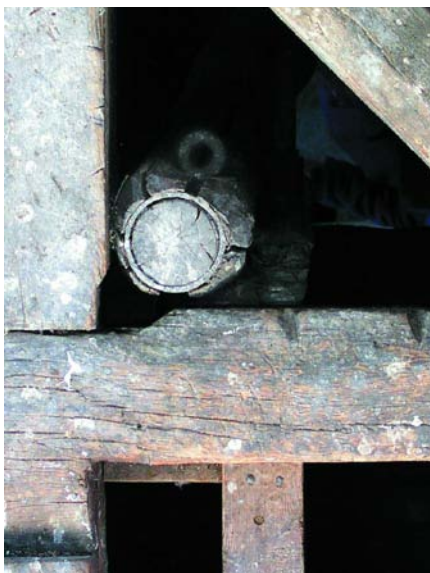
Fig. 10. Deep beams to foot the mast, the latter cut away in 1853 to make way for slender shafting to drive clock faces installed over the windows of steeple's third stage.

The mast was originally footed with a tenon on a crossed pair of immense timbers, cambered both top and bottom, forming the roof system over the belfry (Figs. 10–11).

If Fillmore and Crandal believed the first, they were proved wrong by 1853 when the base of the mast was cut off about 9 ft. above its bearing point to make room for the clock shafts. This offcut base segment lies about 3 ft. away from its original mortise, carrying some flooring today. The great number of braces, crabs and partners proved adequate to keeping the mast in place, so that while it isn't pendant (hanging unsupported from the apex, as the mast is in some other steeples), it's no longer footed either, and none the worse for it.

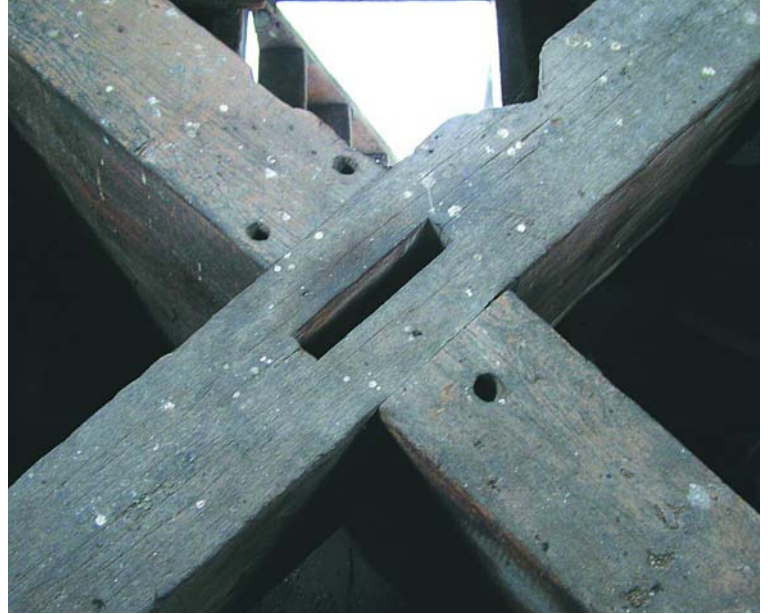
Fig. 11. Original mast foot of massive 10x17 crossing ties notched only 2 in. at lap, with tapered 10x12 packing pieces pinned over one tie and 9x8 braces stiffening the crossing. Posts for first lantern omitted.

Timbers this size, each cambered to 10x17 at the crossing and one augmented on top by a cambered 10x12, are usually reserved to carry the weight and dynamic loads of a bell, not the lightweight roof over it, so it can be supposed that the framer thought one of two things: first, that the mast might permanently carry the accumulated load of the three stages and spire forming the upper 54 ft. of the wooden structure; or, second, that the mast was to be erected, somehow braced, and used as a lifting rig (or at least a stabilizing axis) for these upper levels.

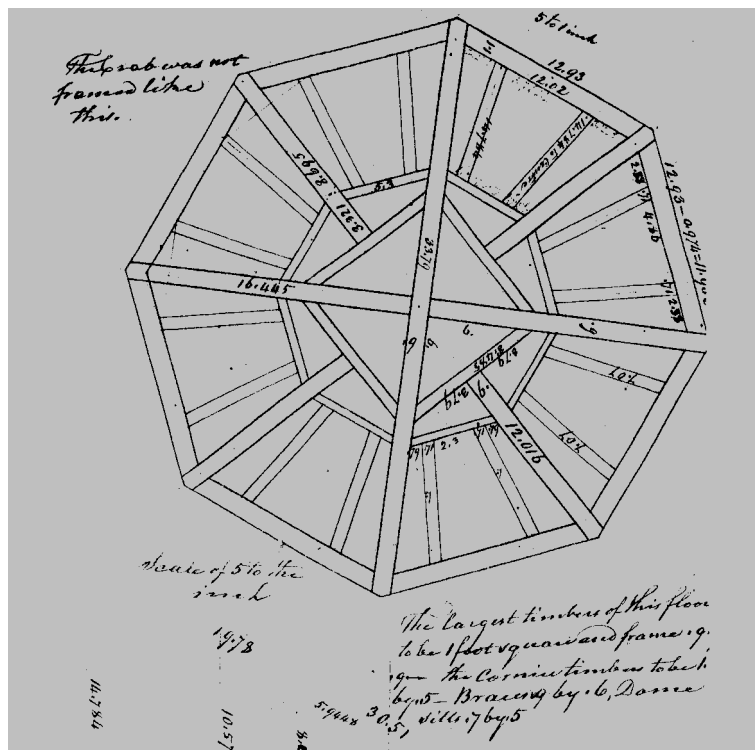
THE CRAB. In timber framing, “crab” refers to a horizontal frame with eight legs or regularly spaced points of bearing or tying, flat or slightly cambered, sitting atop the posts of one octagon and supporting the posts or rafters of another. The term has historic credentials. The Burlington, Vermont, framer John Johnson drew and labeled crabs and specified them in his lumber lists for the Orleans County Courthouse (1816) in Irasburg, Vermont, as well as for an immense one, 34 ft. across, for the octagon atop the Centre College building at the University of Vermont in Burlington in 1829 (Fig. 12).

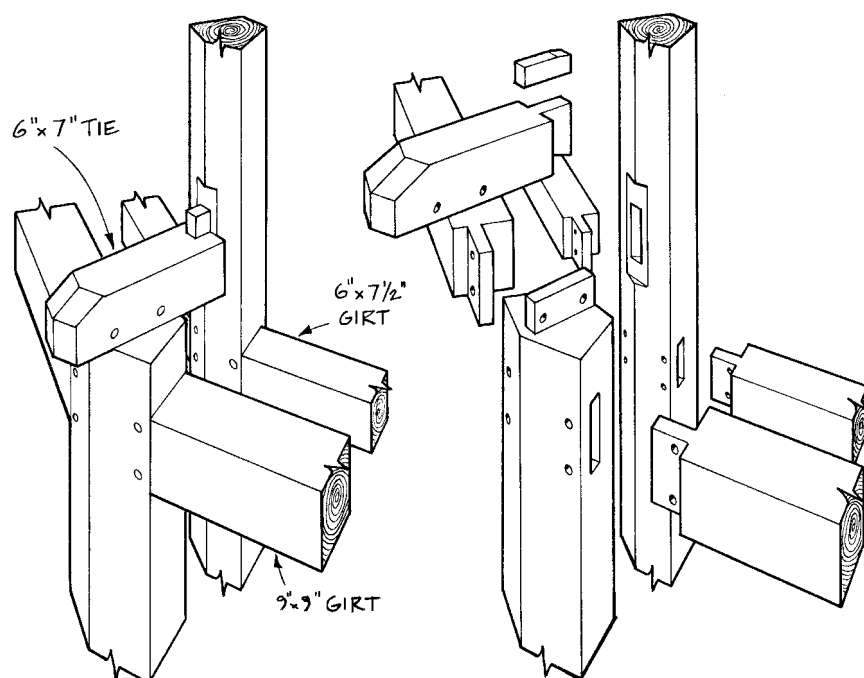
Fig. 16. Short ties connect posts of lower and upper lanterns using wedged dovetail joint. Mast partners omitted for clarity.

Shortly above that point the pairs of octagon posts are joined by pairs of crossing braces (X-bracing) that tenon into the posts themselves at their feet and the octagon connecting girts at their tops—the same connecting girts lapped by the partners mentioned in the discussion of the clock stage. This lantern's five-sided posts pass through the partners, snugged against the outside of each member of the pair, rise 12 ft. and terminate in a short tie. Just below the tie lies a girt lapped by another set of partners, lapping a second octagonal lantern girt as well and clasping the mast (Figs. 8 and 16).

Second octagonal lantern. The fifth and last stage before the spire is the upper octagon, with its elliptical fenestration. Its eight five-sided oak timbers began approximately 11 ft. below within the lower octagon, at the crib timbers atop the partners at the top of the clock stage (Fig. 6). This upper octagon has become smaller, 7 ft. 3 in. wide across the flats, and exposes 9 ft. of height to wind and view. X-bracing and connecting girts lie right beneath where it emerges, and the set of partners that laps into the lower octagon plate also laps over these connectors before clasping the mast (Figs. 8 and 16).

The second method was a bi-level sort of crab based upon two, or two pairs of, timbers crossing the octagon at right angles to each other and another square of sleepers or crib timbers lodged diagonally on top of these. The upper level carries the eight posts. Compress the two levels into one and you have a crab. This type of crab is found in Middlebury over the belfry at the massive base for the mast, on which are lodged the sleepers for the lower octagon frame (Fig. 11), and found again at the bottom of the upper octagon, where short ties connect the tops of the posts of the lower octagon with the midheights of the posts of the upper octagon and parallel sets of ring girts connect the respective post sets (Fig. 16).

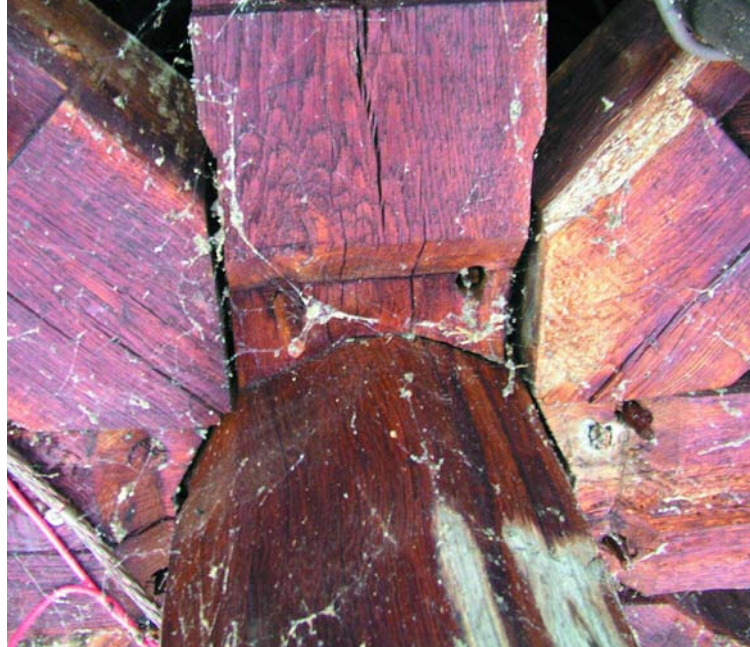
Fig. 17. Seen from below, intricate joinery at base of spire connects legs of crab to mast, which continues on to carry weathervane.

At Middlebury, the framers used three different types of structures to support octagons. The first was a crab or star with eight legs radiating out from the mast. This form is usually the weakest since there is not likely to be room in the mast for eight good mortises or, if there is, no room to pin them. At the foot of its eight spire rafters, Middlebury solves this problem ingeniously by dropping four 8x7½ legs into wedged half-dovetail mortises in the mast, while the other four double-miter between these and tenon horizontally into the sides of the dovetailed legs, to which they are pinned. These crab legs do not align with the flats of the octagonal mast but are centered on its arrises (Figs. 17–18).

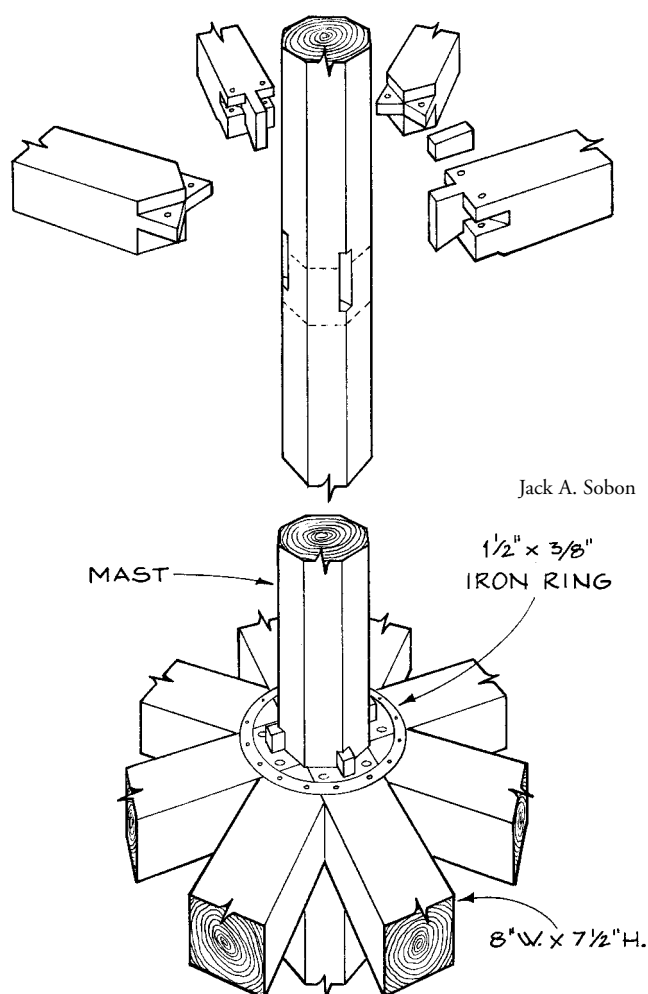
Fig. 18. Crab at base of spire. Four legs join mast with wedged half dovetails, remaining four join first four via pinned triangular tenons in open mortises. Nailed iron ring completes the job.

The eight legs of this uppermost crab, or star as it is sometimes called, join ingeniously to the mast and can be seen as interrupted tie beams across the octagon. The rigidity of this crab is reinforced by a 3/8-in.-thick iron ring set 4 in. away from the mast, crossing all the legs and spiked to each of them twice (Figs. 9 and 18).

Even the spire, a 19-ft. tall tapering octagon with low wind resistance, centered on a stout oak mast virtually buried in 34 ft. of timber work below, is framed for rigidity. The spire rafters and an inner set of rising braces (half the rafter height and with a different slope) share a common wedged mortise on the tie beams of the spire crab. The curving skirt of the spire is framed of 3-in. plank let into rather than tacked to the rafters, another form of buttressing (Figs. 18 and 22).

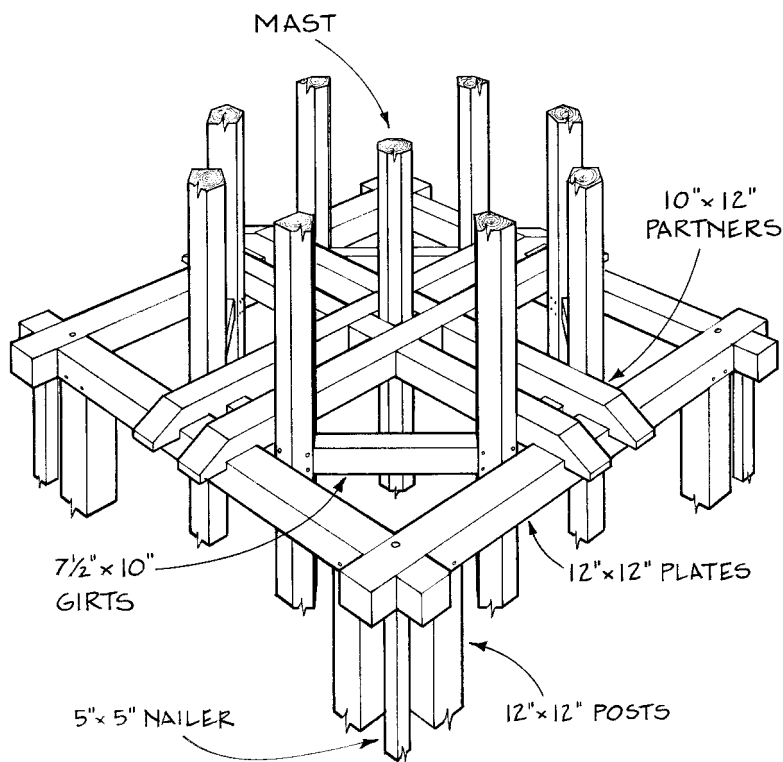
Fig. 19. Framing of partners at top of clock stage. Mast partners tie across top plates and restrain octagon posts rising through them. Plates are halved and pinned and a 5x5 nailer fills out the corner. Inner octagon (second lantern) posts and base omitted for clarity.

spire are restrained by the rigidity and mass of the bulkier lower stages. At Middlebury, two levels of partners—one at the top of the clock stage (base of first octagon) and the other at the top of the first octagon (base of second octagon)—are not designed to tenon into posts or arrive at a panel point, nor to be expressed in the exterior finished form of the steeple, but instead are opportunistically attached to the framing of the two surrounding telescoping stages and correctly spaced to clasp the mast (Figs. 19–20).

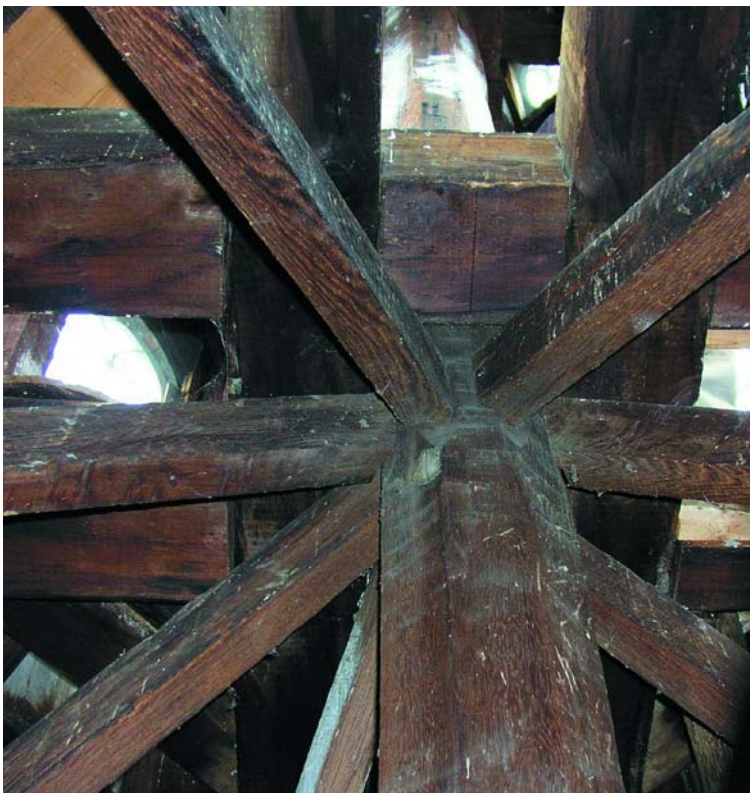
Fig. 20. Viewed from below, upbraces from rising lower octagon posts assist partners at top of clock stage.

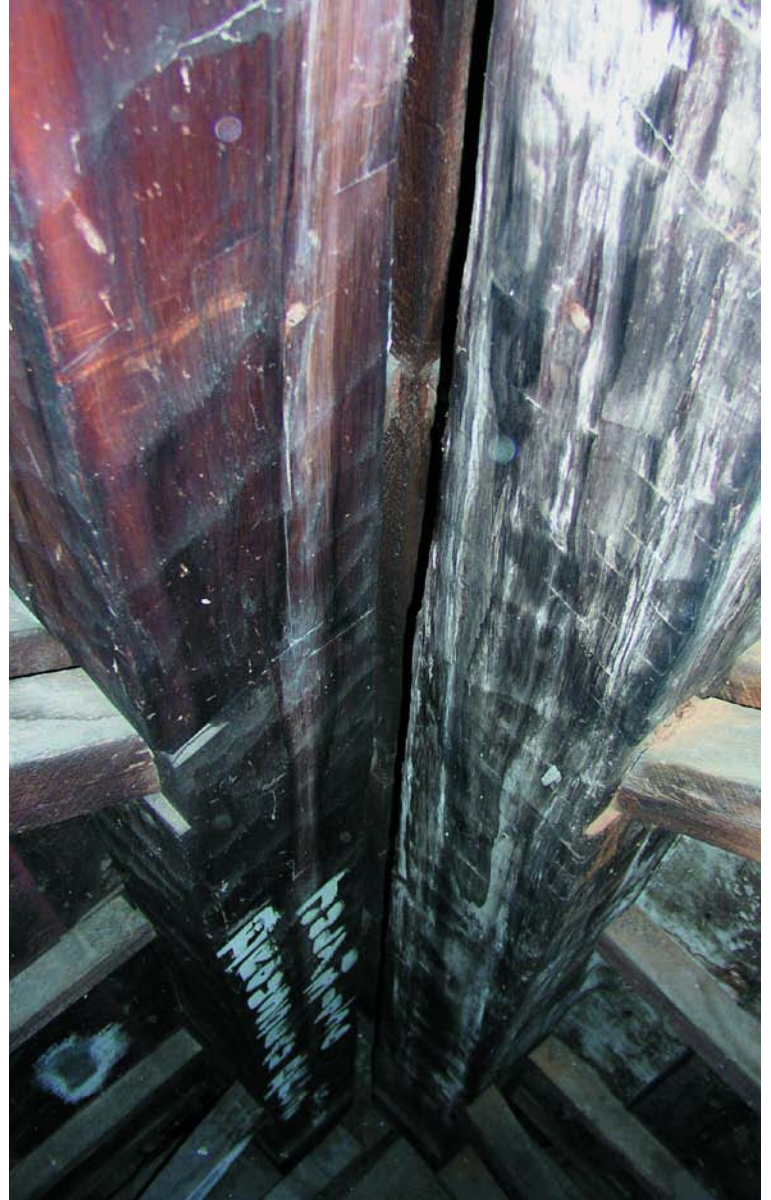
Fig. 21. Eight 12x12x28 posts in cater-corner pairs rise from the belfry roof to the top of the clock stage. Plan views in Figs. 5–6.

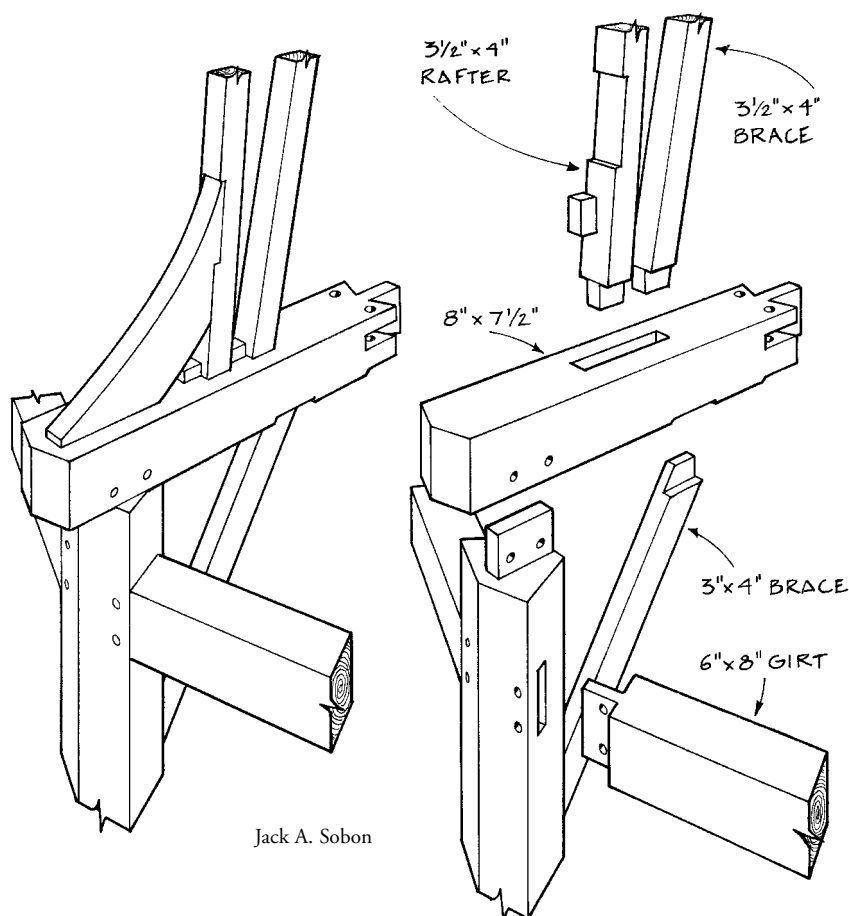
Fig. 22. One-eighth of spire base and roof framing. (Plan view Fig. 9.) Each crab leg supports a rafter and a brace both up to the mast and down to the octagon post. Wedges allow fine-tuning.

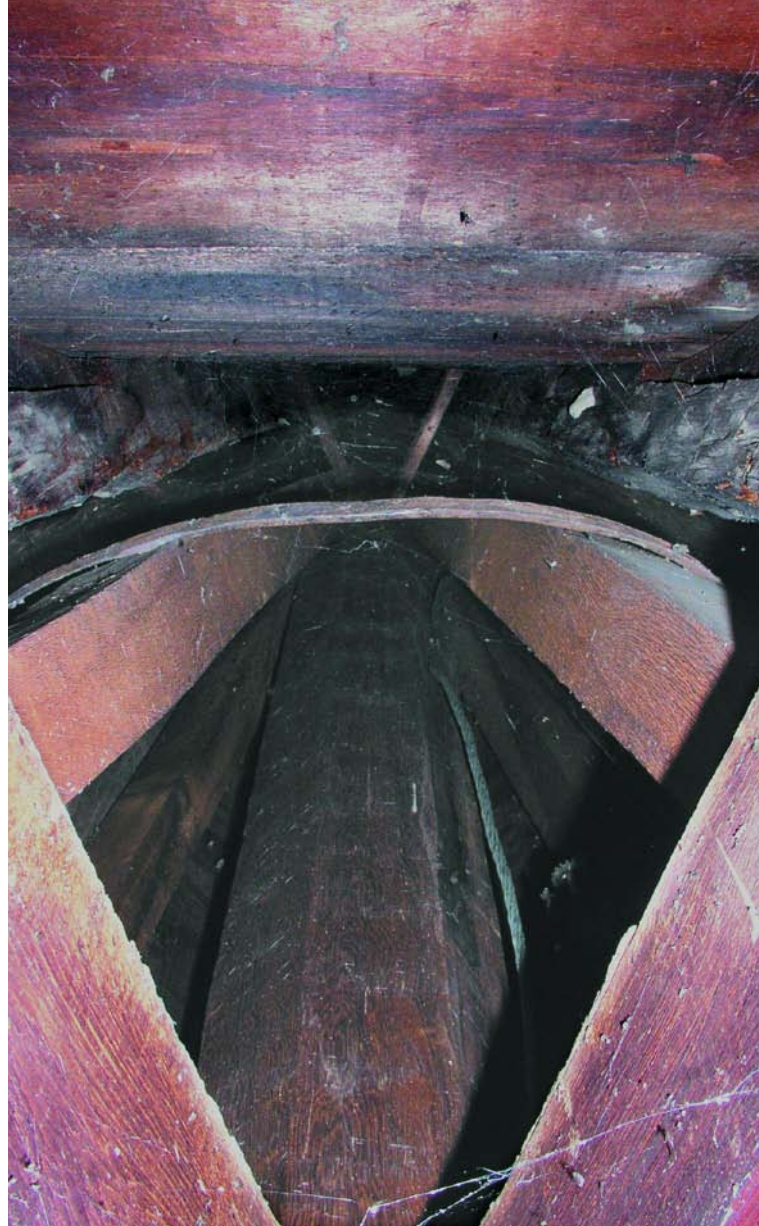
Fig. 23. View straight up into spire. Curved pine roof boards at top, oak mast at center, oak braces and spire rafters at left and right.

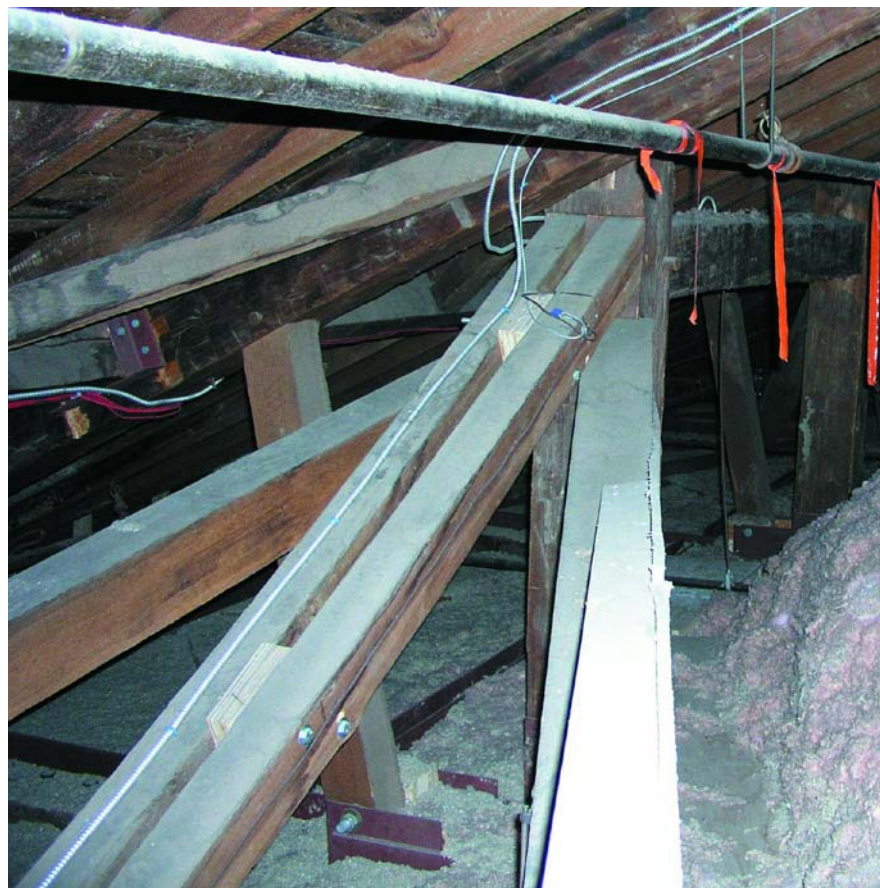
Fig. 25. Multiply braced queenpost trusses run the long way in the attic flanking the dome, to account for absent transverse kingpost truss.

However, truncated tie beams are still found on the regular truss centers, as supporting structure for the ceiling and the dome, and these in turn are suspended from curiously framed longitudinal queenpost trusses with multiple external braces on either side of the dome (Fig. 25).

The 10x10 queenposts hang directly over these truncated tie beams, and the main braces of these trusses are quadripartite: four vertically sawn oak timbers fanning out to bear, in wedged mortises, on the bottom chords of the adjacent third and fifth truss.

From each queenpost a pair of main braces drops directly to the chords of the third and fifth trusses just over their supports by the colossal columns. The efficacy of the other two braces, which drop to unsupported points on the chord, is less clear, unless they act to stabilize the lightly built truss laterally.
