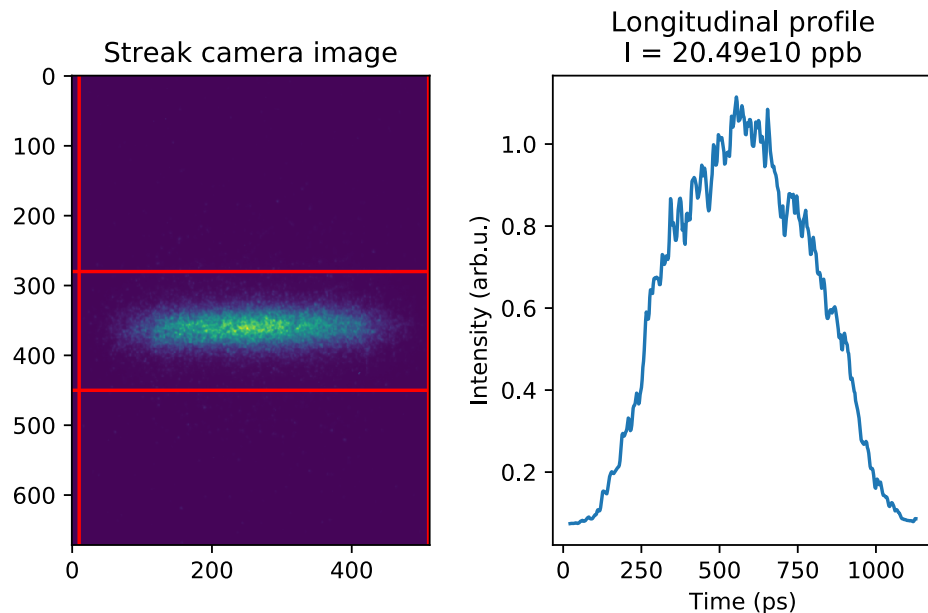
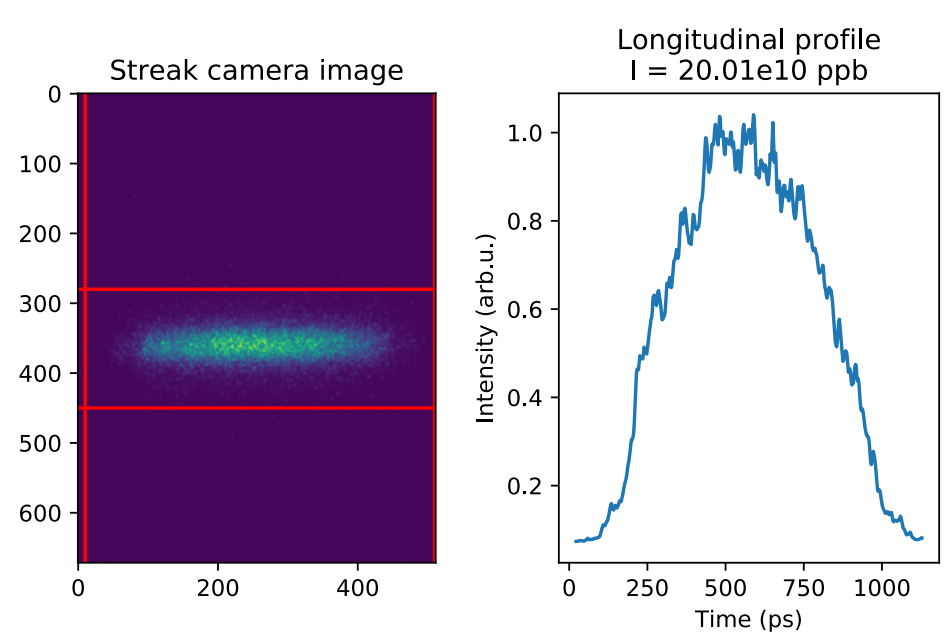
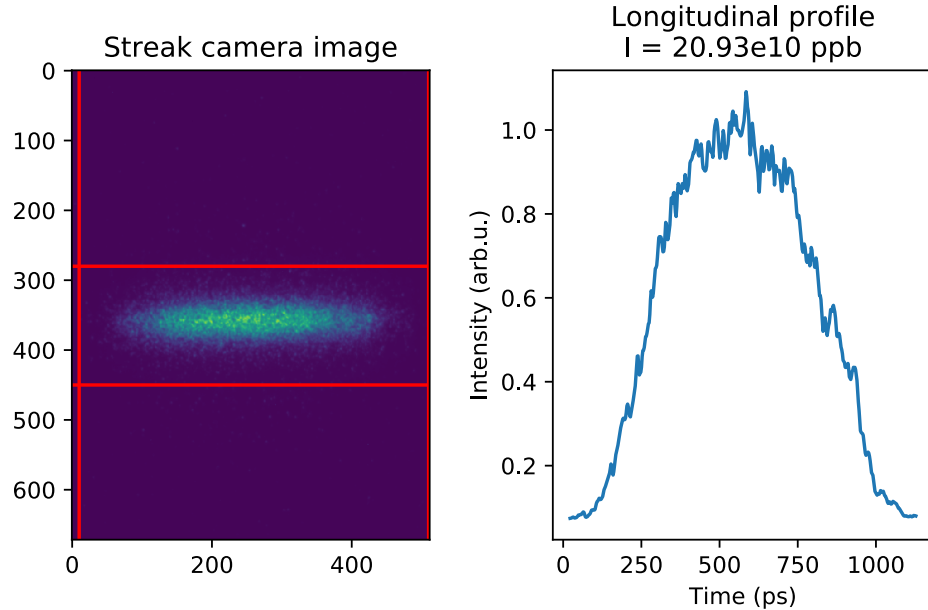
- Streak image: 1ns time window
- 170x500 pixel ROI is selected
- Sum of all the pixel columns to get the profile
- Intensity axis 1.0 = 1e6 pixel ADC count

Are the small peaks on the profile an artifact of the instrument ? Or can we assume they come from the beam ? These are high frequency components in the order of tens of GHz.

Up to which frequency we can trust the profile produced by the streak camera in the 1 ns time window operation ?
