Parking slot detection using digital image processing and computer vision

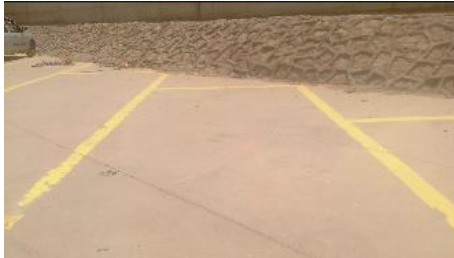
Original image

Using median filter, which is a nonlinear digital filtering technique, to remove any noise in the photo and remove any cracks in the floor, which the obstacle detector could detect as an obstacle later.

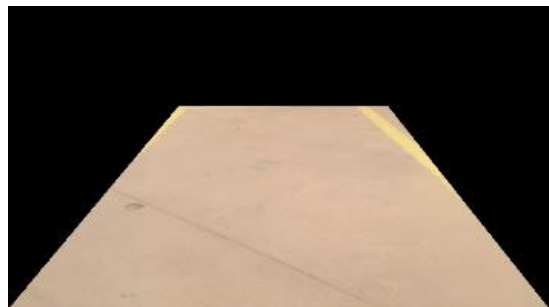
Output image from lane detector

This module main function is detecting the right and left lanes of the parking slot and then cropping the original photo taken by the camera to extract only the parking slot area between the lanes. Lane detection module works for white and yellow lanes as well.

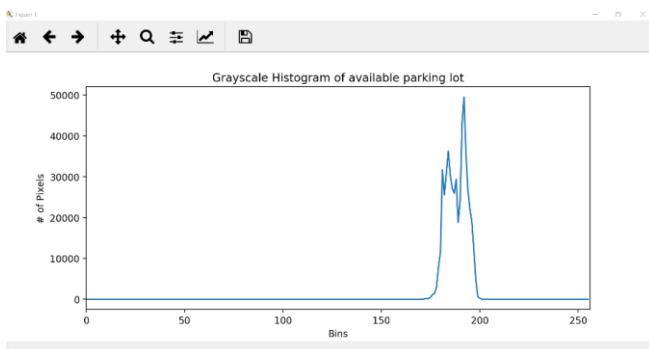
This method is completely image processing based approach. There's a stored photos of cropped empty parking slot area. The module then compare the histogram between the taken image from the camera and the empty parking slot stored photo. If the similarity in histogram is less than a certain limit, then there's an object in the taken photo and car cannot park in this slot.

The taken image is converted to a grey scale image and after applying a median filter to the grey scale image the empty slot histogram is enclosed in a certain narrow range. By experiment, this range always starts after a certain value while an image of a slot containing a car or any obstacle histogram always has low values due to the black regions that exist at least at the car wheels. As illustrated in the following graphs.
