APPENDIX 3: Photographs of test setup

Radiated Emission

UL Japan, Inc.

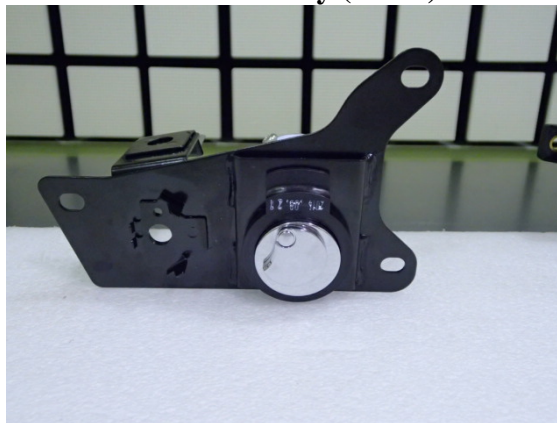
Not insert Key (worst)
