PIFA Antenna Report

ALLIS COMMUNICATIONS CO., LTD.

1. TEST CONDITIONS

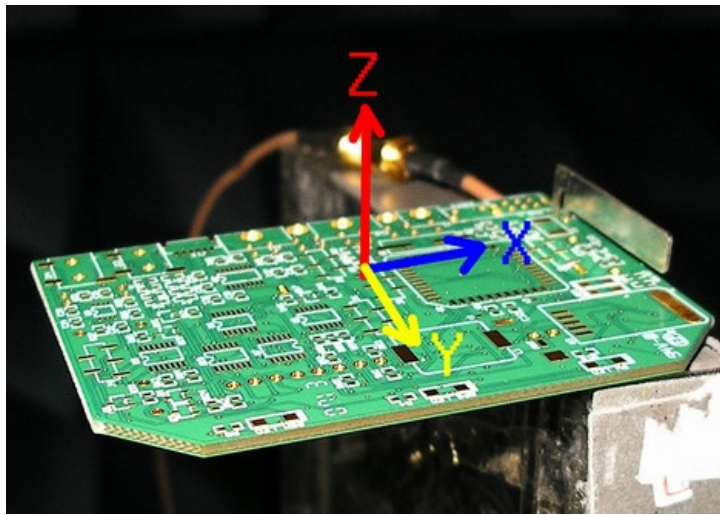
Diagrams

Item	Peak Gain
V-CUT	-4.573dB
H-CUT	-3.007dB

V-CUT : Z-Y

H-CUT : X-Y

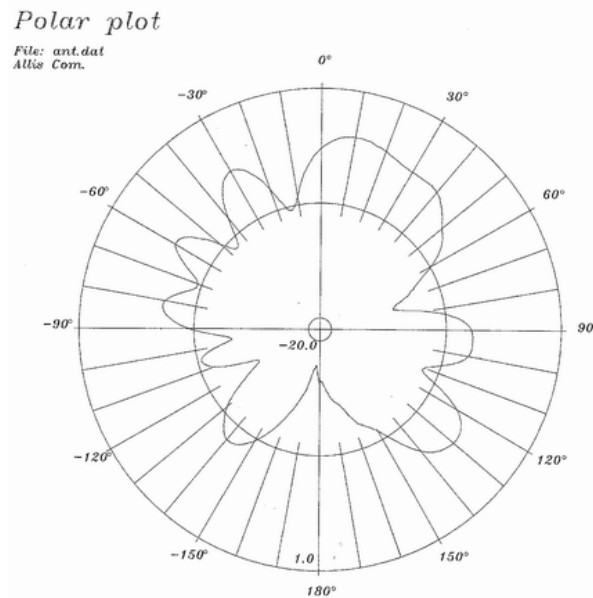
H-CUT Polar plot

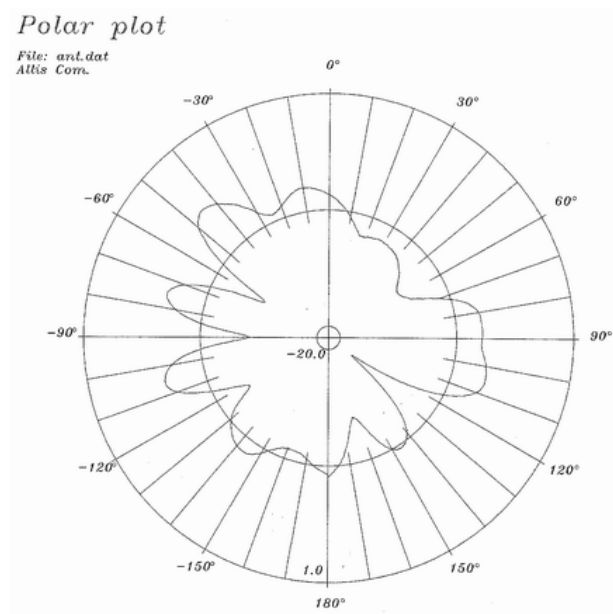
V-CUT Polar plot
