APPENDIX 3: Photographs of test setup

Radiated emission

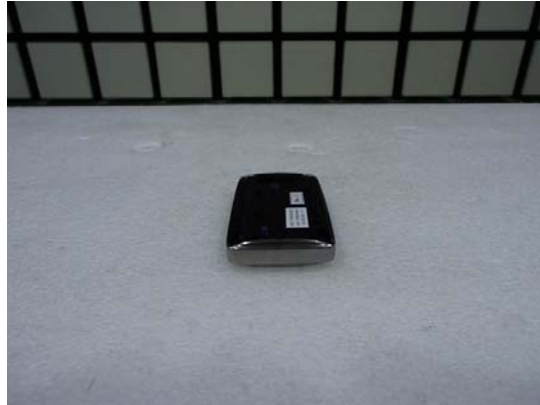
Worst case position

(Below 1GHz Horizontal: X-axis / Vertical: Y-axis)

(Above 1GHz Horizontal: X-axis / Vertical: Y-axis)

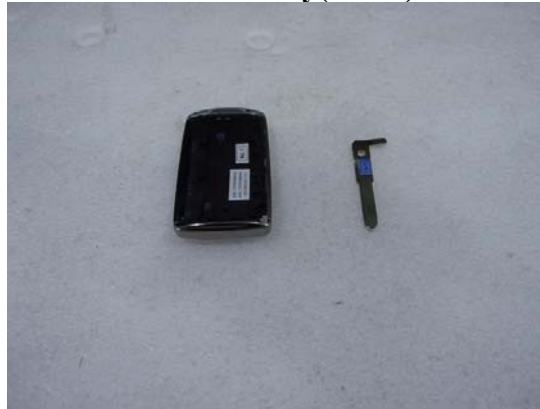
Worst case position

Without Key(worst)

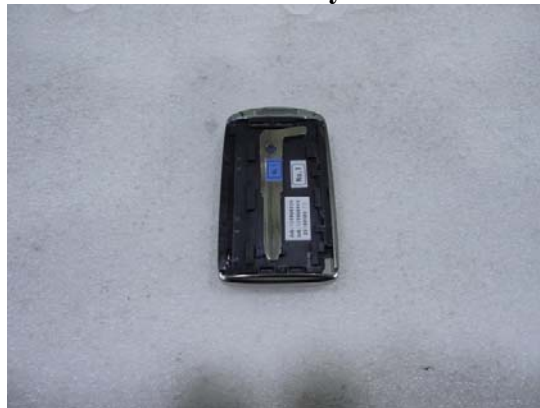
With Key
