APPENDIX 3: Photographs of test setup

Radiated Emission **Below 1GHz**

Radiated Emission
Above 1GHz

Worst Case Position

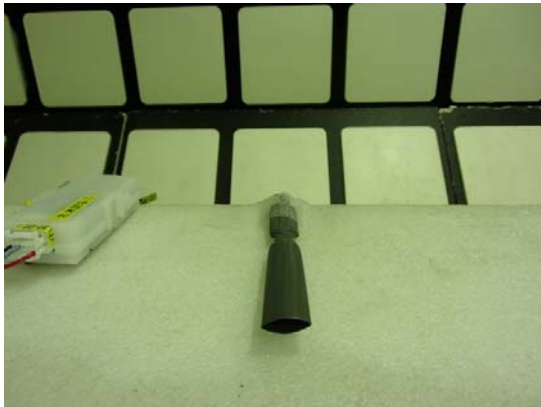
X-axis

ANT

Below 1GHz

Horizontal: Z-axis / Vertical: Y-axis

Above 1GHz

Horizontal: Y-axis / Vertical: Y-axis
