Test Data – Spurious Emissions at Antenna Terminals

Appendix A: Test results

Report number: **210165-3TRFWL**

Specification: FCC 22 Subpart H

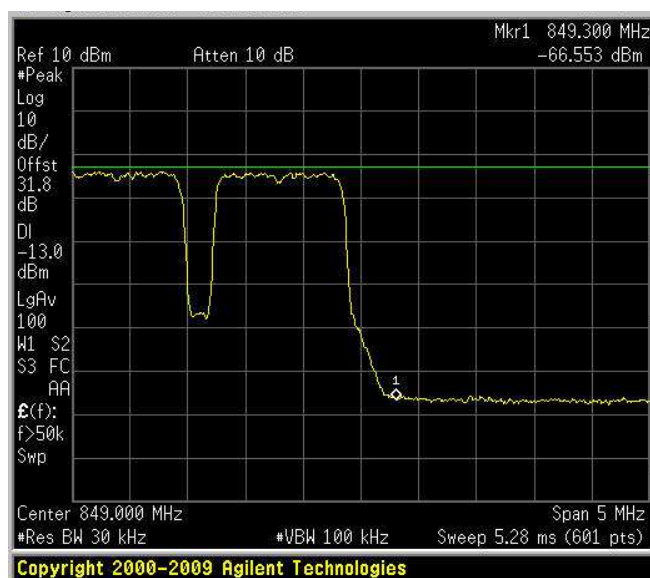
Uplink – 1.4 QAM
HIGH BAND EDGE

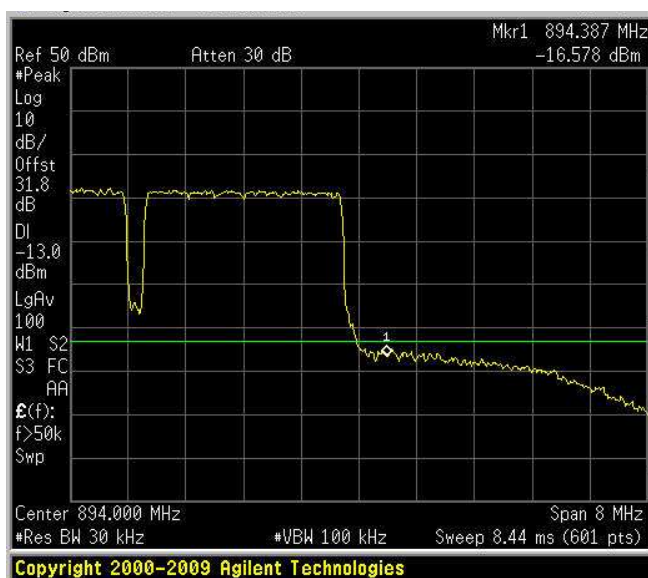
Downlink – 3 QAM
HIGH BAND EDGE

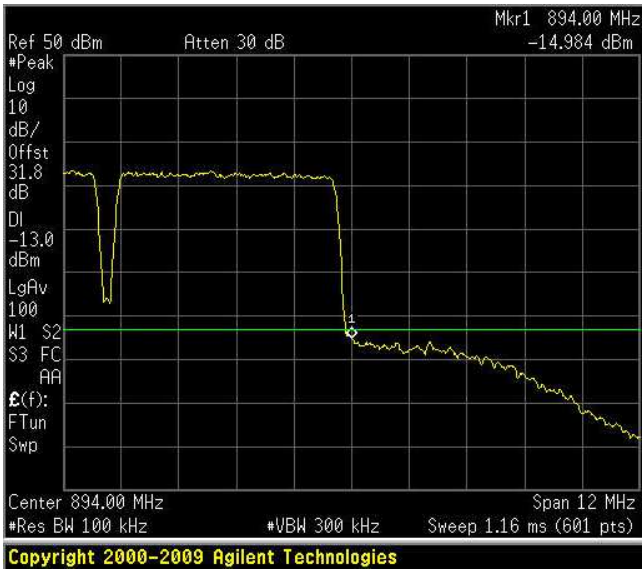
Downlink – 5 QAM
HIGH BAND EDGE

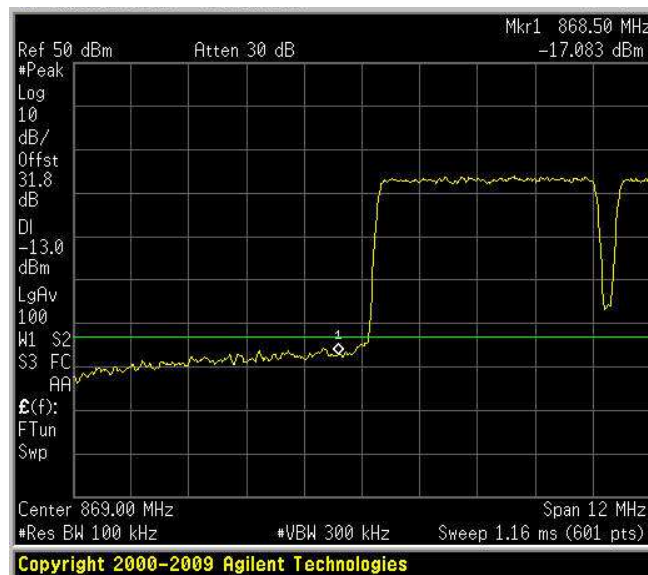
Downlink – 5 QPSK
LOW BAND EDGE

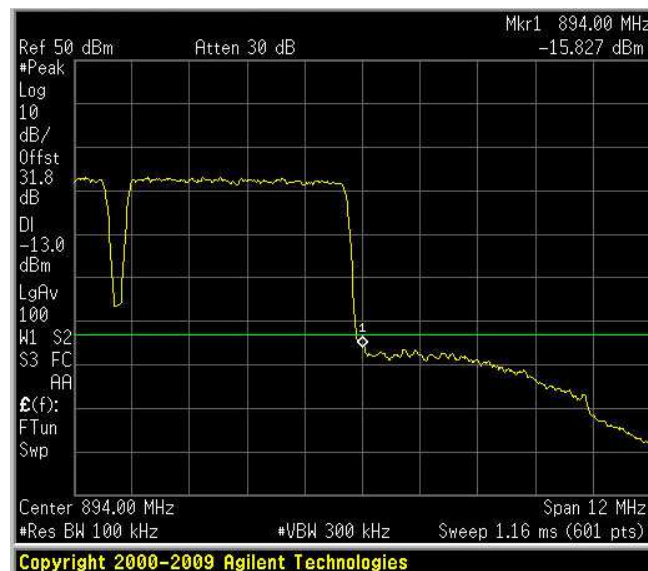
Downlink – 5 QPSK
HIGH BAND EDGE

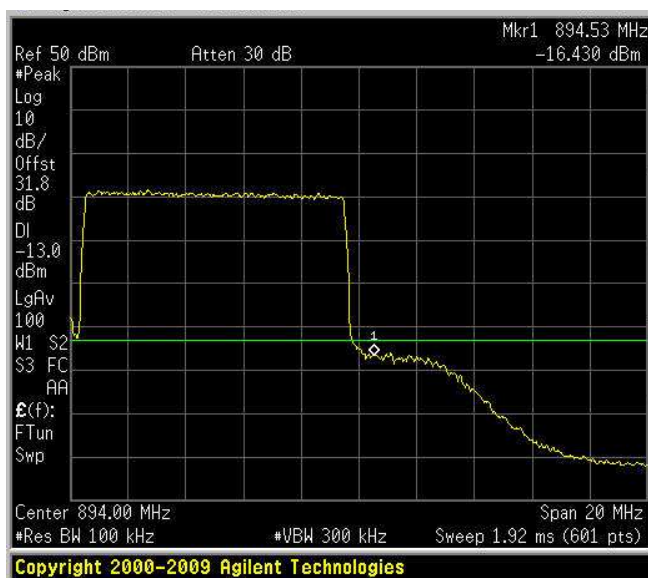
Downlink – 10 QAM
HIGH BAND EDGE

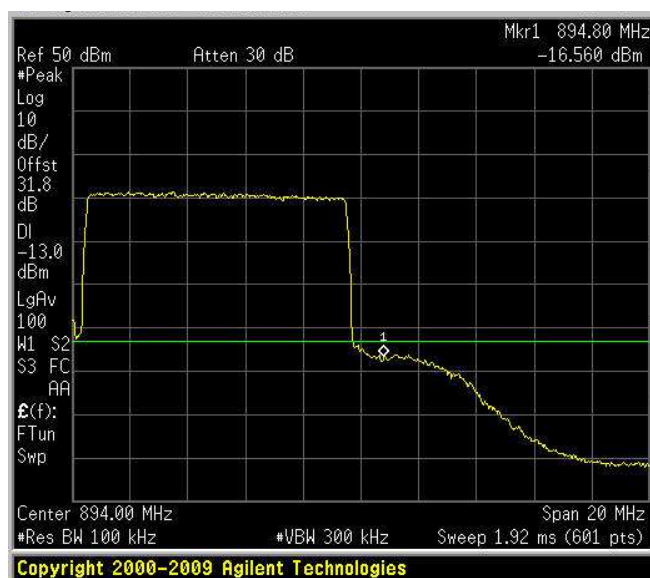
Downlink – 10 QPSK
HIGH BAND EDGE

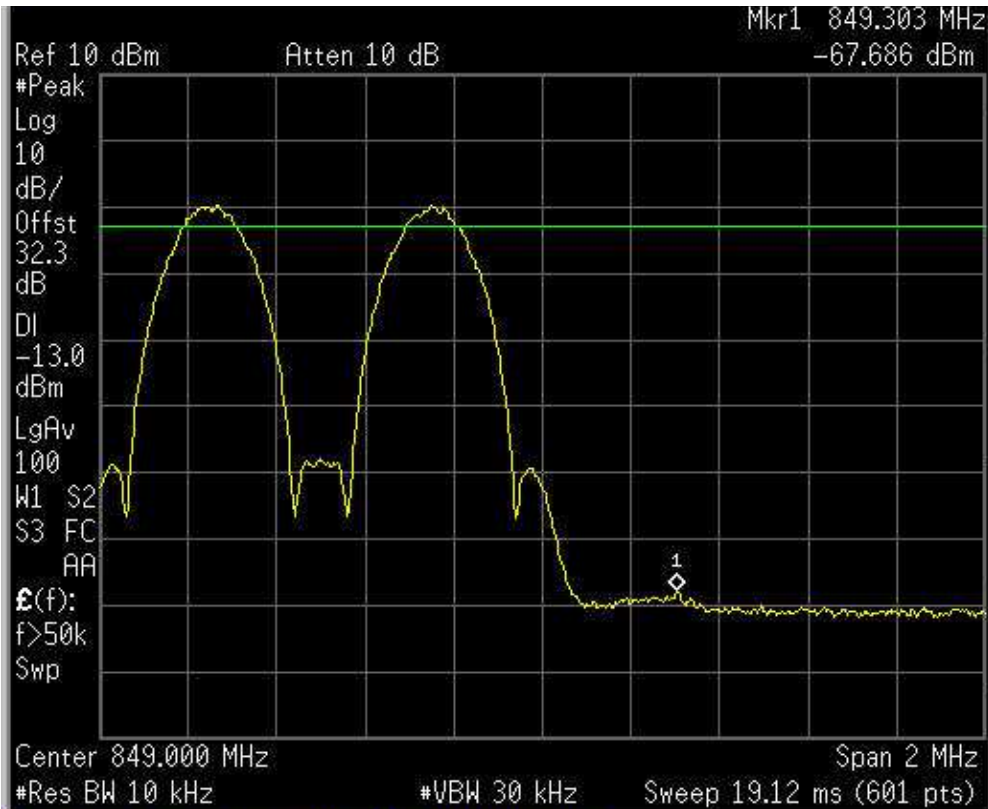
Upper Bandedge Intermodulation
EDGE
Uplink
