APPENDIX

11. Photographs of Test Setup

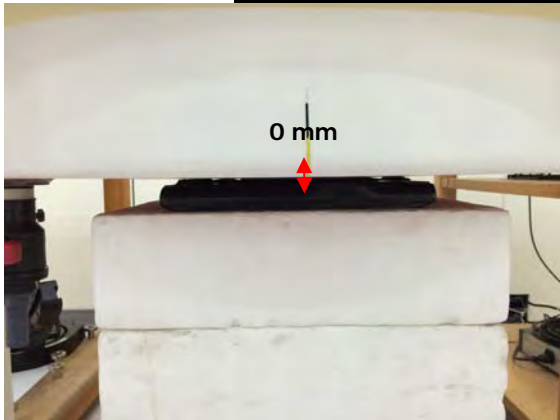
Body - distance between flat phantom and EUT is 0 mm

Fig.3 EUT Back side to flat phantom

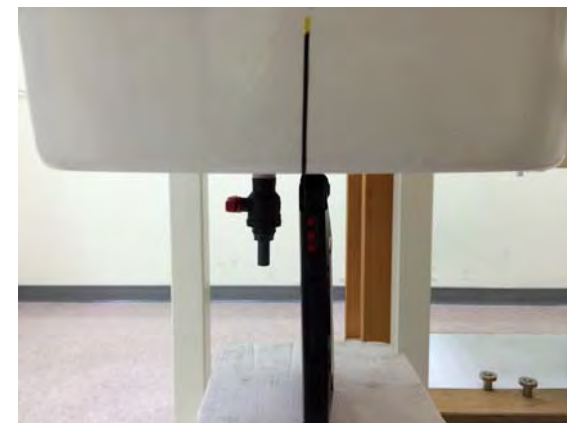
Fig.5 EUT Right side to flat phantom

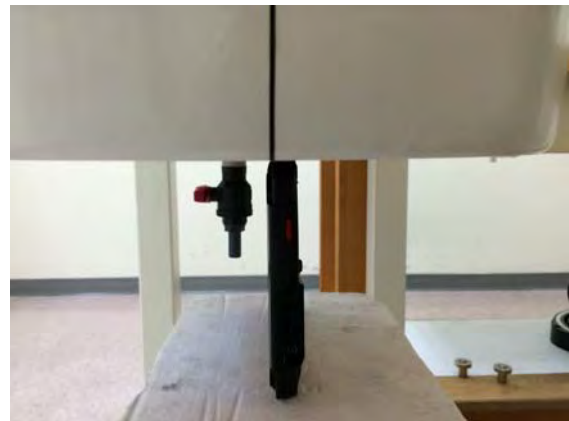
Fig.6 EUT Top side to flat phantom

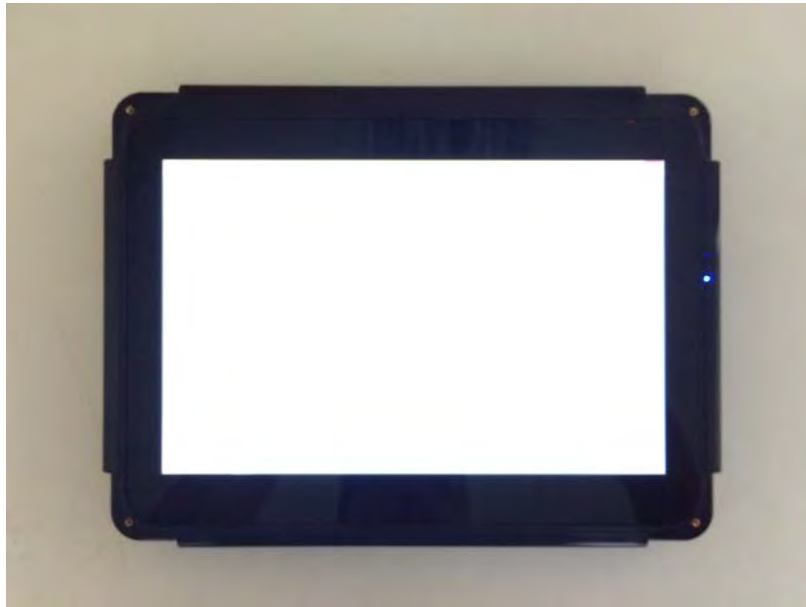
Fig.7 Front view of EUT

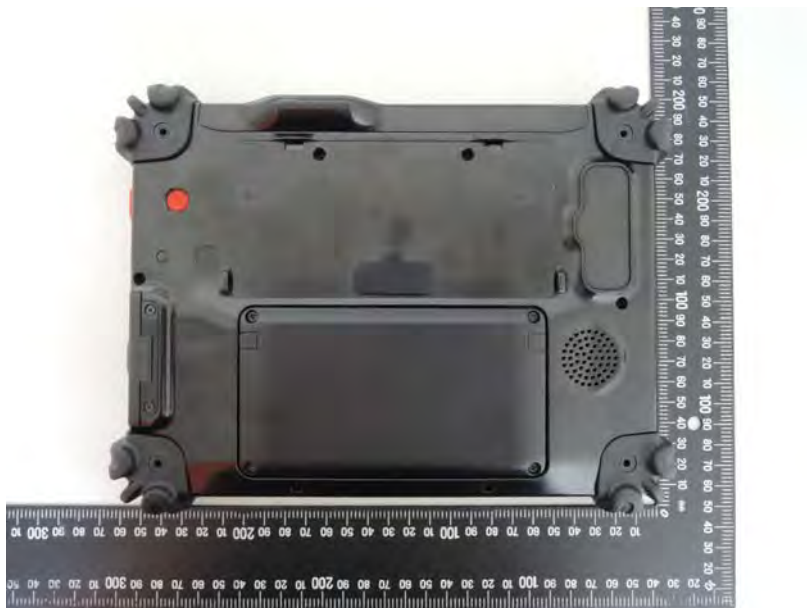
Fig.8 Back view of EUT
