APPENDIX

10. Photographs of Test Setup

11. Photographs of the EUT

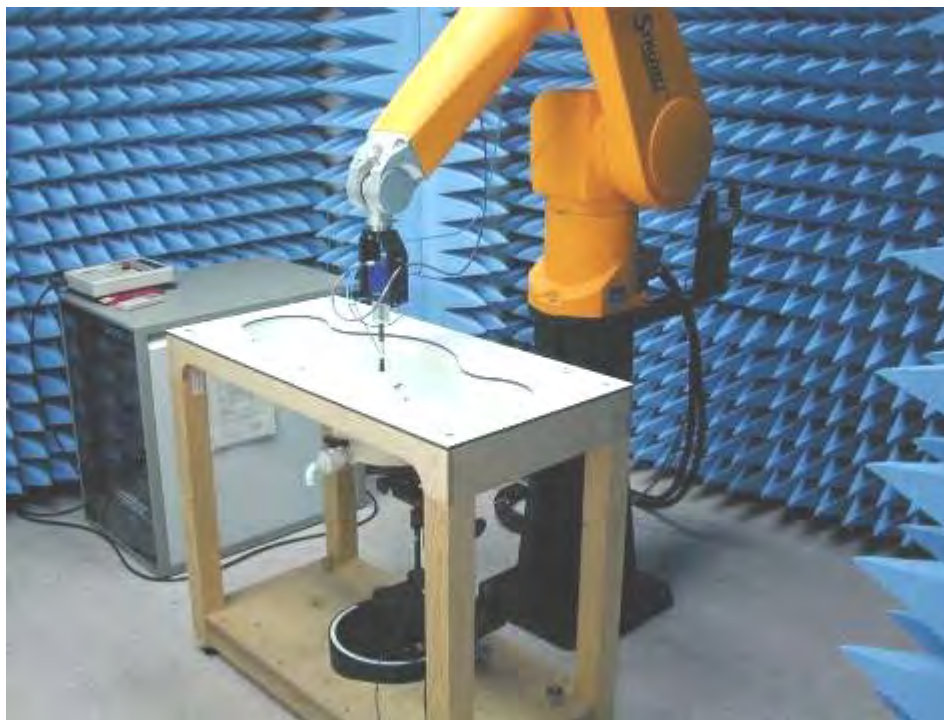
Fig.1 Photograph of the SAR measurement System

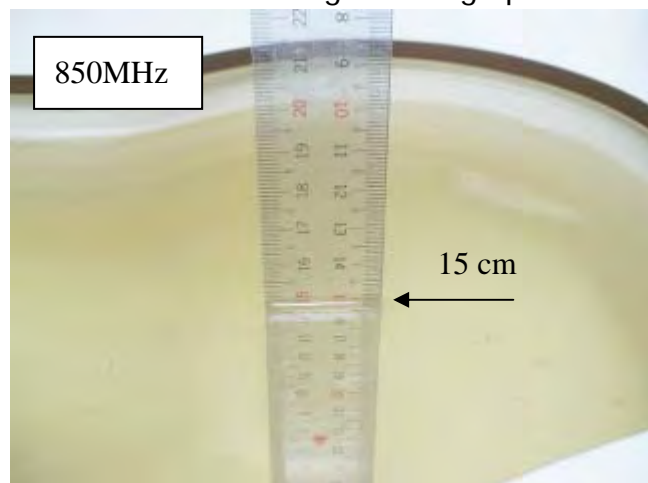
Fig.2.1 Photograph of the Tissue Simulant Fluid liquid depth 15cm for Left-head Side

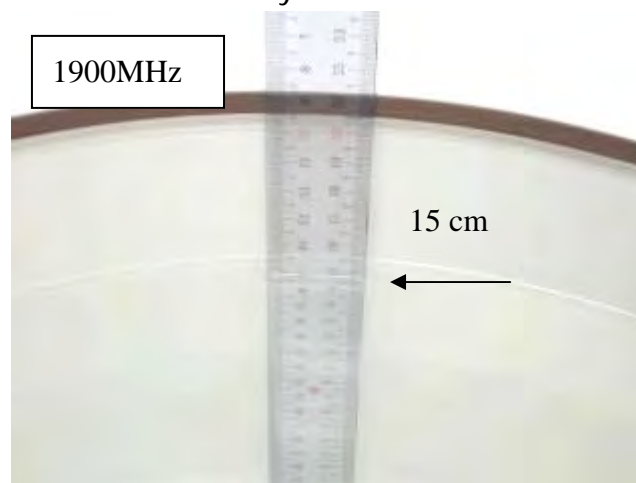
Fig.2.2 Photograph of the Tissue Simulant Fluid liquid depth 15cm for Right-head Side

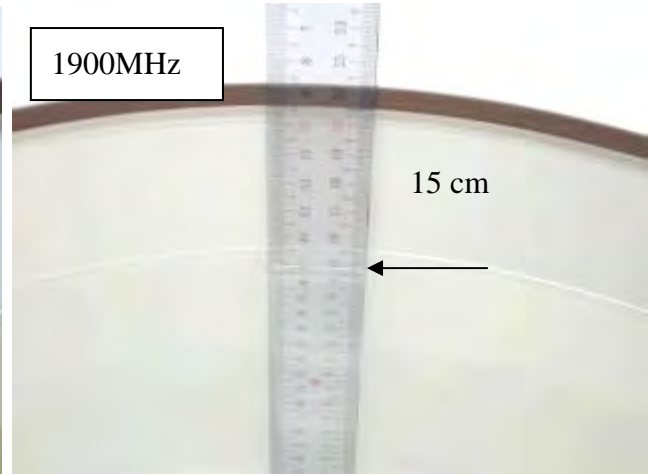
Fig.2.4 Photograph of the Tissue Simulant Fluid liquid depth 15cm for Flat (Body)

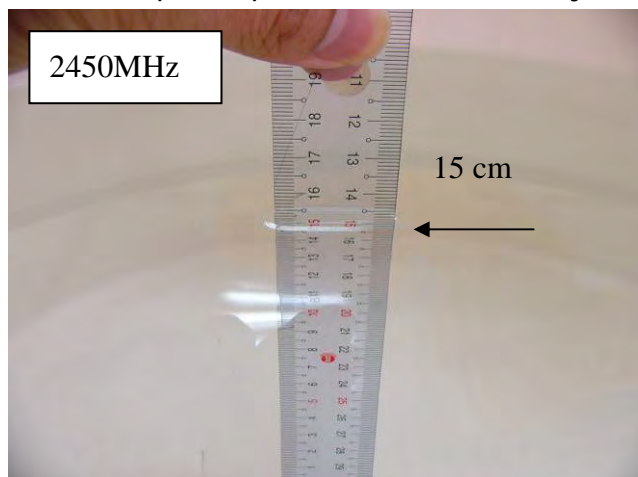
Fig.2.5 Photograph of the Tissue Simulant Fluid liquid depth 15cm for Flat (Body)

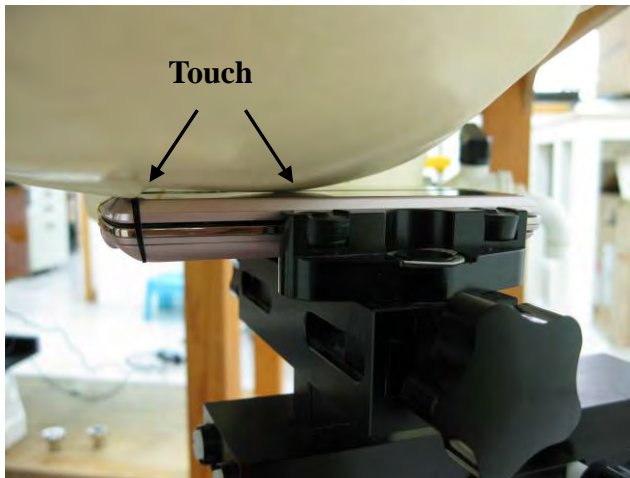
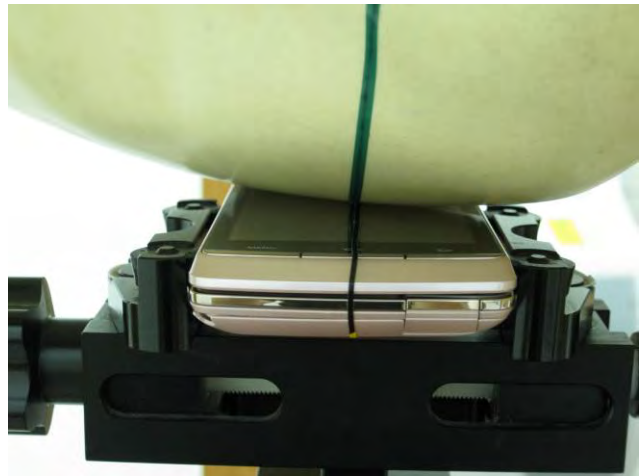
Fig.3 Right Head Section / Cheek-Touch Position_ Slider off

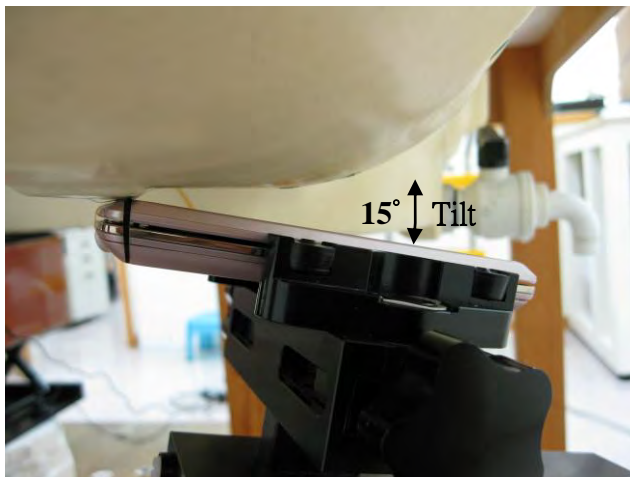
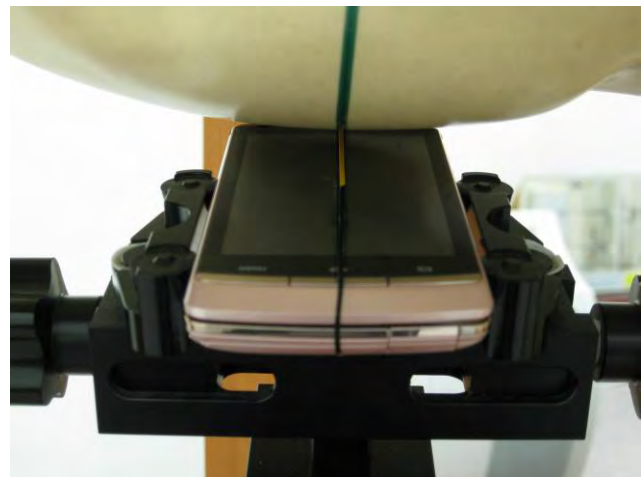
Fig.4 Right Head Section / Ear-Tilt Position(15°)_ Slider off

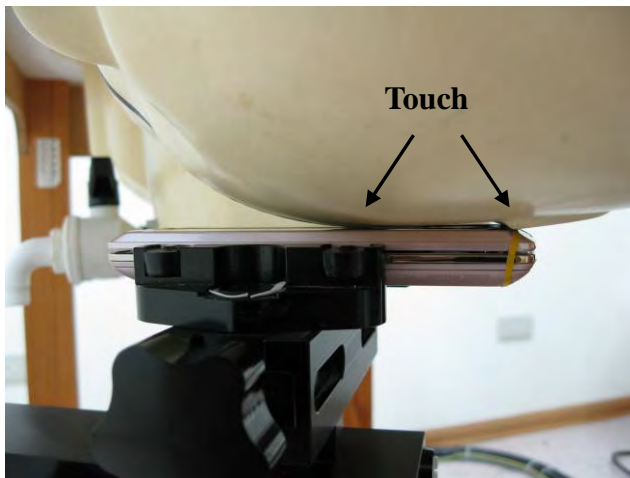
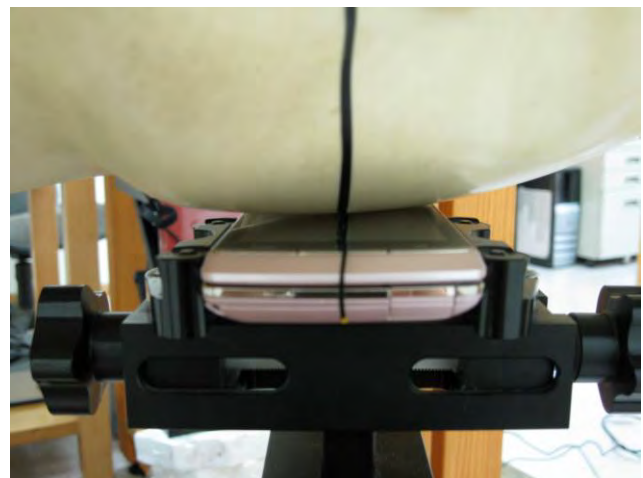
Fig.5 Left Head Section / Cheek-Touch Position_ Slider off

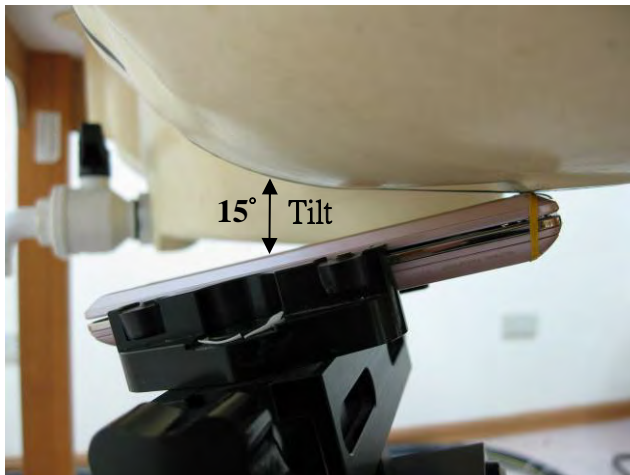
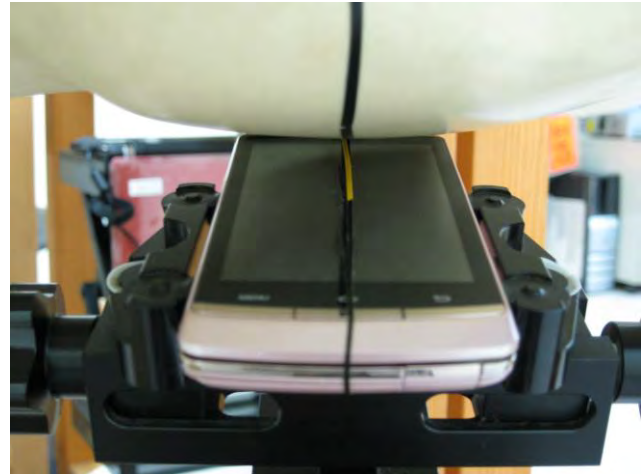
Fig.6 Left Head Section / Ear-Tilt Position(15°)_ Slider off

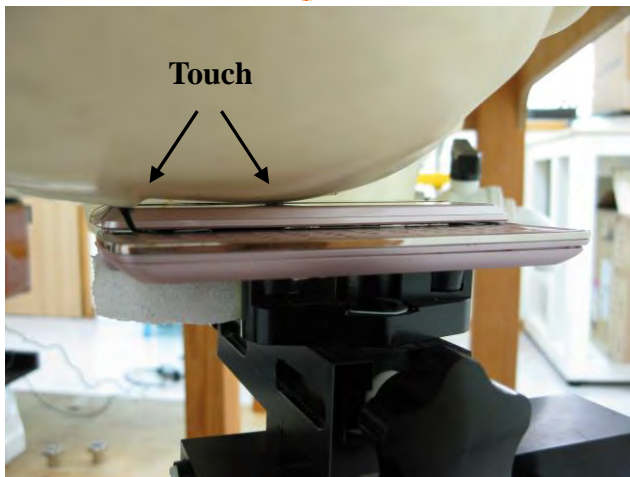
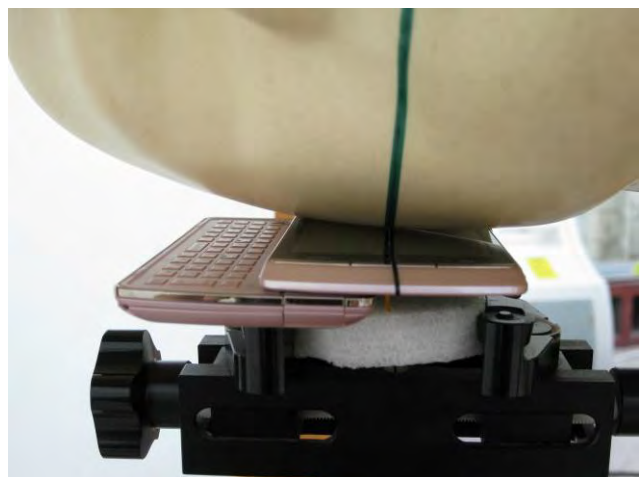
Fig.7 Right Head Section / Cheek-Touch Position_ Slider on

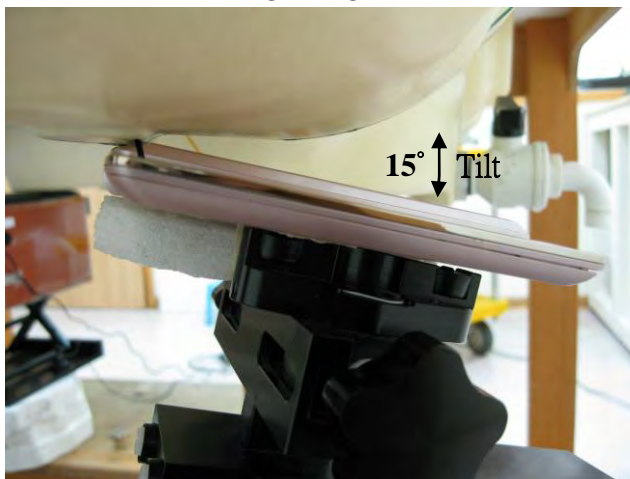
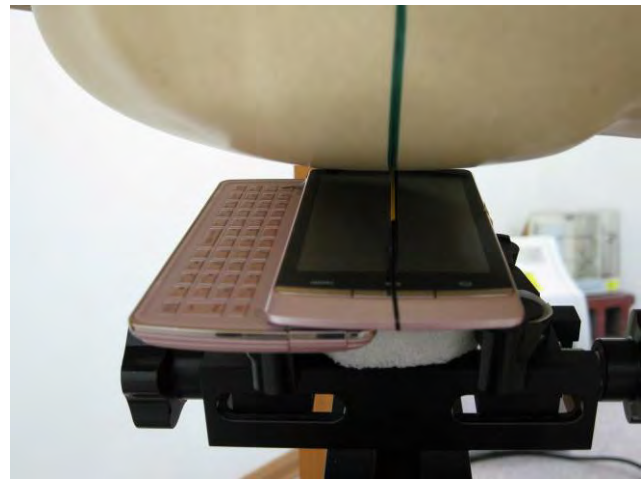
Fig.8 Right Head Section / Ear-Tilt Position(15°)_ Slider on

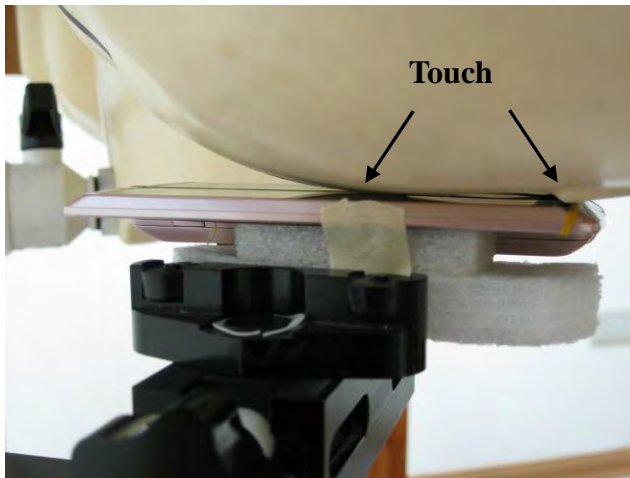
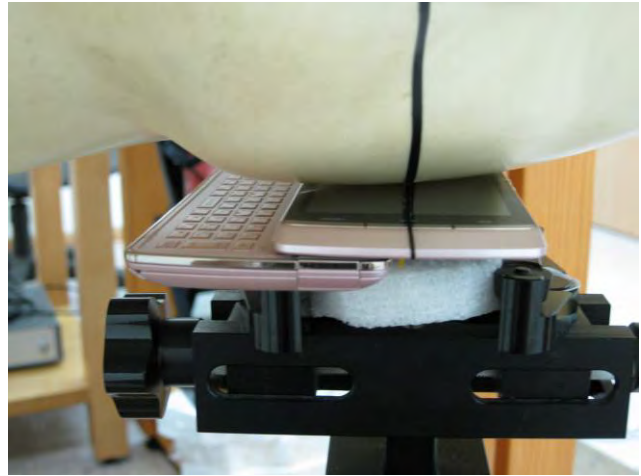
Fig.9 Left Head Section / Cheek-Touch Position_ Slider on

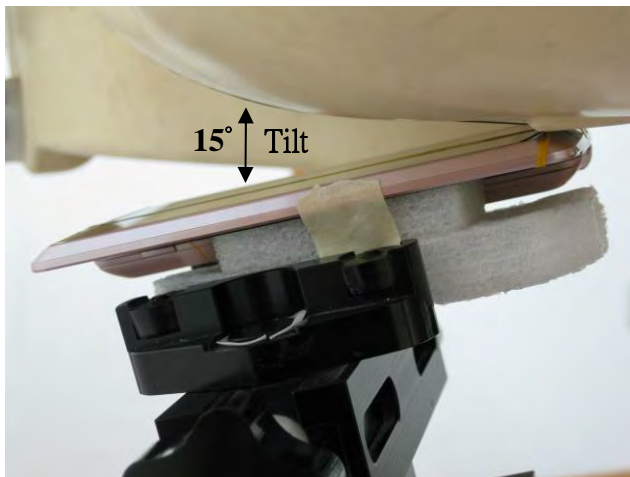
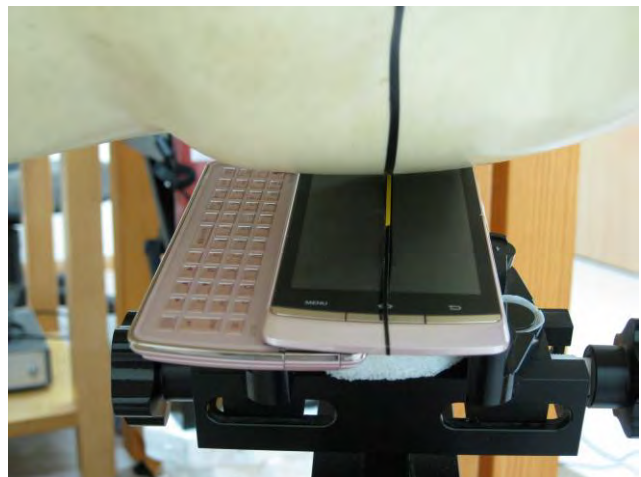
Fig.10 Left Head Section / Ear-Tilt Position(15°)_ Slider on

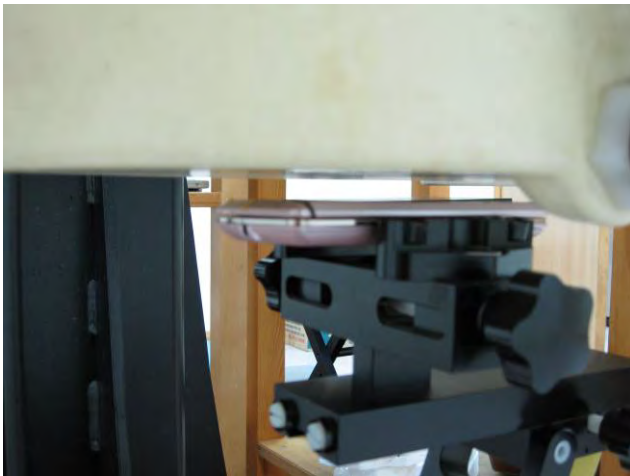
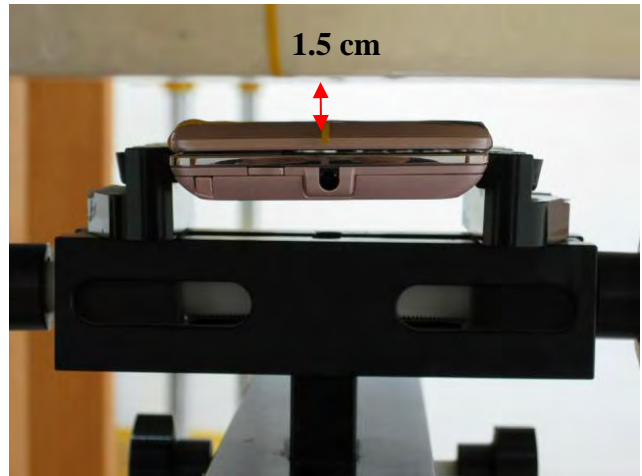
Fig.11 Body worn- EUT front to flat phantom and distance between flat phantom and mobile phone is 1.5 cm.

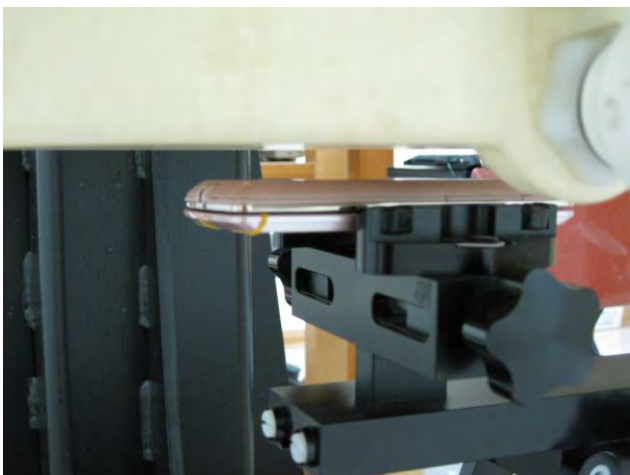
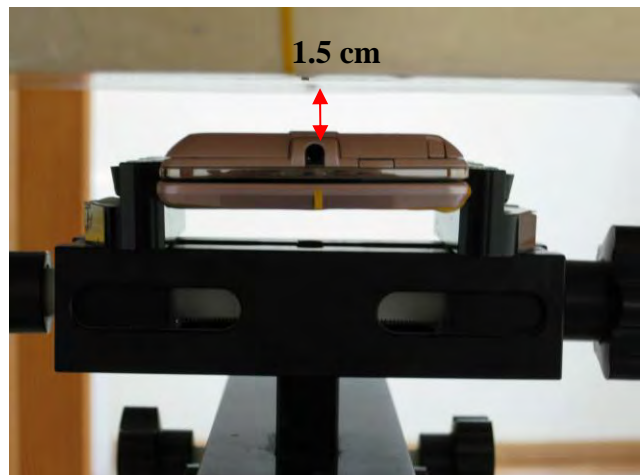
Fig.12 Body worn - EUT back to flat phantom and distance between flat phantom and mobile phone is 1.5 cm.

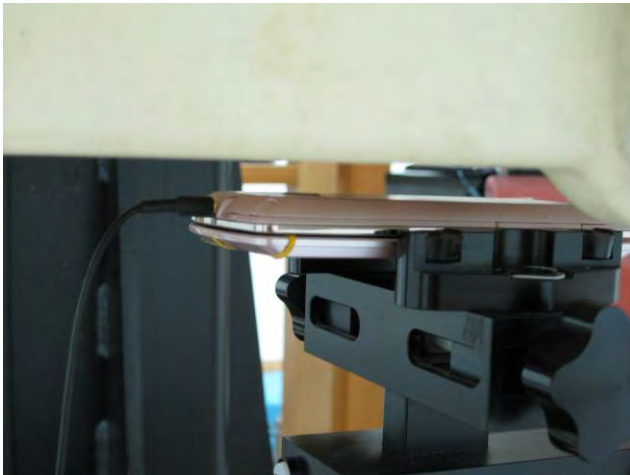
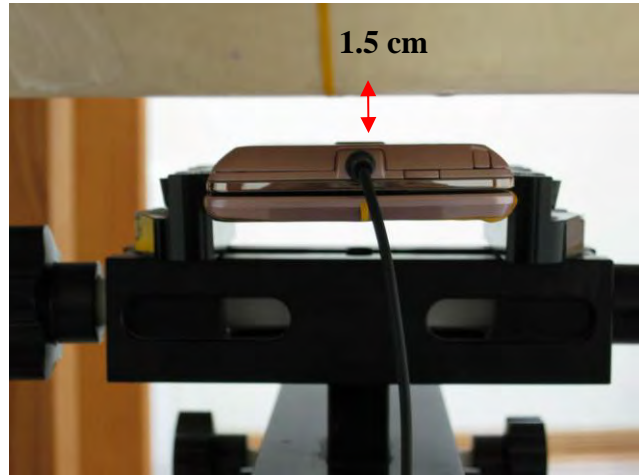
Fig.13 Body worn - EUT back to flat phantom and distance between flat phantom and mobile phone is 1.5 cm_ repeated with headset.

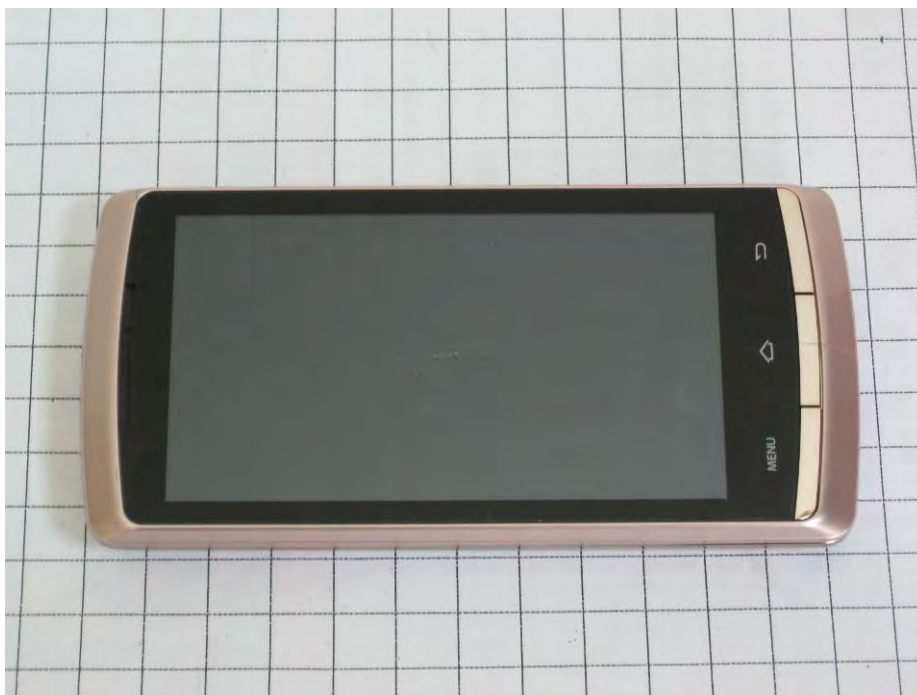
Fig.14 Front view of device(Slider off)

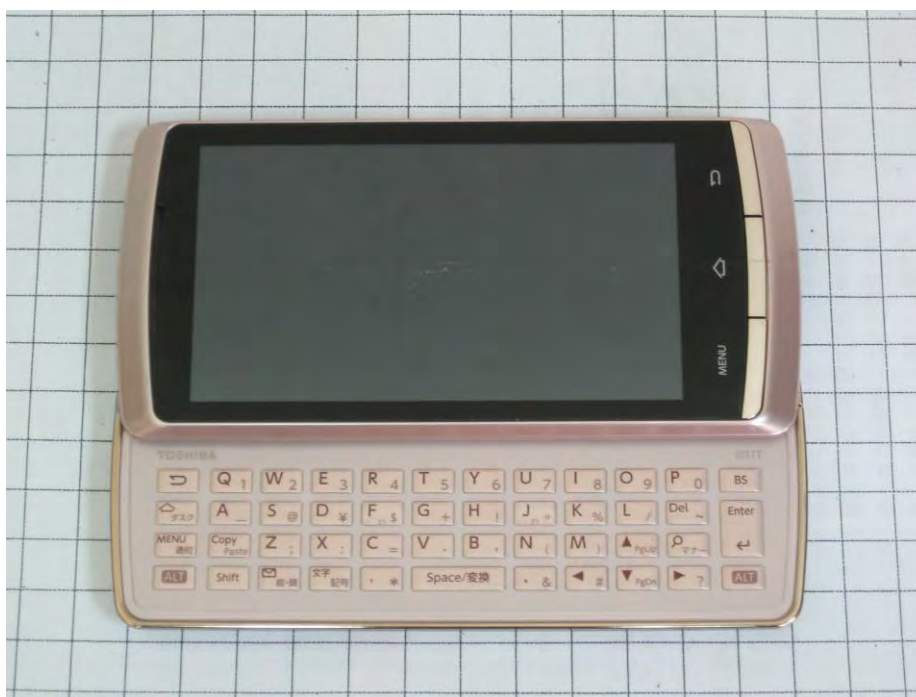
Fig.15 Front view of device(Slider on)

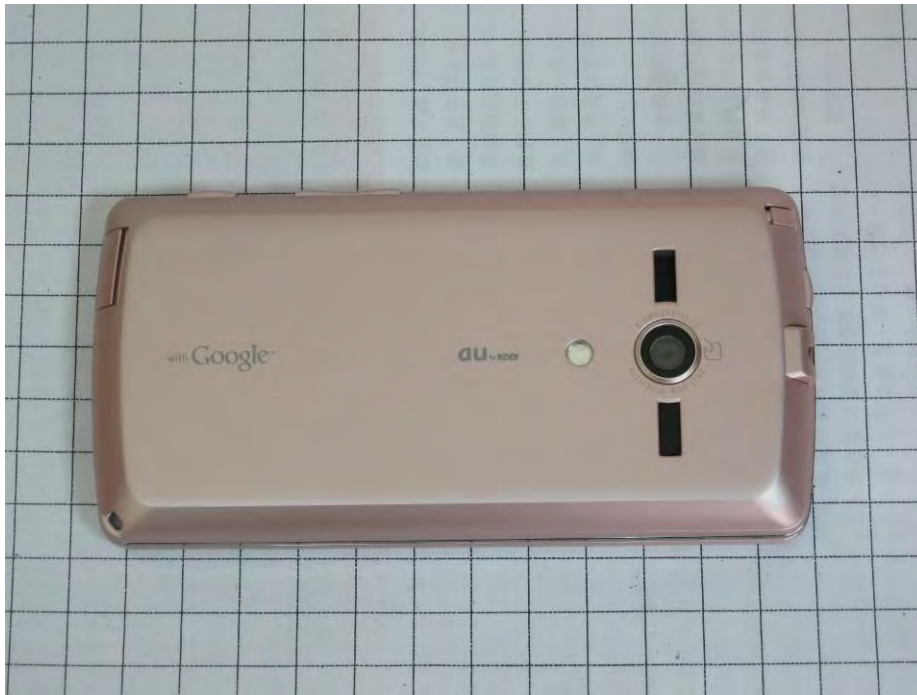
Fig.16 Back view of device

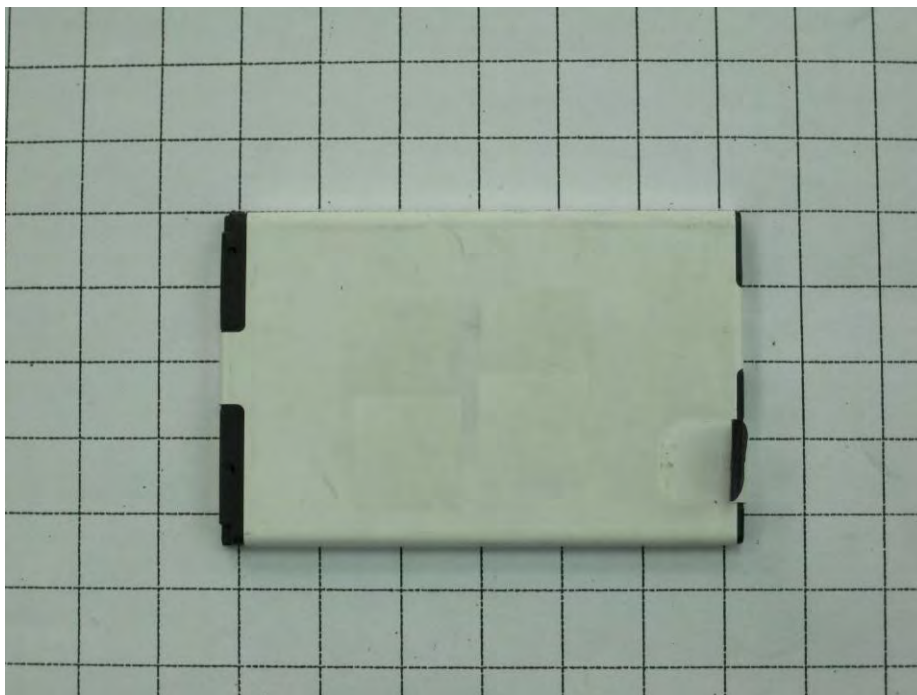
Fig.17 Front view of Battery

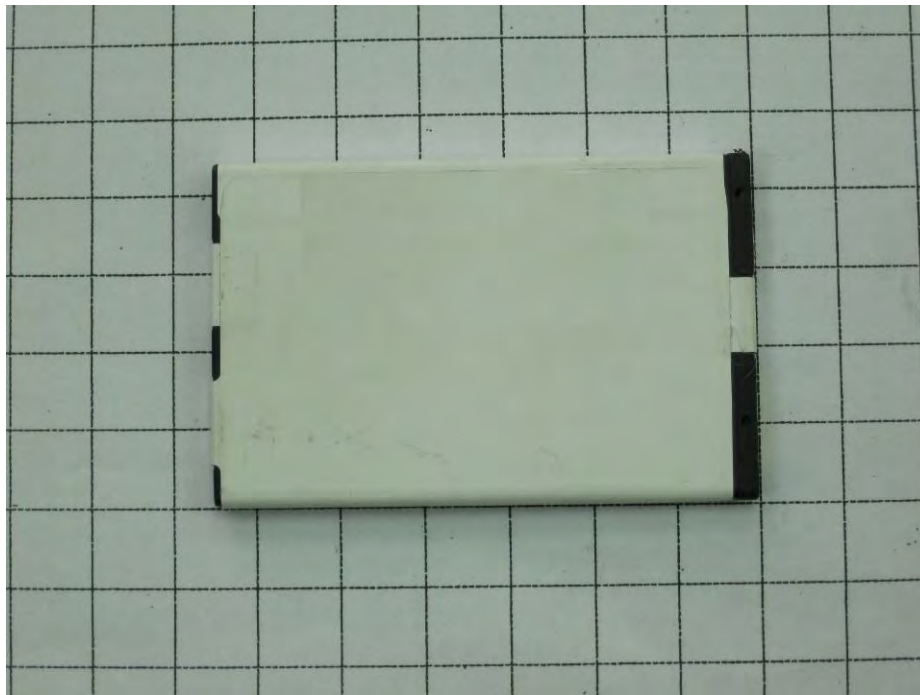
Fig.18 Back view of Battery

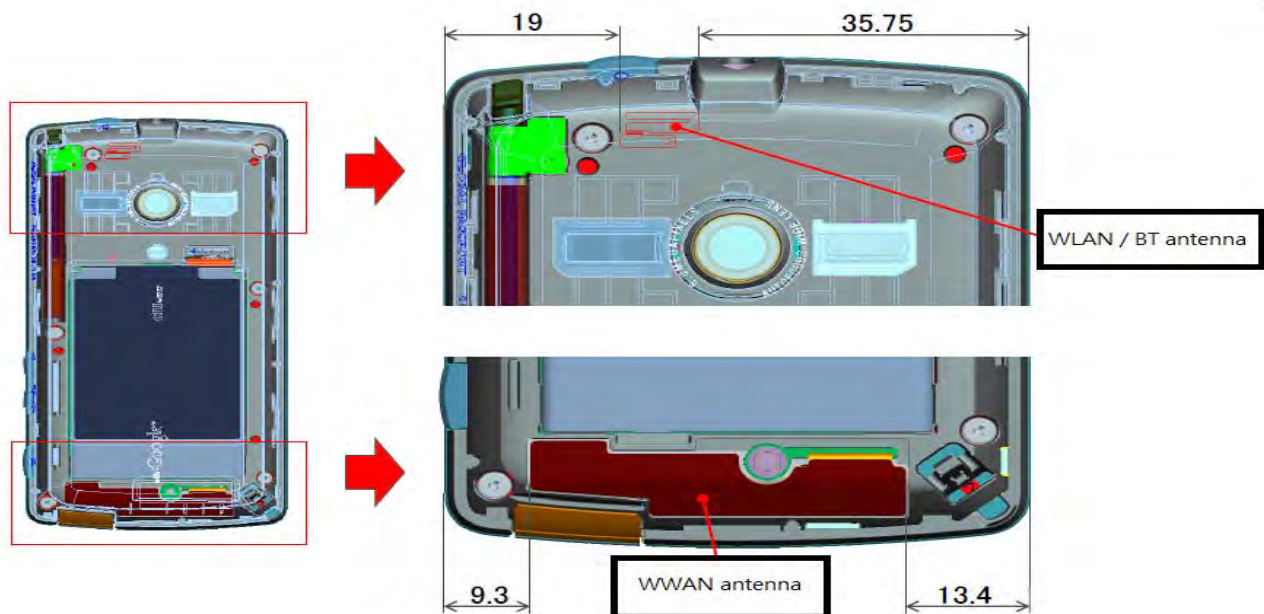
Fig.19 Antenna position of EUT
