## ANNEX 1 - TEST SETUP PHOTOS

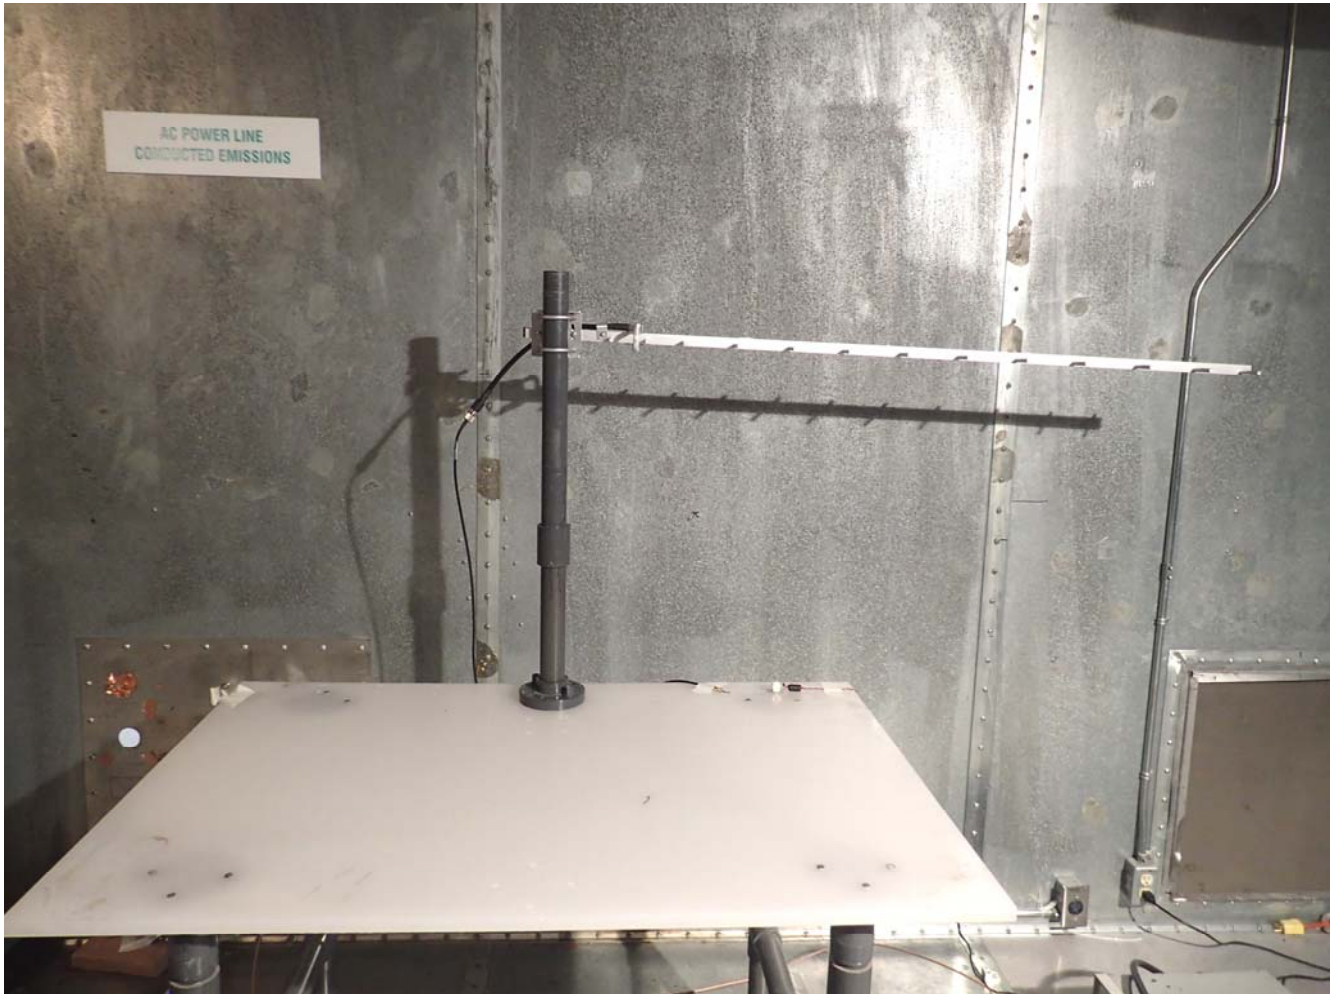
### Power Line Conducted Emissions

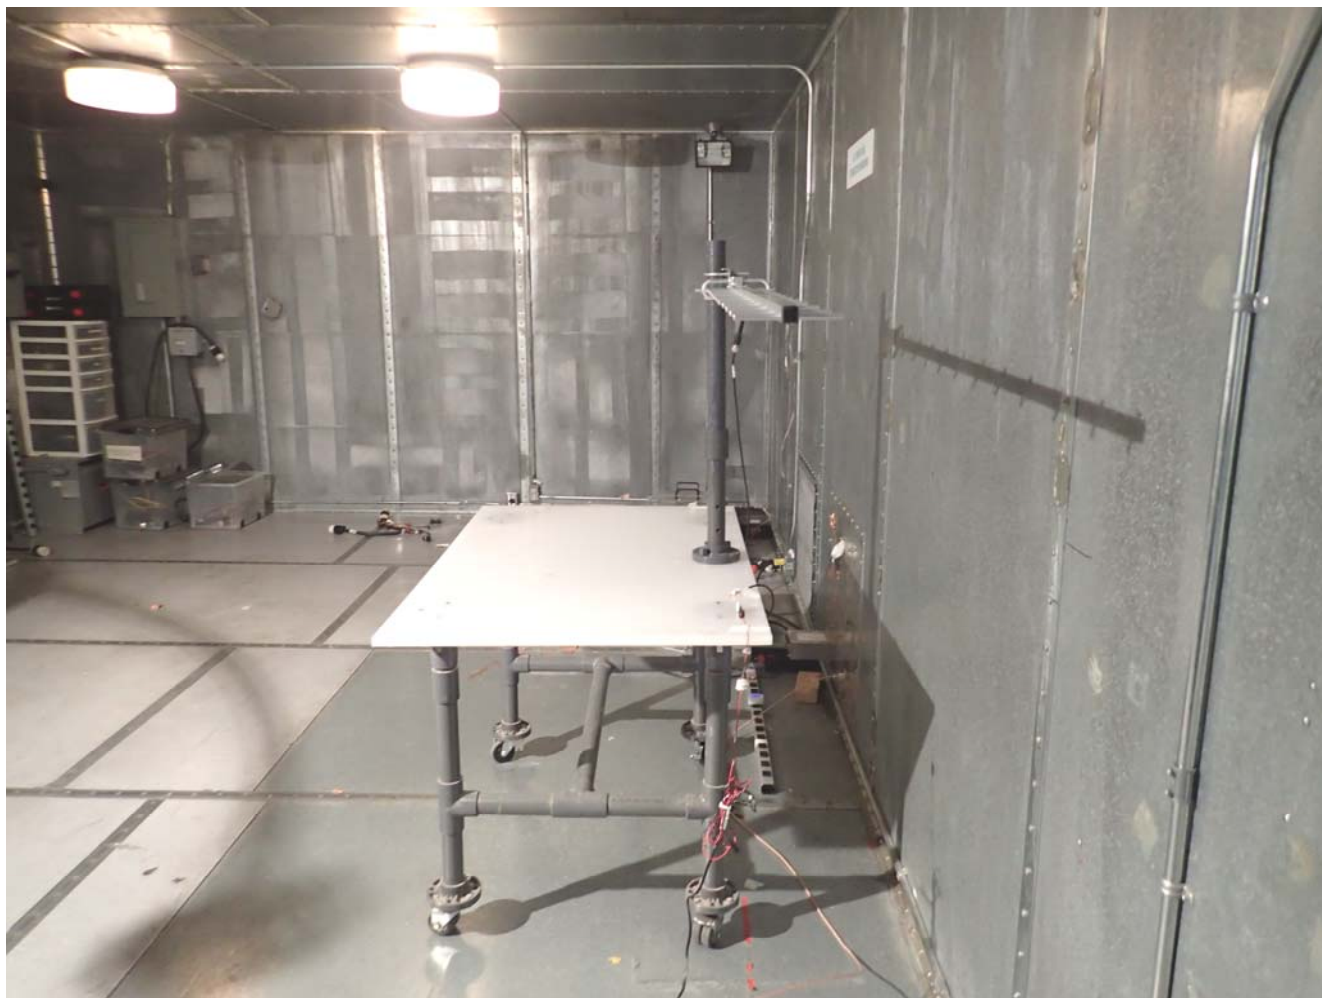
### Power Line Conducted Emissions

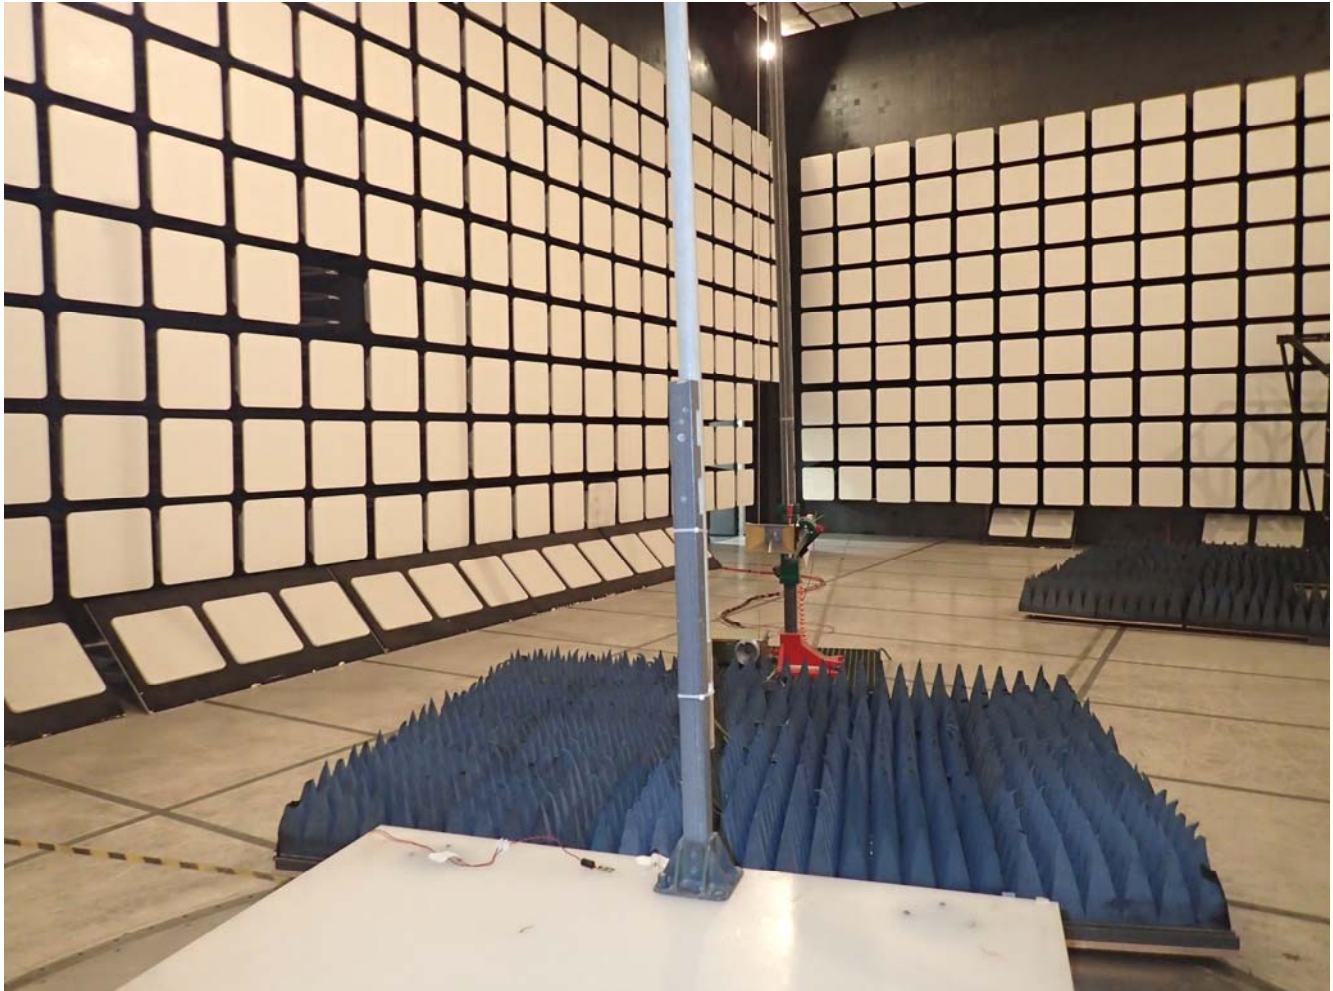
**Radiated Emissions @ 3 m, Orthogonal Position 1  
EUT with 8.0 dBi Omni-directional Antenna and 0.86 dB Assembly Cable Loss**

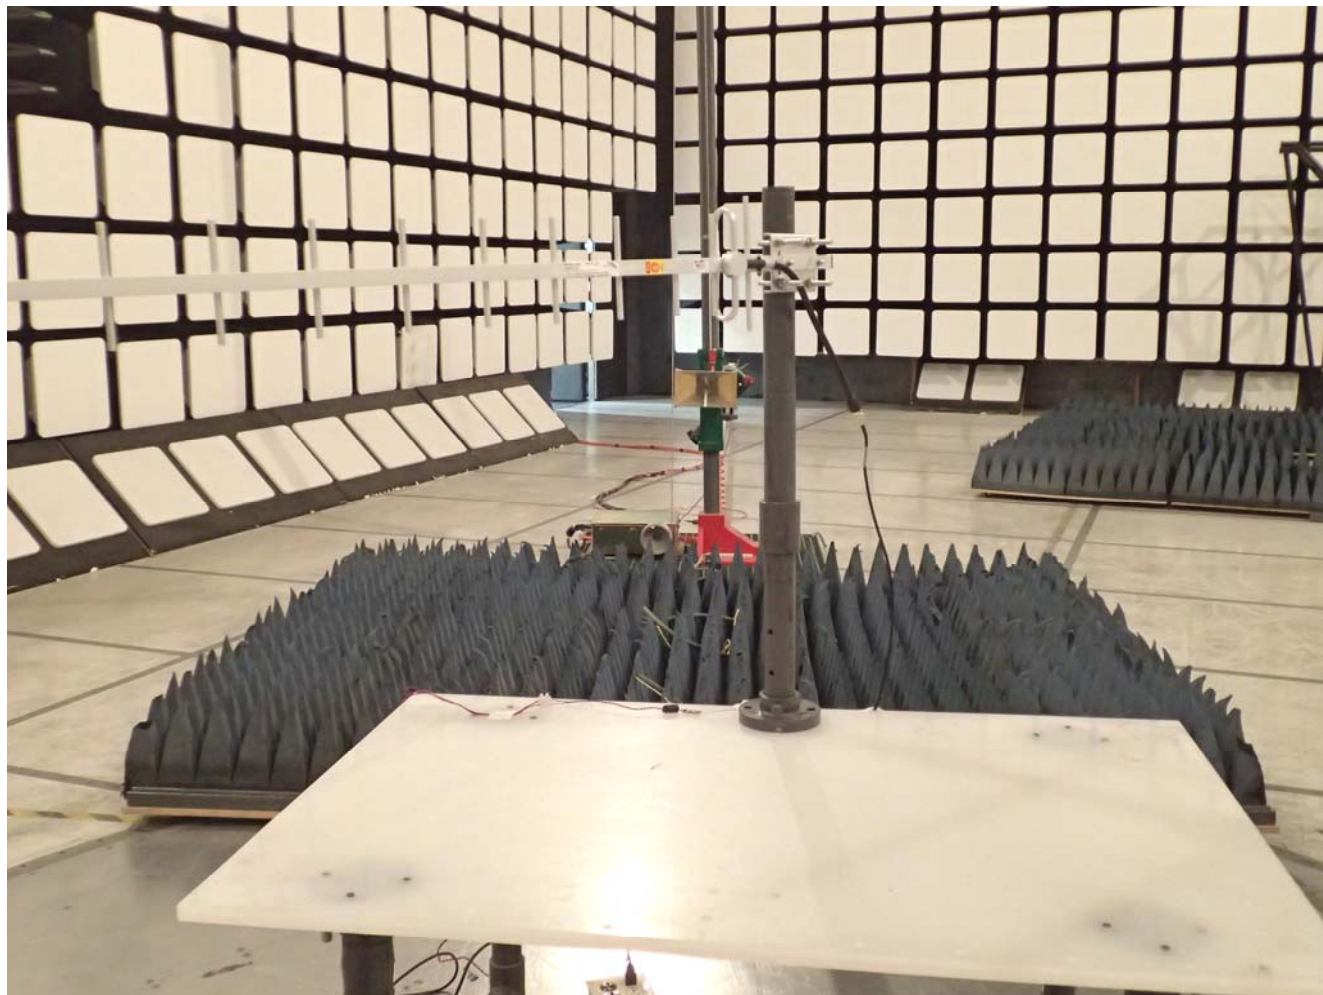
**Radiated Emissions @ 3 m, Orthogonal Position 2  
EUT with 14.0 dBi Yagi Antenna and 0.86 dB Assembly Cable Loss**

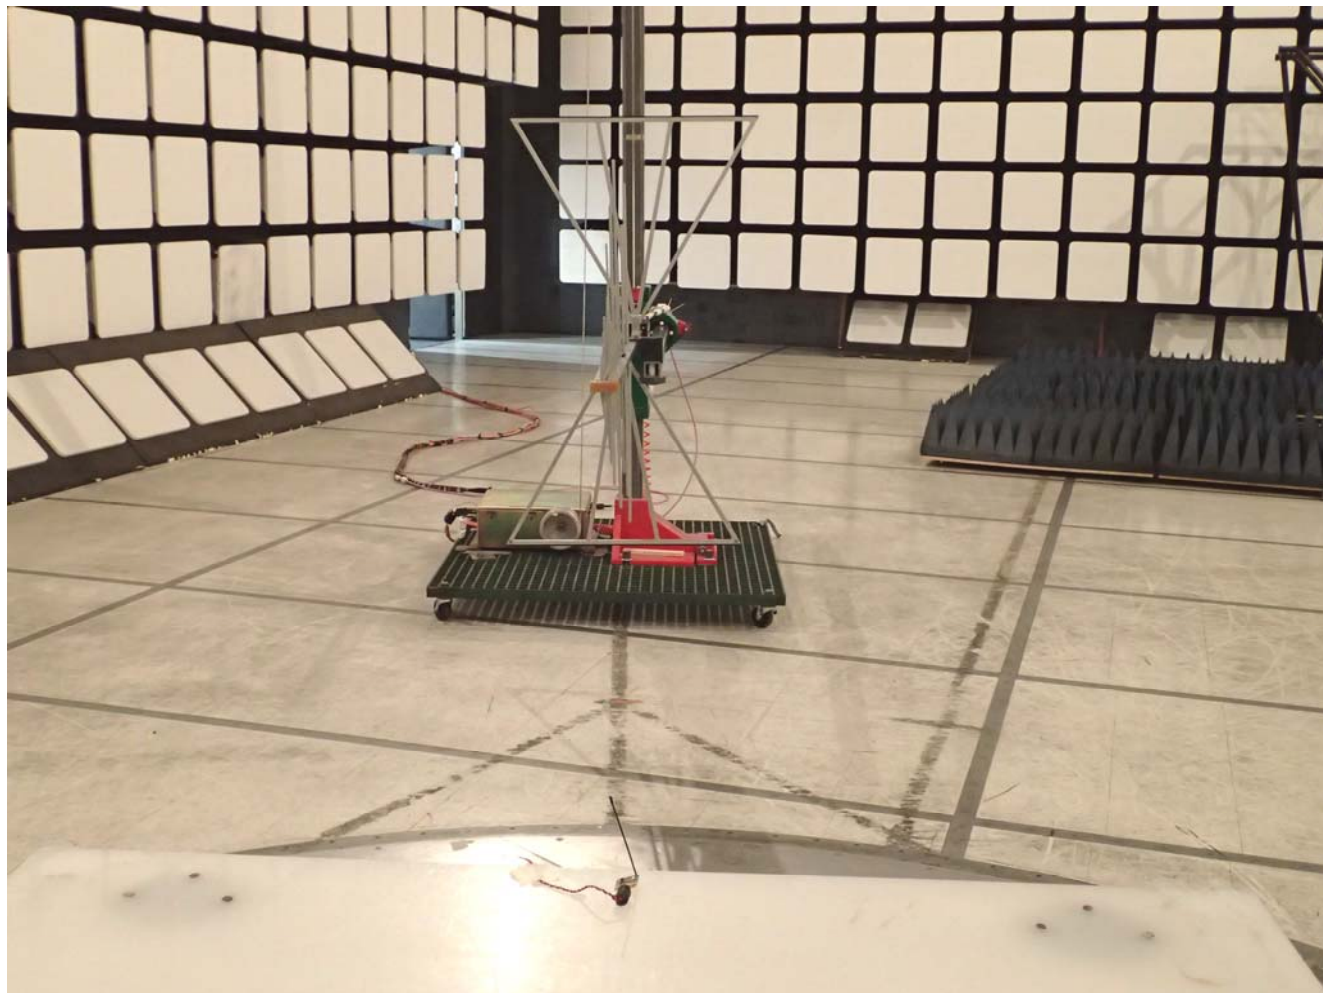
**Radiated Emissions @ 3 m, Orthogonal Position 3  
EUT with 1.0 dBi Wire Antenna and 0.0 dB Assembly Cable Loss**

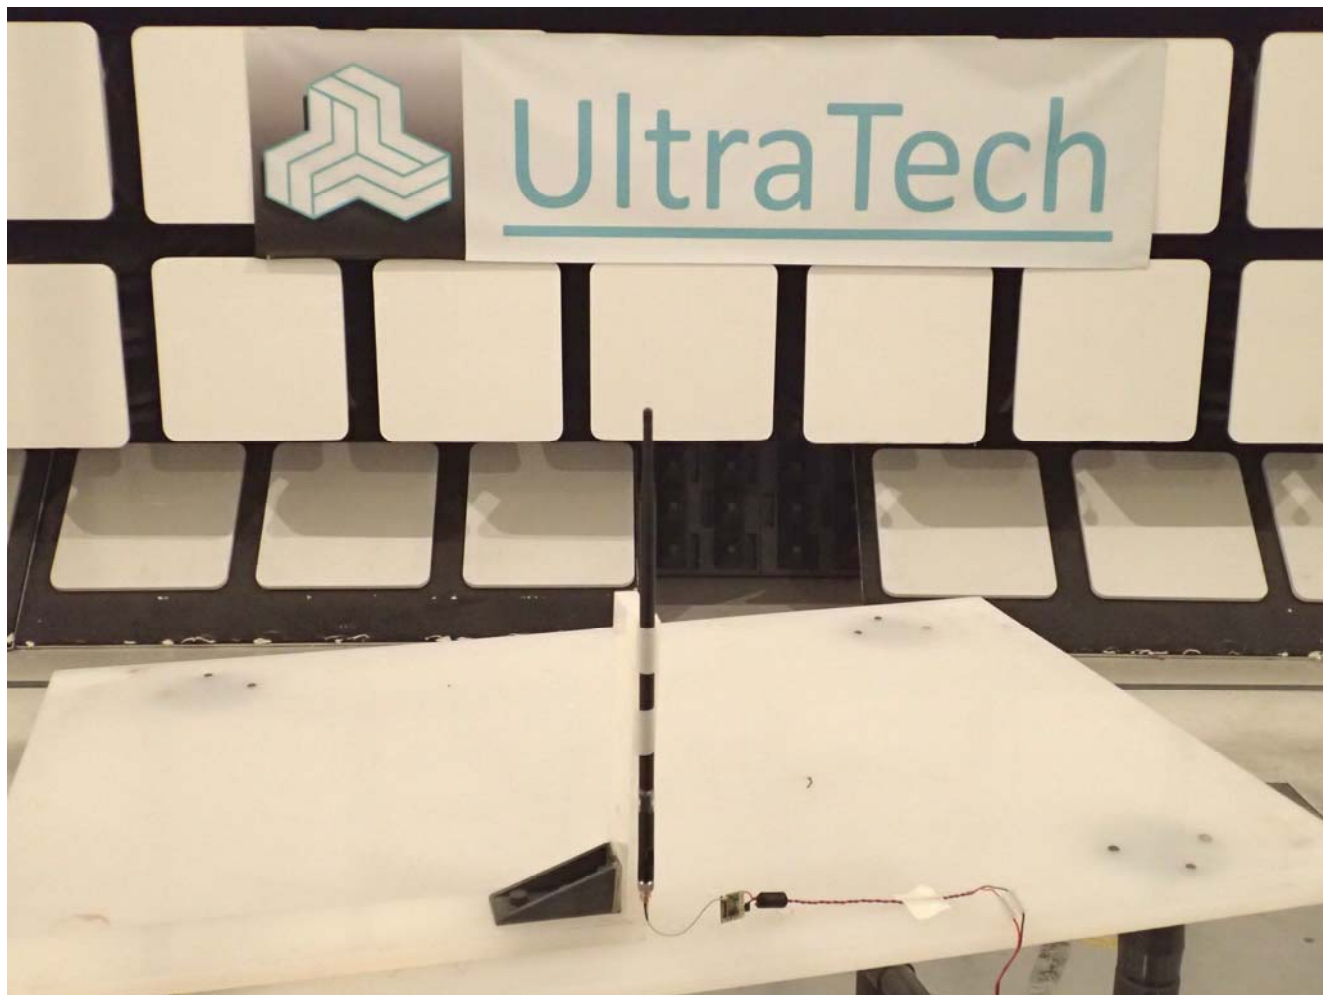
Radiated Emissions @ 3 m  
EUT with 5.0 dBi Dipole Antenna and 0.30 dB Assembly Cable Loss

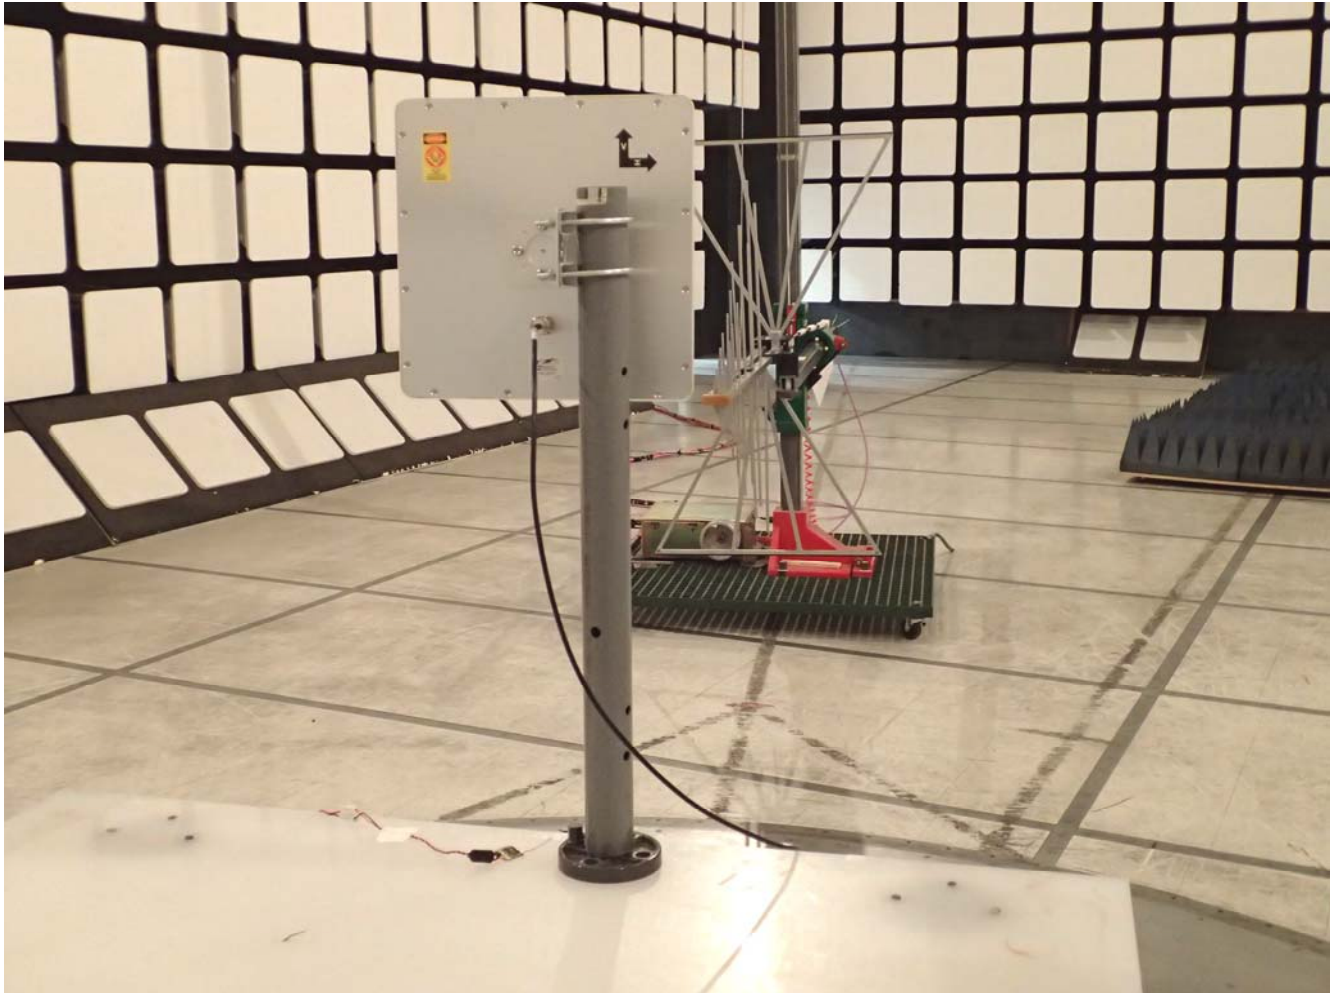
**Radiated Emissions @ 3 m**  
**EUT with 9.0 dBi Flat Panel Antenna and 0.86 dB Assembly Cable Loss**
