CENTER FUSELAGE II - PASSENGER CABIN LH/RH SIDES - EXTERNAL - INSPECTION/CHECK

TASK 05-20-23-200-801-A

2. CENTER FUSELAGE II - PASSENGER CABIN LH/RH SIDES - EXTERNAL GENERAL VISUAL INSPECTION

TASK 05-20-23-200-802-A

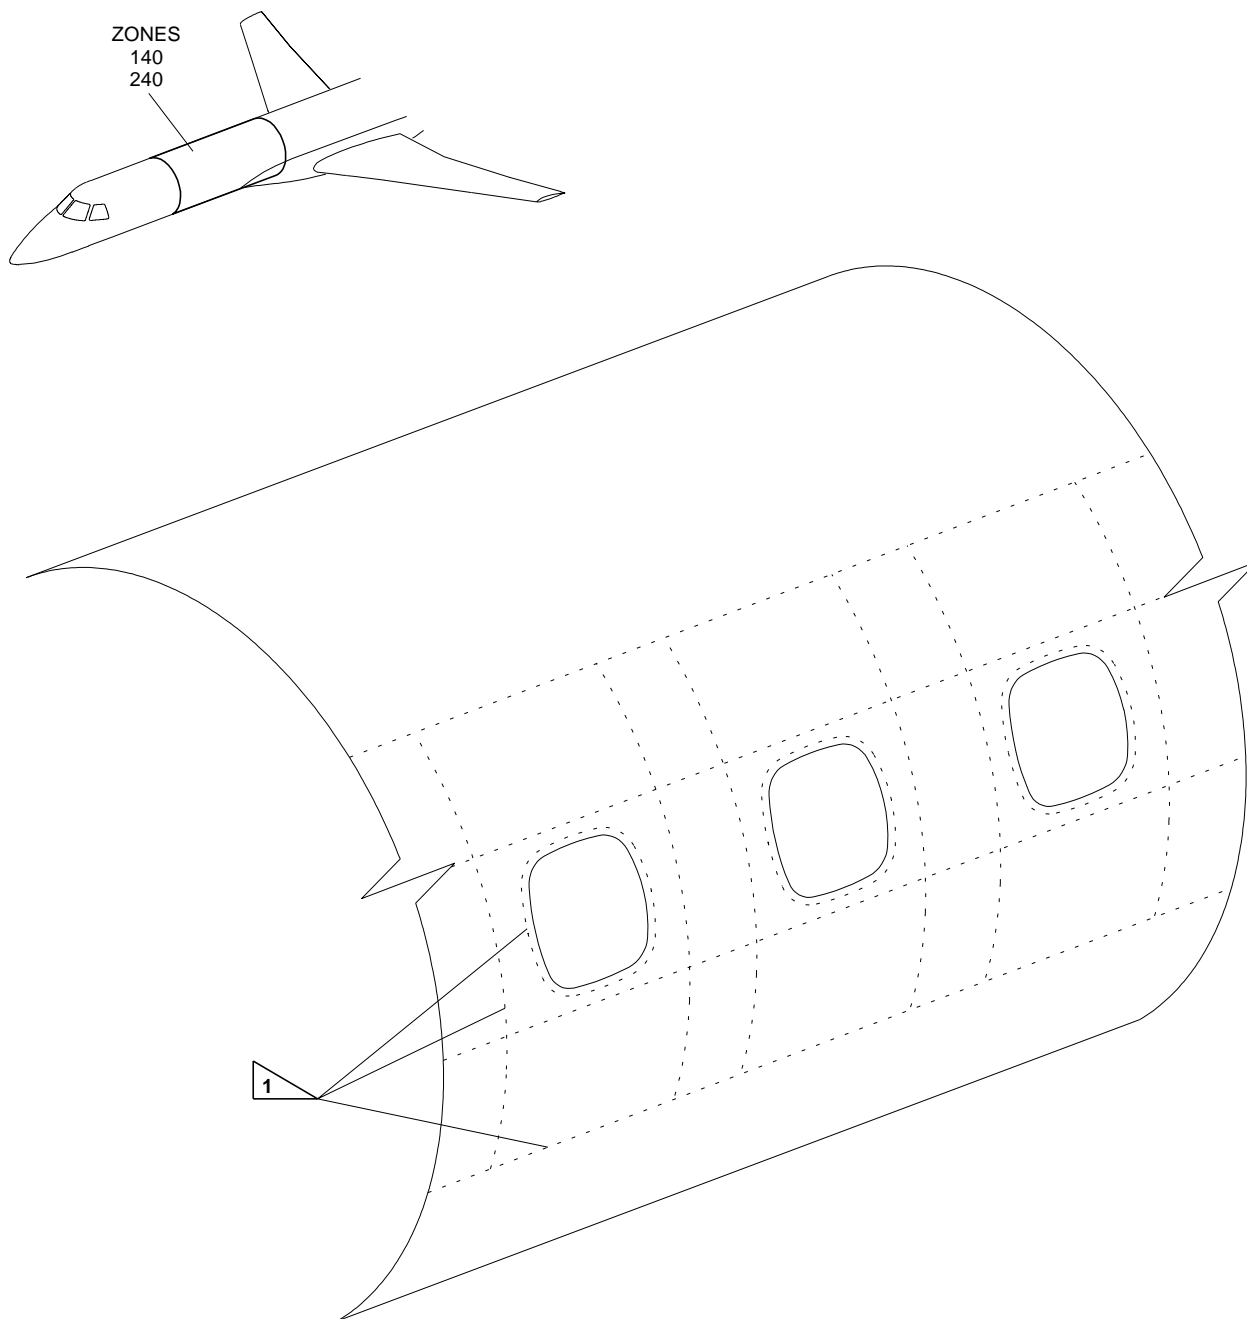
Figure 601

Center Fuselage II - Passenger Cabin LH/RH Sides - External General Visual Inspection

EXTERNALLY INSPECT THE FUSELAGE SKIN PANEL AT STRINGER, FRAMES/BULKHEADS, SKIN LONGITUDINAL AND CIRCUMFERENTIAL SPLICES.

J. External General Visual Inspection ([Figure 601](#))

- (1) Examine the fuselage zone for painting bad condition, loose rivets, skin deformation, fillet sealant condition, nicks, cracks, scratches, gouges, creases, dents, erosion, corrosion, and deteriorated protective treatment.
- (2) Examine the fuselage skin panel at stringers and frames/bulkheads for loose rivets, nicks, cracks, dents, erosion, corrosion, and deteriorated protective treatment.
- (3) Examine the fuselage skin longitudinal and circumferential splice for loose rivets, nicks, cracks, dents, erosion, corrosion, and deteriorated protective treatment.
- (4) Examine the passenger-cabin windows frames for loose rivets, nicks, cracks, dents, erosion, corrosion, and deteriorated protective treatment.
- (5) Examine the passenger-cabin windows for delaminations and crazing ([AMM TASK 56-20-01-200-801-A/600](#)).

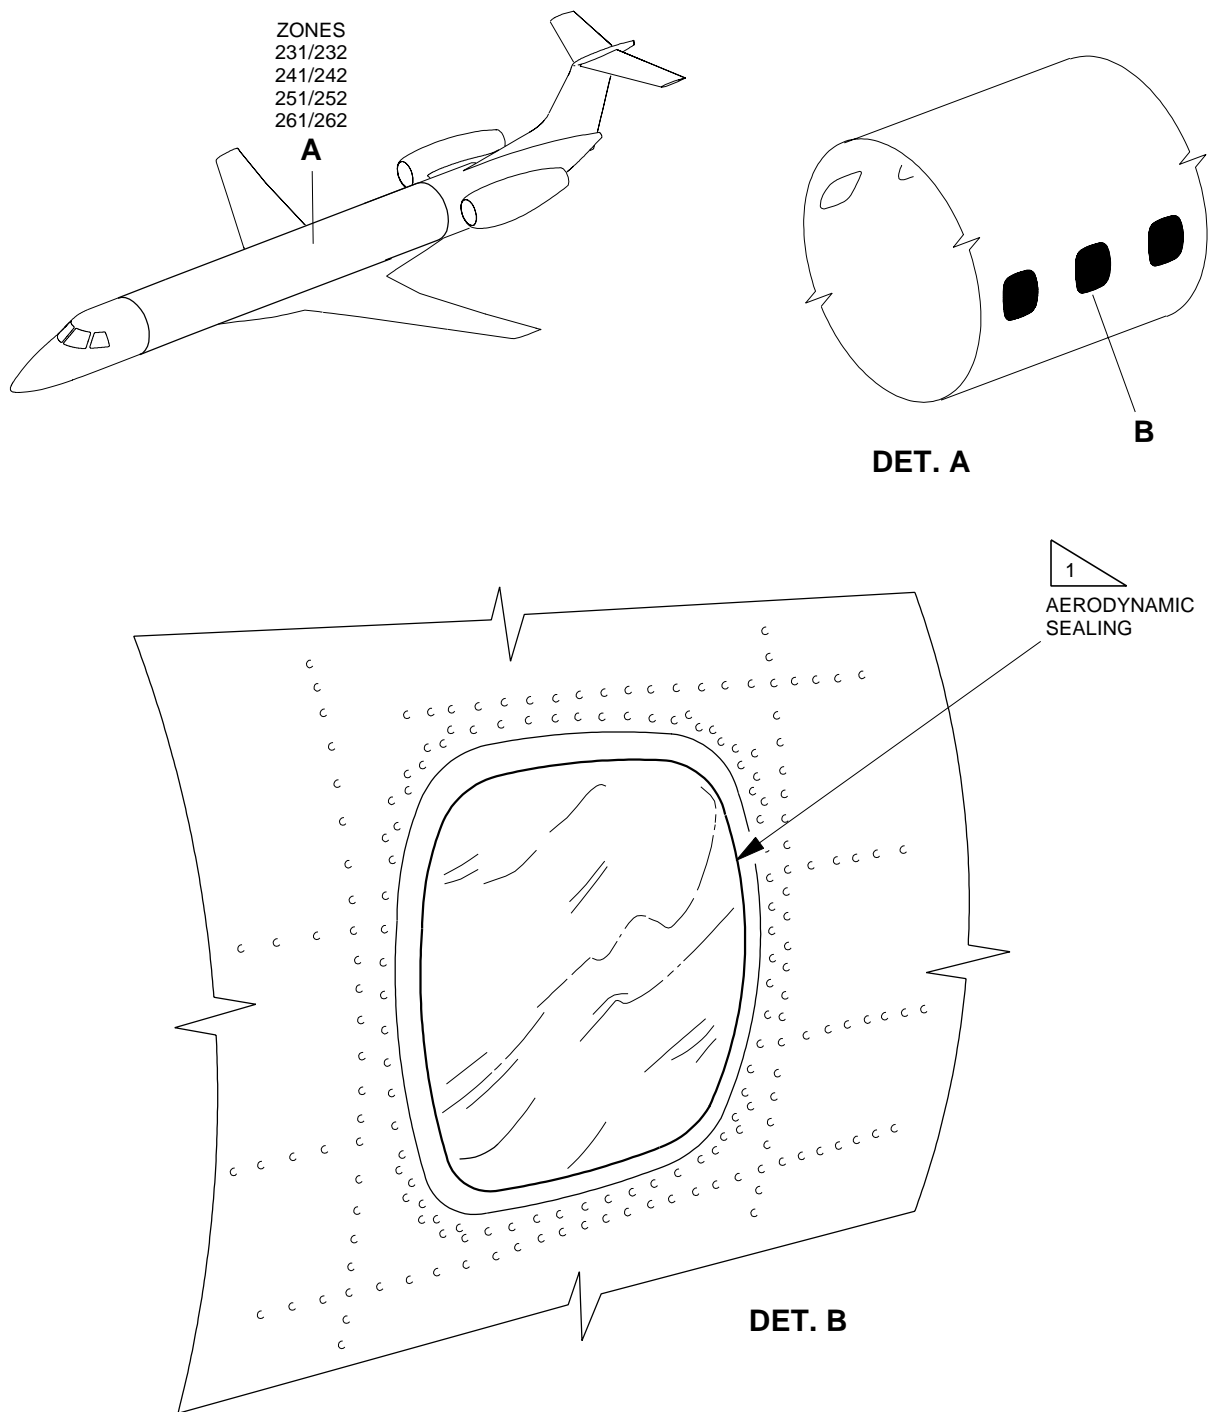
Center Fuselage II - Passenger-Cabin-Window Aerodynamic Sealing - External General Visual Inspection
Figure 602

1 EXTERNALLY INSPECT THE AERODYNAMIC SEALING.

J. External General Visual Inspection ([Figure 602](#))

- (1) Make sure that the passenger-cabin-window aerodynamic sealing is not scratched, scored, cracked, or ruptured.
