**CENTER FUSELAGE III - WING STUB MIDDLE SECTION - EXTERNAL - INSPECTION/CHECK**

*EFFECTIVITY: EMB-145LR/LU/MR/MP/MK AND EMB-135LR/KE/KL MODELS*

TASK 05-30-22-200-801-A

## 2. CENTER FUSELAGE III - WING STUB MIDDLE SECTION - EXTERNAL GENERAL VISUAL INSPECTION

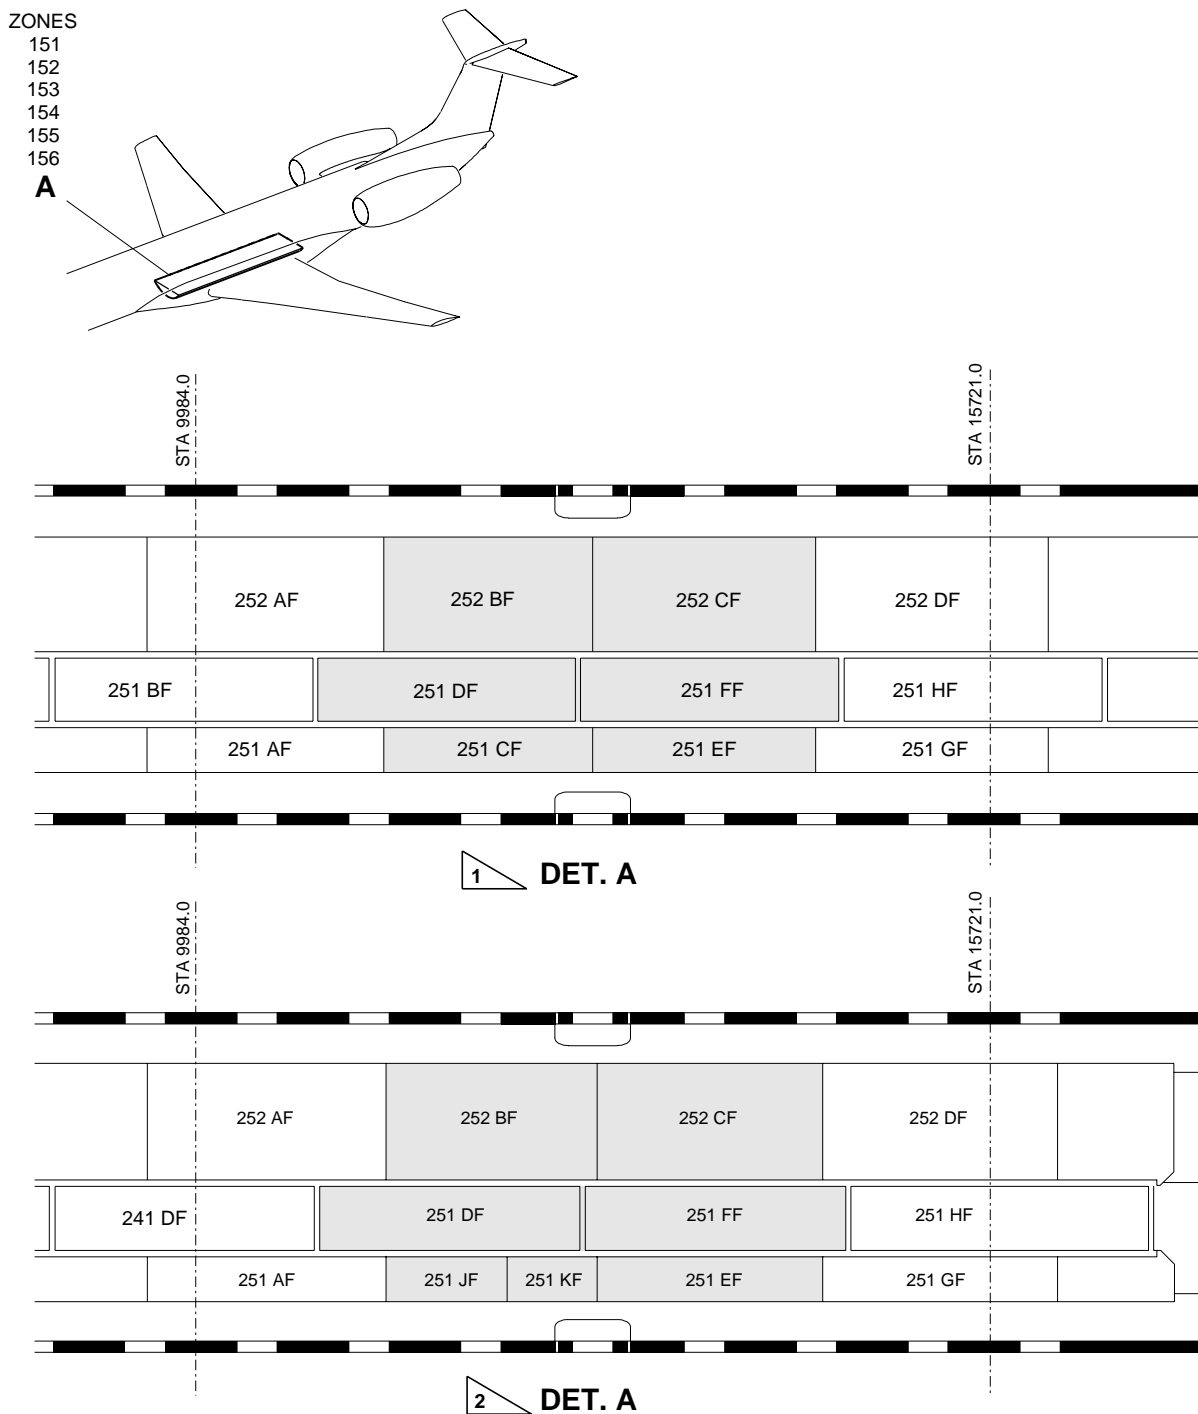
EFFECTIVITY: EMB-145LR/LU/MR/MP/MK AND EMB-135LR/KE/KL MODELS  
Center Fuselage III - Wing-Stub Middle Section - Passenger Cabin Floor Panels  
Figure 601

**1** APPLICABLE TO EMB-145 (ALL) MODELS

**2** APPLICABLE TO EMB-135 (ALL) MODELS

- (1) Make sure that the aircraft is defueled ( **AMM TASK 12-11-01-600-802-A/300**).
- (2) Use table 601 to remove passenger-cabin floor panels as applicable to your aircraft (AMM TASK 53-01-02-000-801-A/400) or (AMM TASK 53-01-02-000-802-A/400) (Figure 601).

Table 601 - PASSENGER-CABIN FLOOR PANELS

AIRCRAFT	PANELS
EMB-145	251CF, 251DF, 252BF, 252CF, 251FF and 251EF
EMB-135	251JF, 251KF, 251DF, 252BF, 252CF, 251FF and 251EF

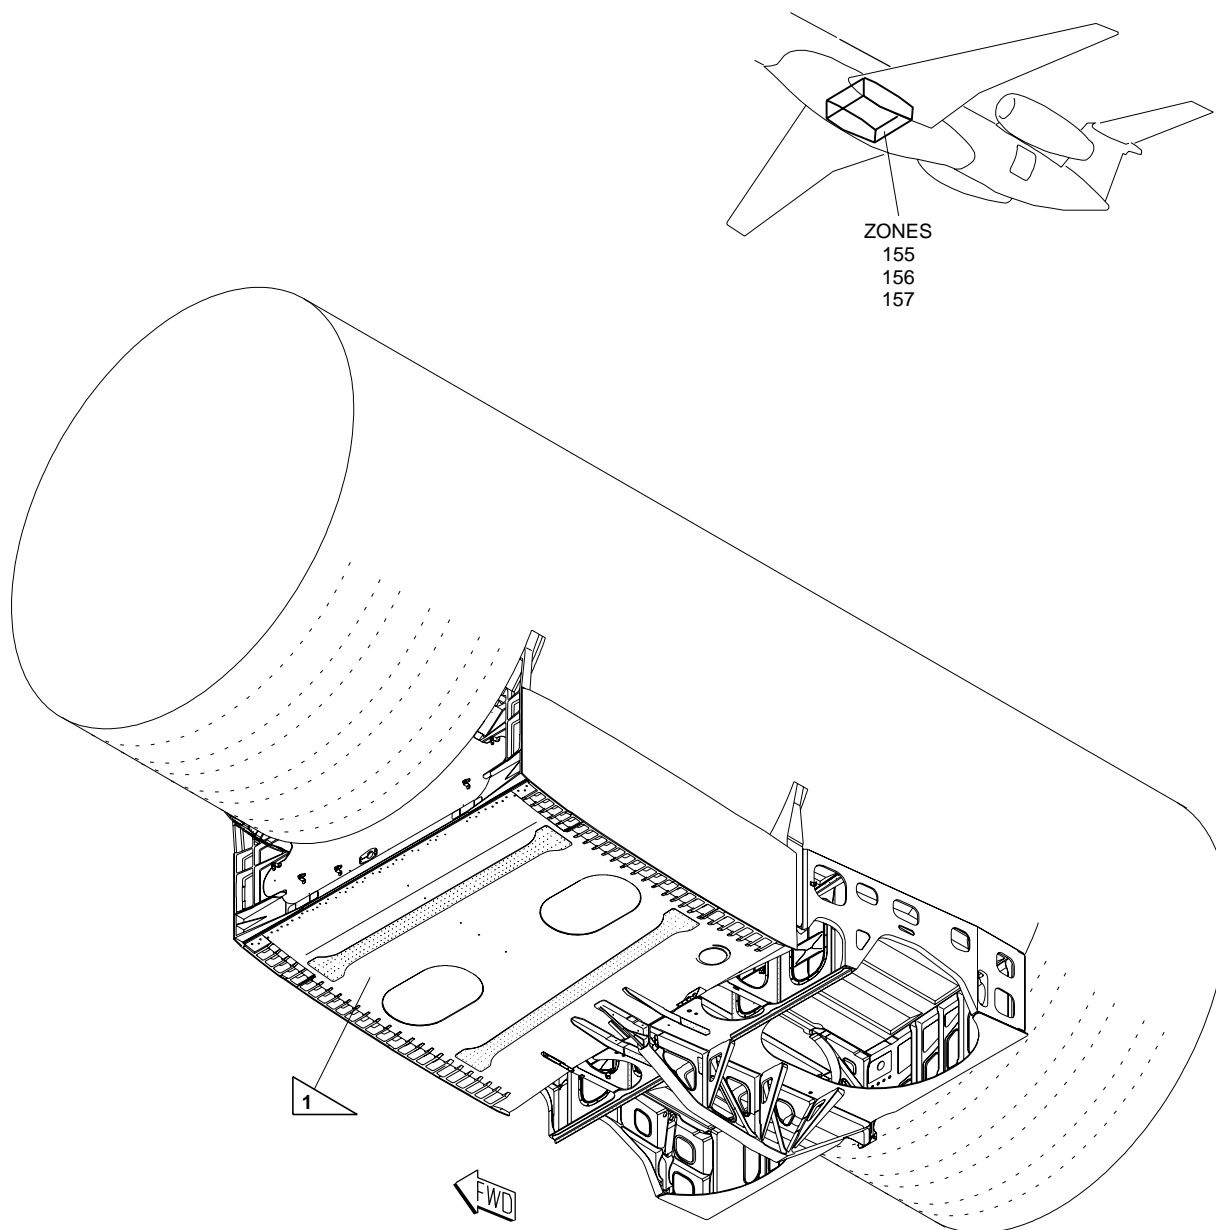
EFFECTIVITY: EMB-145LR/LU/MR/MP/MK AND EMB-135LR/KE/KL MODELS  
Center Fuselage III - Wing-Stub Middle Section - External General Visual Inspection  
Figure 602

EXTERNALLY INSPECT TO WING STUB STRUCTURE.

- (1) Examine the wing stub structure for loose rivets, nicks, cracks, dents, distortion, erosion, and corrosion (Figure 602).
