TOILET OVERSERVICING - CLEANING/PAINTING

EFFECTIVITY: ACFT MODEL(S) EMB-135

TASK 05-50-12-100-801-A

2. TOILET OVERSERVICING - CLEANING

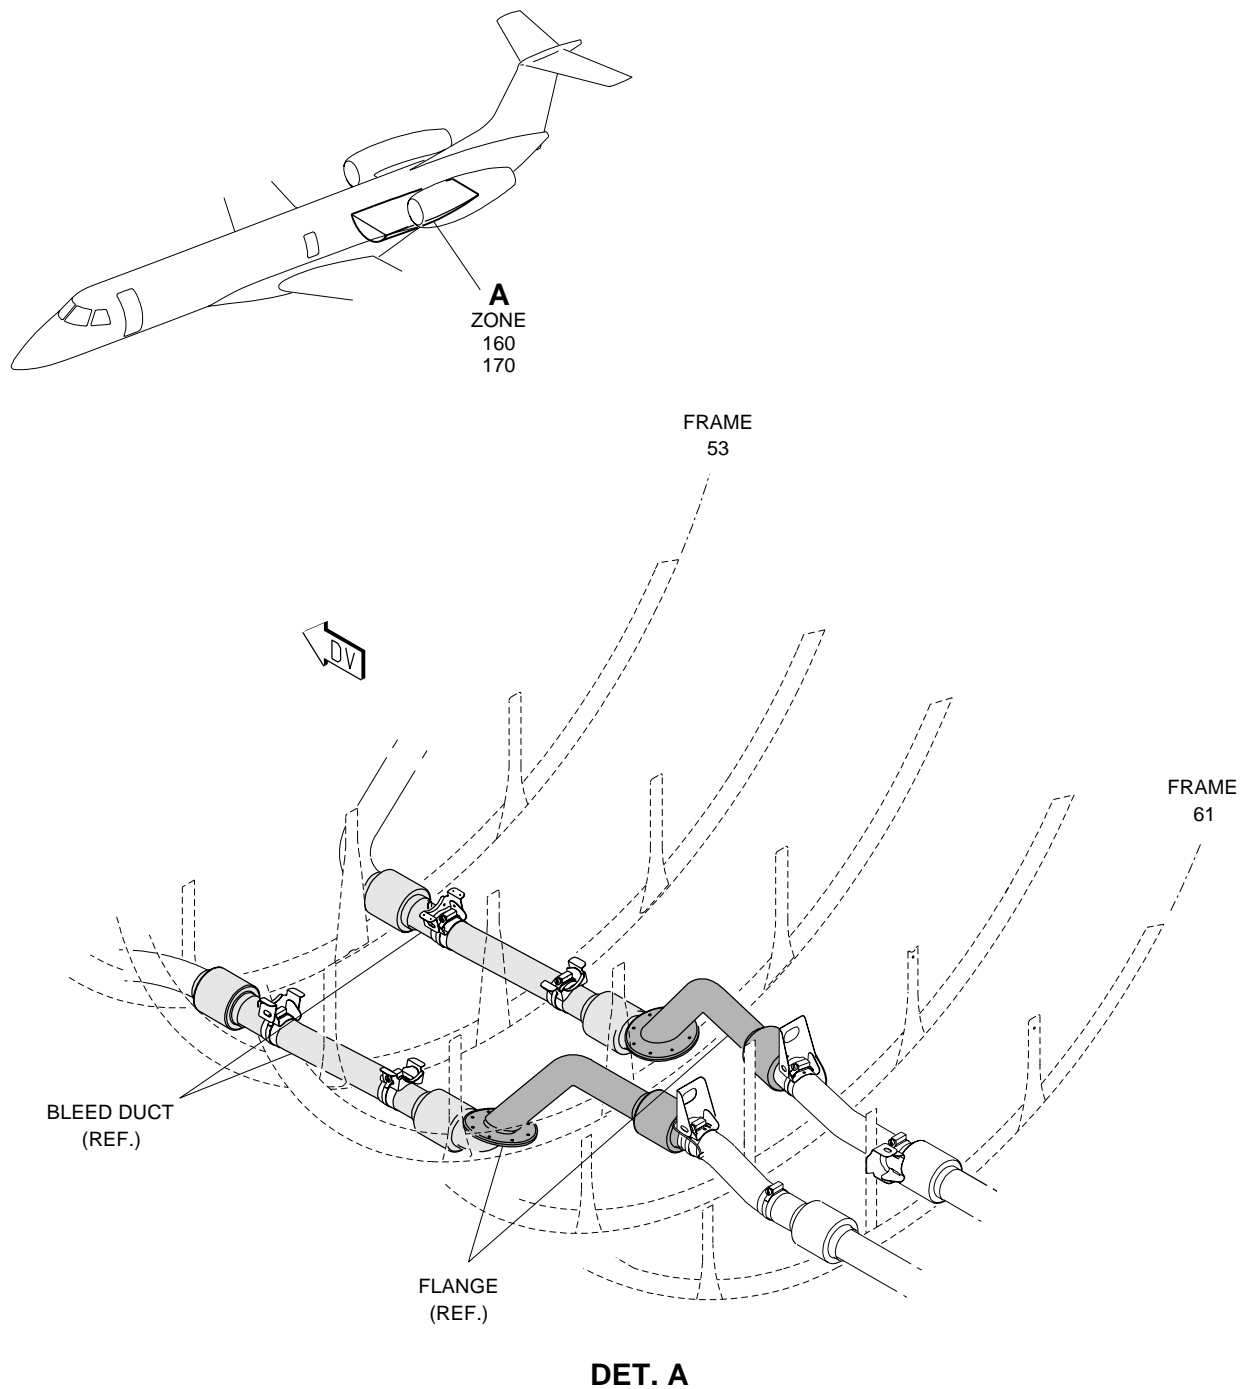
Figure 701

Bleed Duct - Cleaning

I. Toilet Overservicing - Cleaning (Figure 701)

- (2) Remove the carpet, floor path emergency light system and floor panel 251HF of lavatory compartment (AMM MPP 06-41-02/100).
- (3) Wet vac and make sure that all excess of overserviced moisture possibly fallen through the toilet and passenger cabin floor panel, was drained.
- (4) Make a detailed inspection on the bleed duct flange to make sure that there is no remaining moisture over the flange.

NOTE: If there is moisture on the flange, it can cause smoke in the cabin and activate the lavatory and baggage compartment smoke detector.
