EWIS COMPONENTS IN THE CENTER FUSELAGE I (LOWER SIDE) - INSPECTION/CHECK

2. EWIS COMPONENTS IN THE CENTER FUSELAGE I (LOWER SIDE) - DETAILED VISUAL INSPECTION

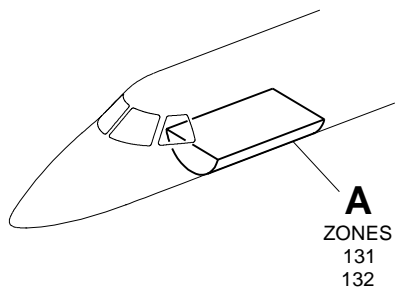
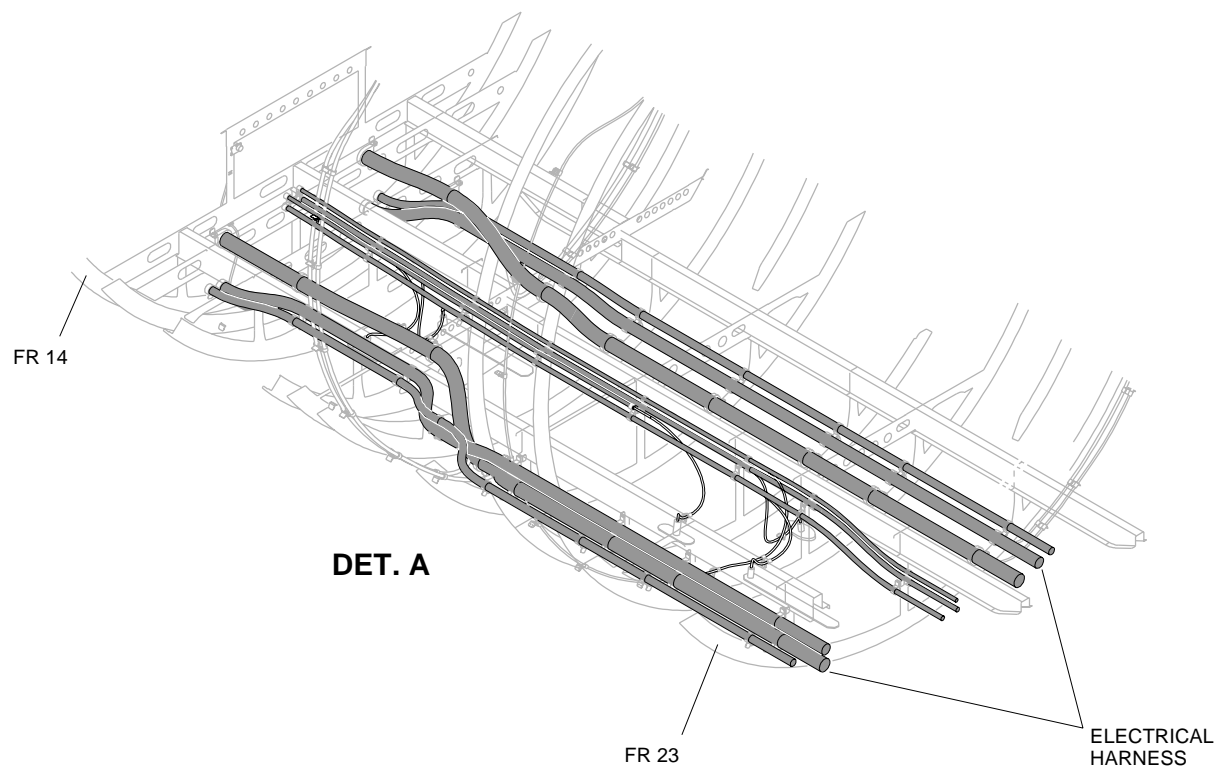
Figure 601

EWIS Components in the Center Fuselage I (Lower Side) - Detailed Visual Inspection

J. EWIS Components in the Center Fuselage I (Lower Side) - Detailed Visual Inspection ([Figure 601](#))

- (1) Do a detailed visual inspection on the APU and engines generators power cables, hydraulic pumps power cables, wiring bundles, and connected EWIS components at Center Fuselage I, lower side, for signs of damage, adequate installation, chafing and general condition. Refer to WM 20-22-00.
