BAGGAGE DOOR - EXTERNAL - INSPECTION/CHECK

2. BAGGAGE DOOR - EXTERNAL GENERAL VISUAL INSPECTION

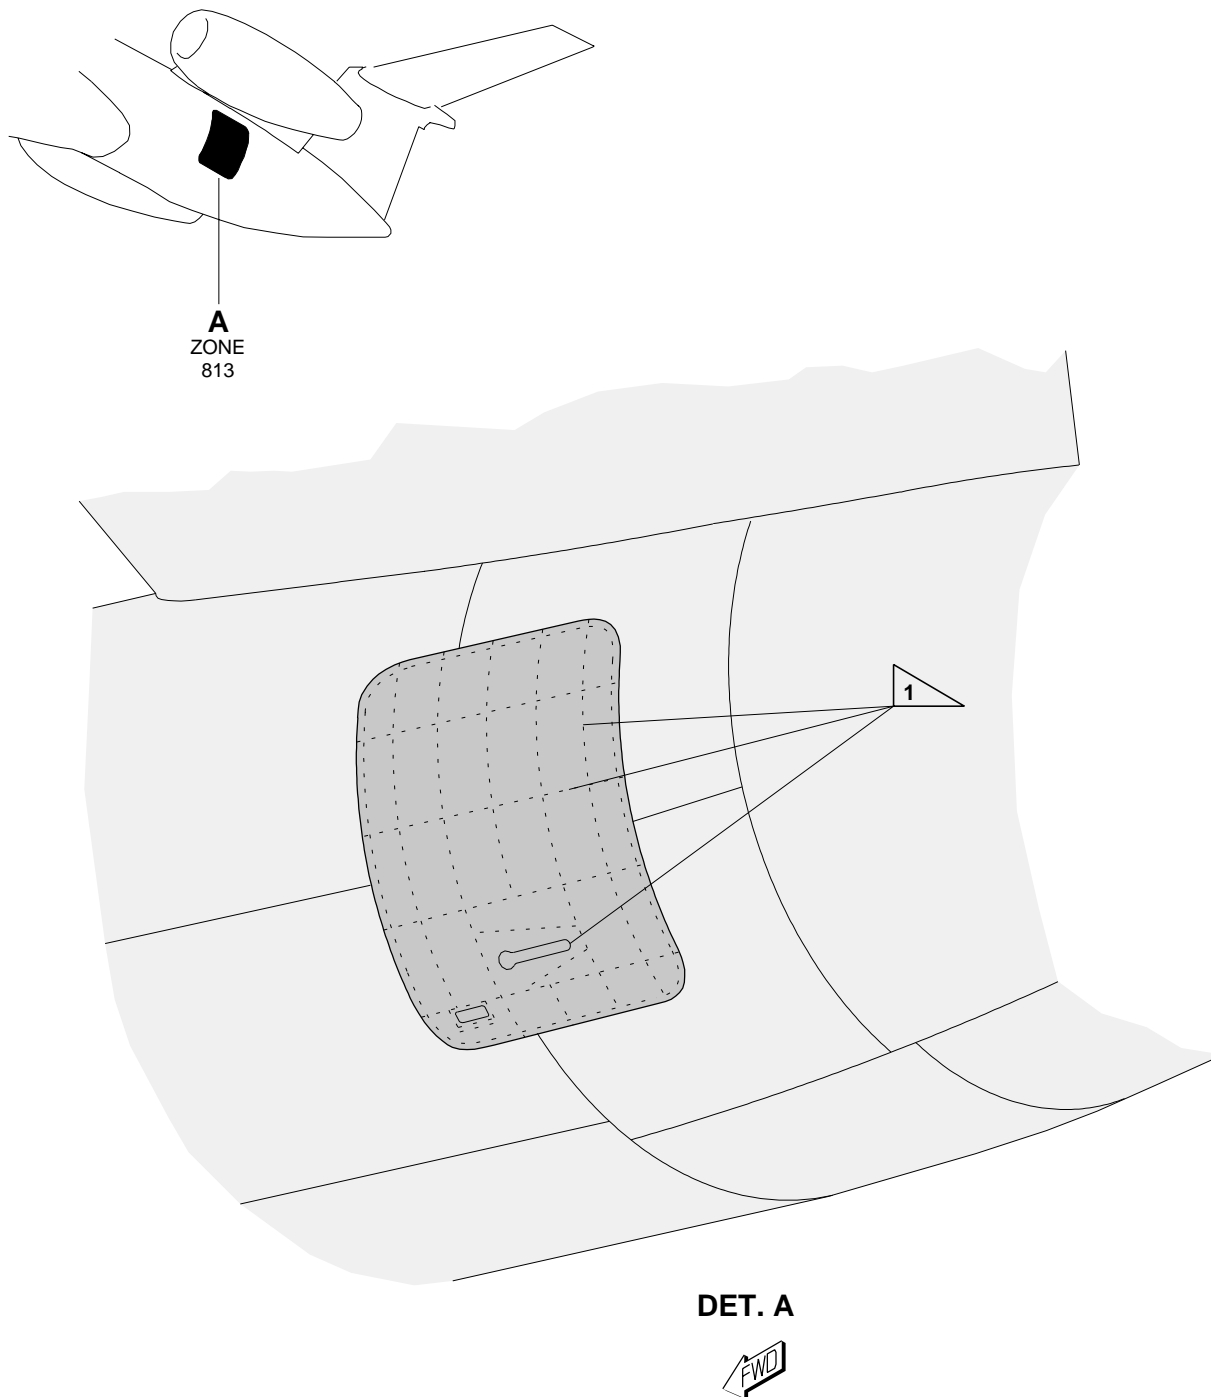
Figure 601

Baggage Door - External General Visual Inspection

1 EXTERNAL VISUAL INSPECTION OF THE BAGGAGE DOOR.

- (1) Examine the baggage door for painting bad condition, loose rivets, skin deformation, sealant poor condition, scratches, gouges, creases, nicks, cracks, dents, erosion, corrosion, and deteriorated protective treatment.

- (2) Inspect the folding flap structure of baggage door for general condition.
