WALTHAM TRAFFIC COMMISSION

MEETING 10/17/12

TO: Waltham Traffic Commission
FROM: J. Michael Garvin, P.E., Traffic Engineer
SUBJECT: **Four-Way Stop Review**
DATE: October 12, 2012

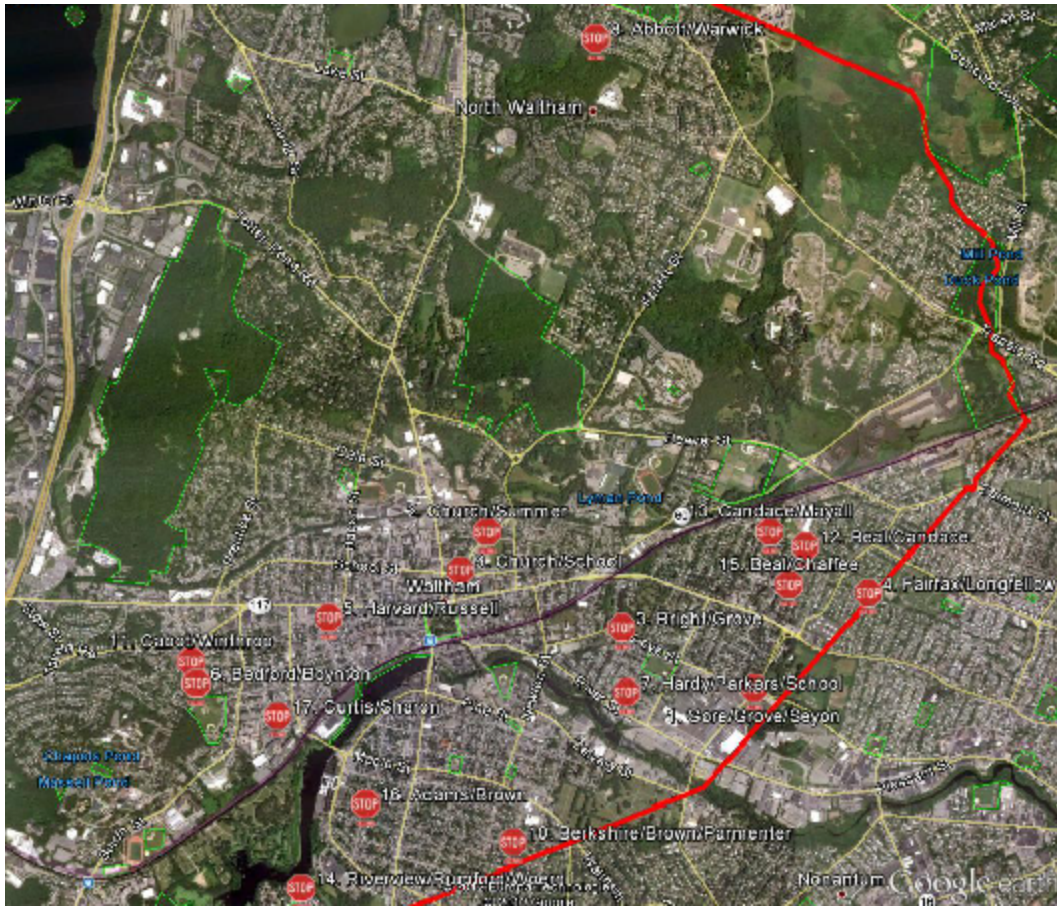
Figure 1
All-Way Stop Sign Locations

Figure 1 shows the locations of all 18 all-way stop controlled intersections in Waltham.
