ADA Curb Ramp New Construction Inspection Form (Perpendicular)

Nw 289 ave

Nw Keenon st

Ramp Style **PR**

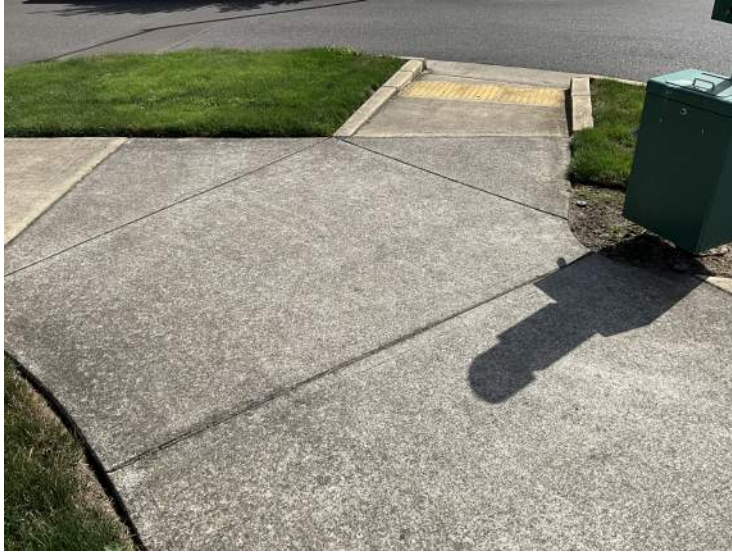
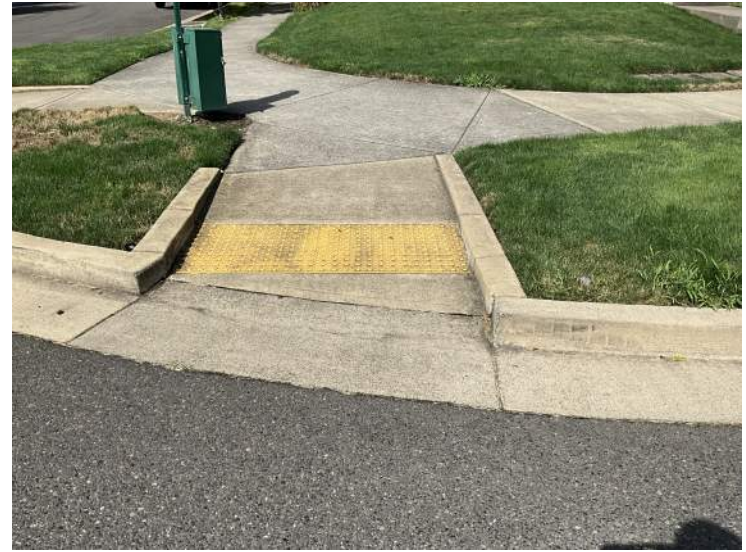
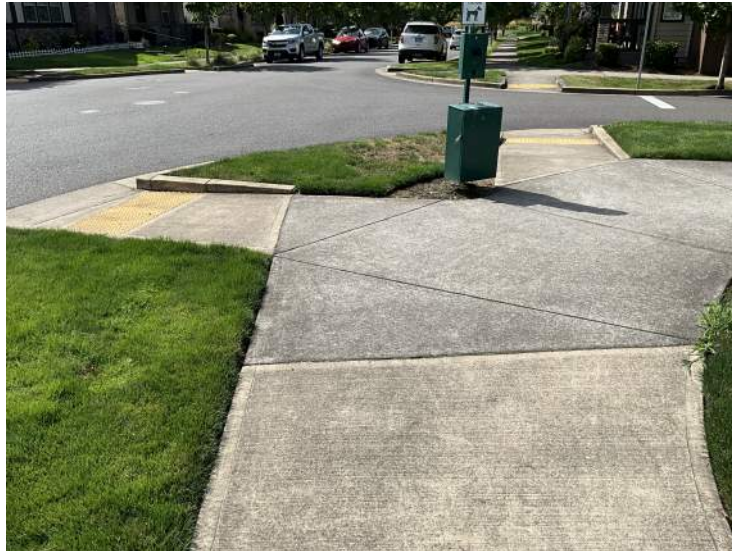
ADA Curb Ramp Images

RR1 ICRR
