ADA Curb Ramp New Construction Inspection Form (Perpendicular)

Nw 285

24952.54

Nw mays

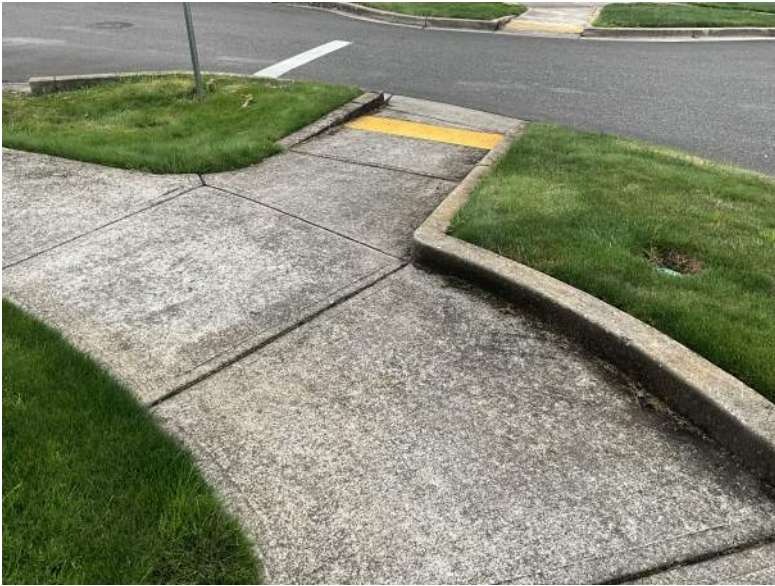
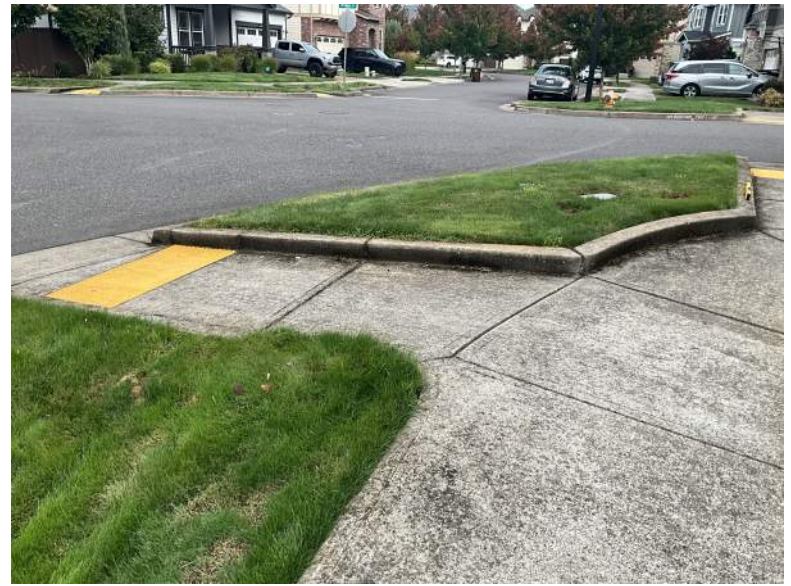
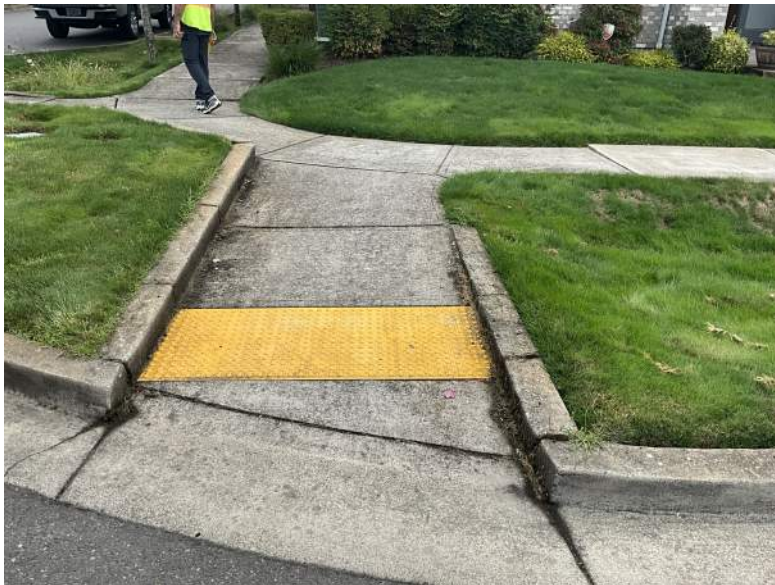
ADA Curb Ramp Images

Running Slope 1

8.3

☒

Slope Y

3.3
