# ADA Curb Ramp New Construction Inspection Form (Parallel)

NW 309th St

24952.54

NW North Ave

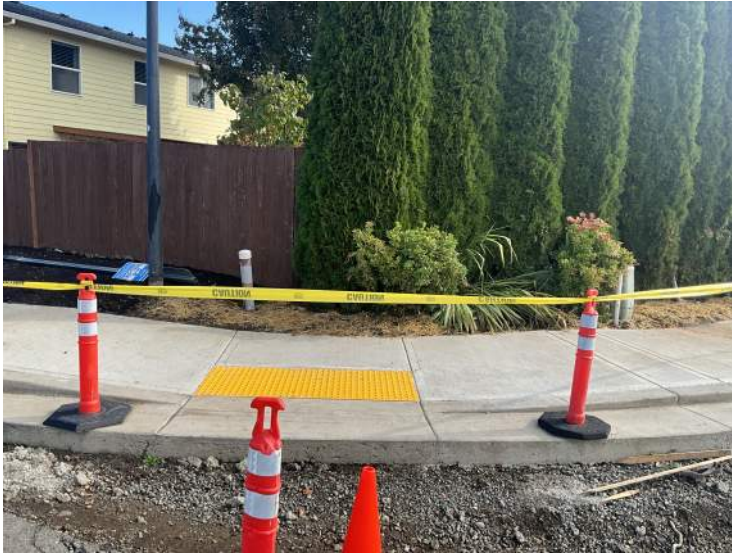
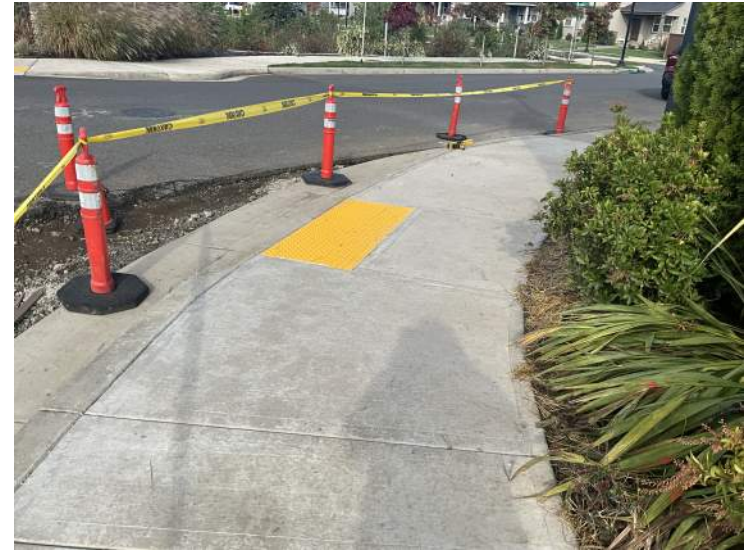
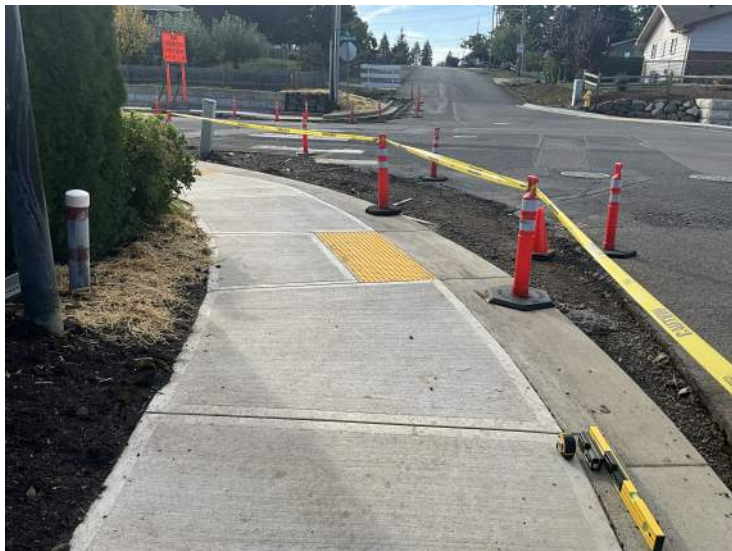
## ADA Curb Ramp Images

Asphalt not completed.
