ADA Curb Ramp New Construction Inspection Form (Perpendicular)

313th Ave

24952.54

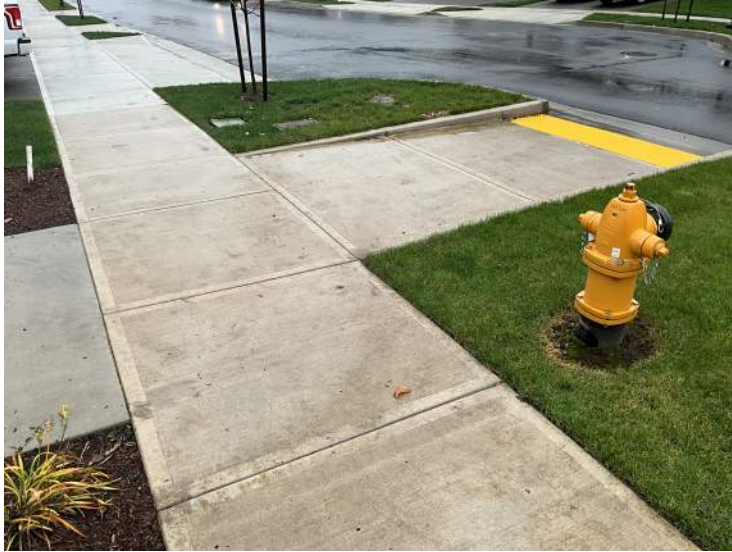
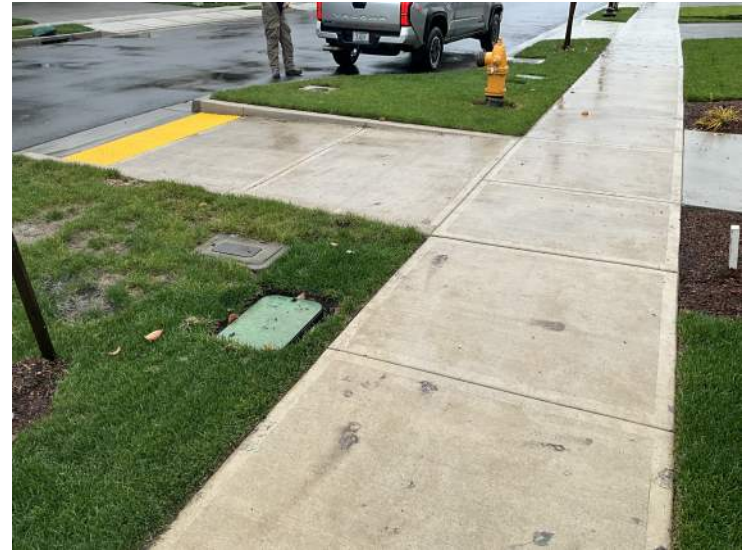
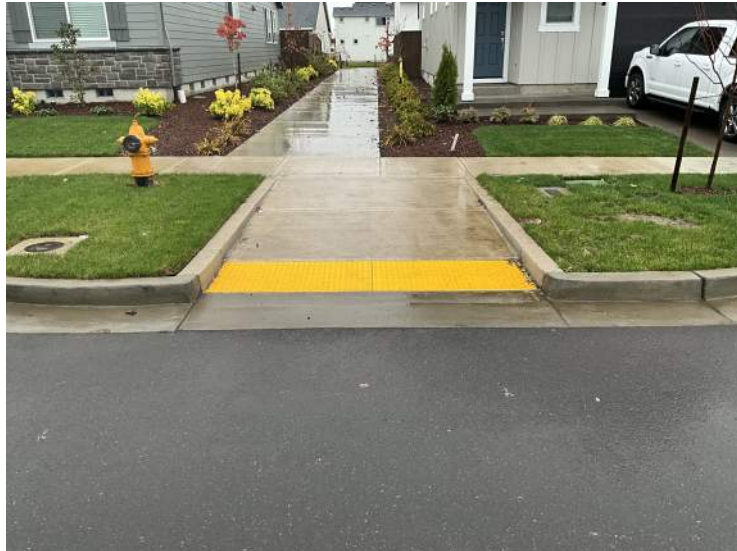
ADA Curb Ramp Images

Cross Slope 1

2.3

☒
