ADA Curb Ramp New Construction Inspection Form (Perpendicular)

23885.56

NW Lenox

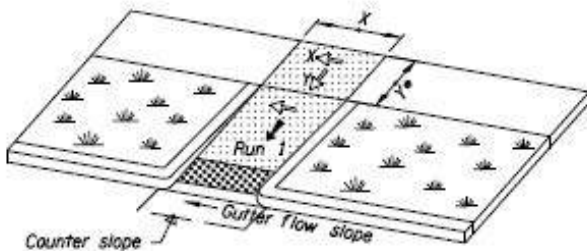
PERPENDICULAR RAMP (PR)

- Pedestrian Access Route (to measure Clear Width)
- Detectable Warning Surface
- Cross Slope (2.0% max.)
- Running Slope (8.3% max.)
- Counter Slope (5.0% max.)
- Turning Space (X & Y) (2.0% max. / 4' x 4' min.)*
* If constrained at back of walk, min. Y length is 5'.
- Gutter Flow Slope (as directed)

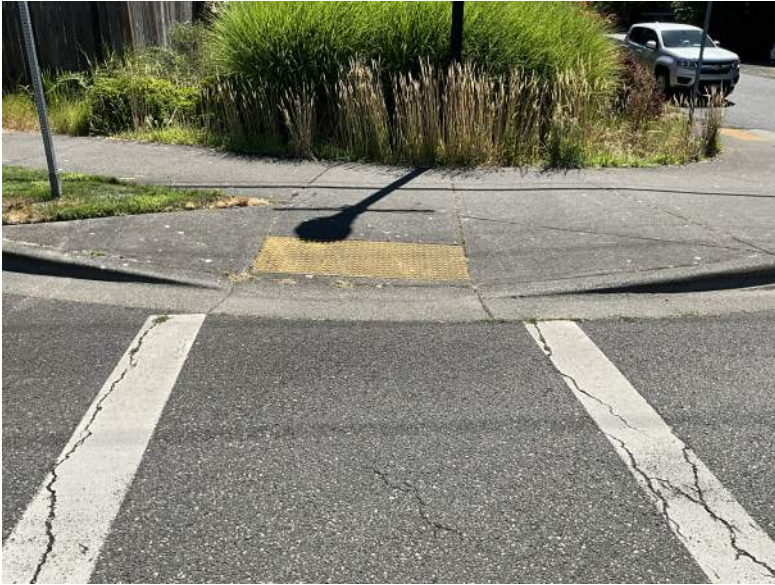
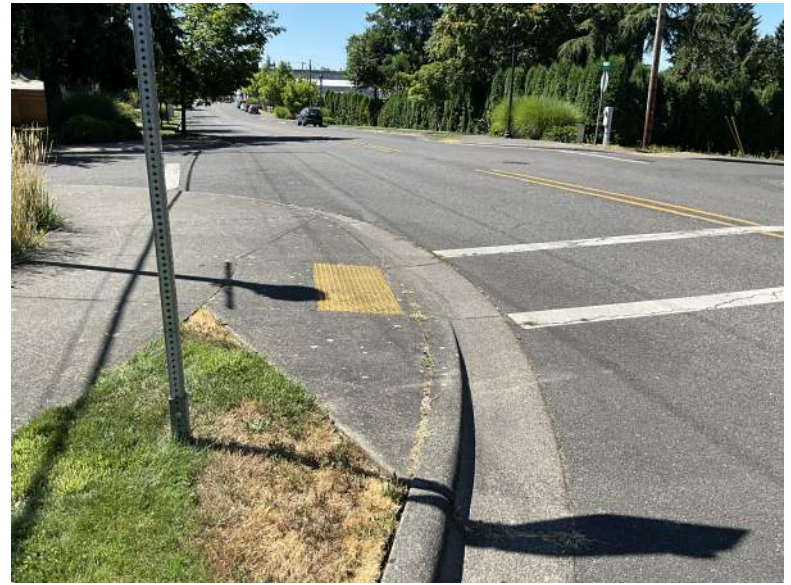
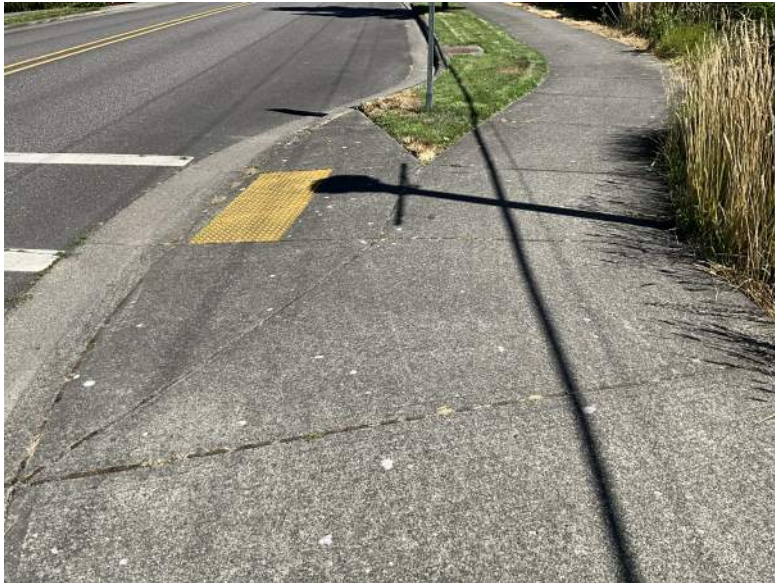
ADA Curb Ramp Images

DWS IITD Fails RR 1
