ADA Curb Ramp New Construction Inspection Form (Perpendicular)

NW 313th Ave

24952.54

NW North Ave

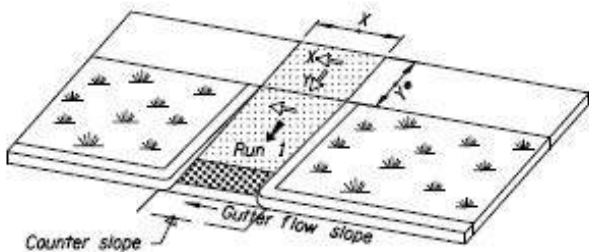
PERPENDICULAR RAMP (PR)

Pedestrian Access Route (to measure Clear Width)

Detectable Warning Surface

Cross Slope (2.0% max.)

Running Slope (8.3% max.)

Counter Slope (5.0% max.)

Turning Space (X & Y) (2.0% max. / 4' x 4' min.)*
* If constrained at back of walk, min. Y length is 5'.

Gutter Flow Slope (as directed)
