ADA Curb Ramp New Construction Inspection Form (Perpendicular)

Nw 287 ave

24952.54

Nw Shaddon st

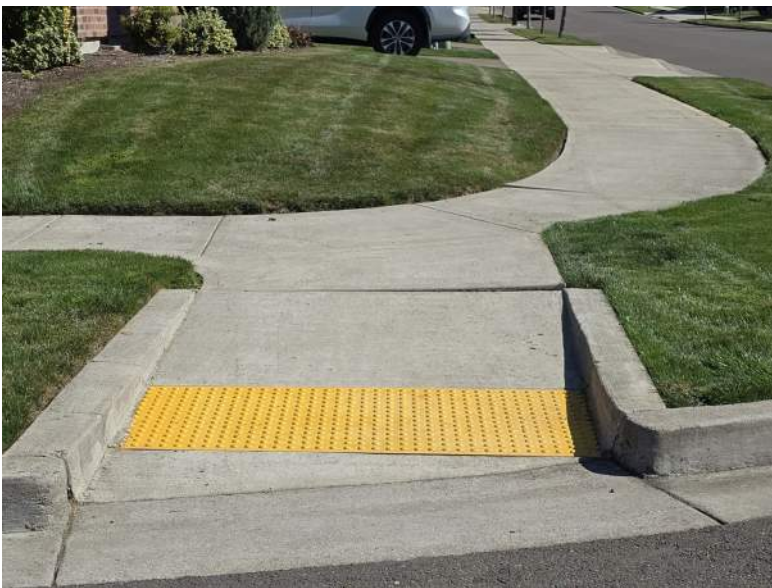
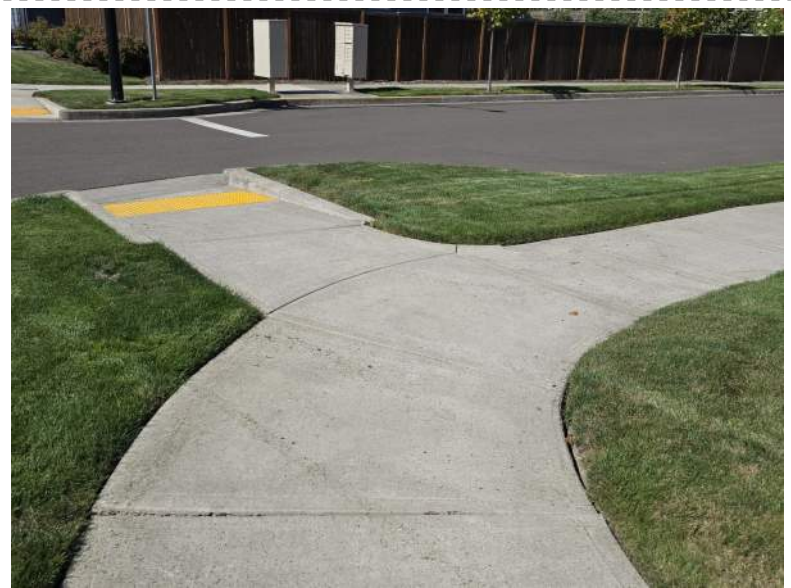
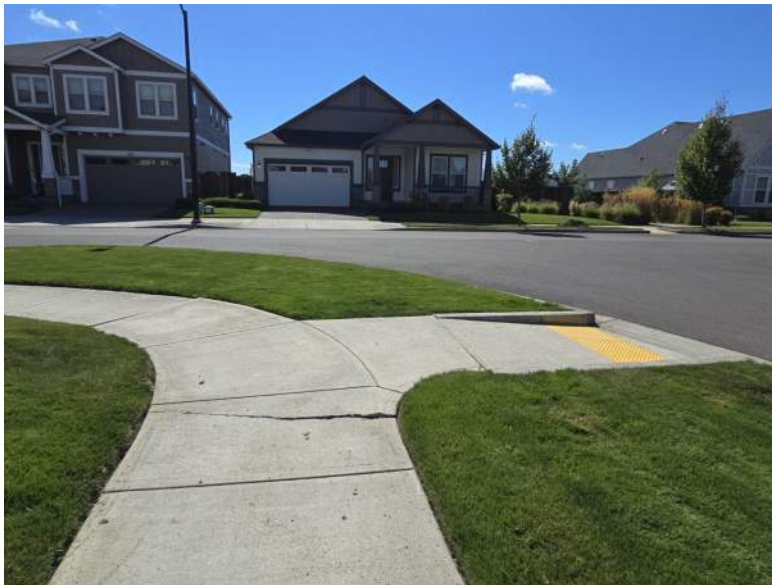
ADA Curb Ramp Images

RR1 ICRR turn space position area of differential settlement
