ADA Curb Ramp New Construction Inspection Form (Perpendicular)

Nw 289th

Project No.

Nw Kaye

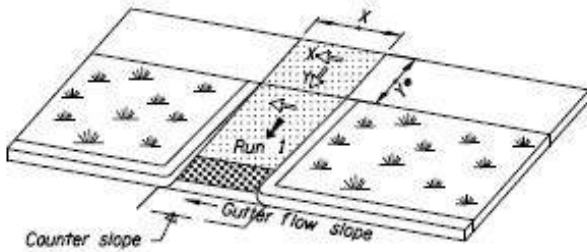
PERPENDICULAR RAMP (PR)

- Pedestrian Access Route (to measure Clear Width)
- Detectable Warning Surface
- Cross Slope (2.0% max.)
- Running Slope (8.3% max.)
- Counter Slope (5.0% max.)
- Turning Space (X & Y) (2.0% max. / 4' x 4' min.)*
* If constrained at back of walk, min. Y length is 5'.
- Gutter Flow Slope (as directed)

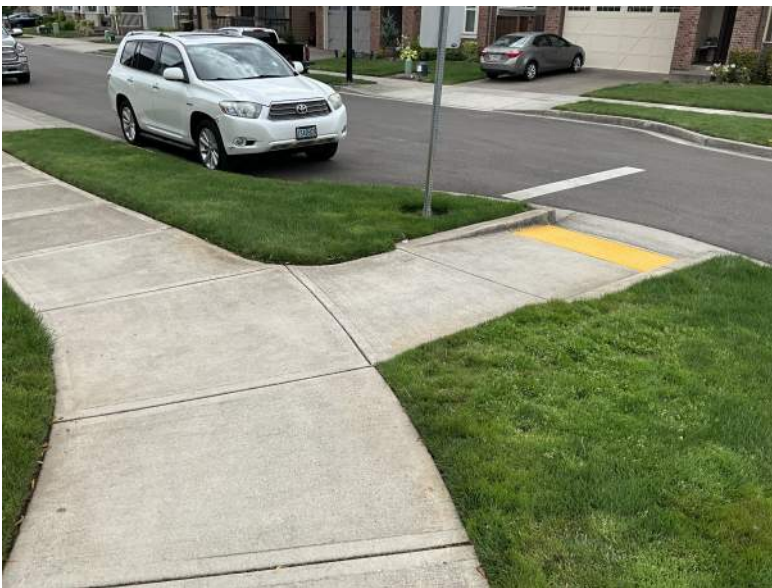
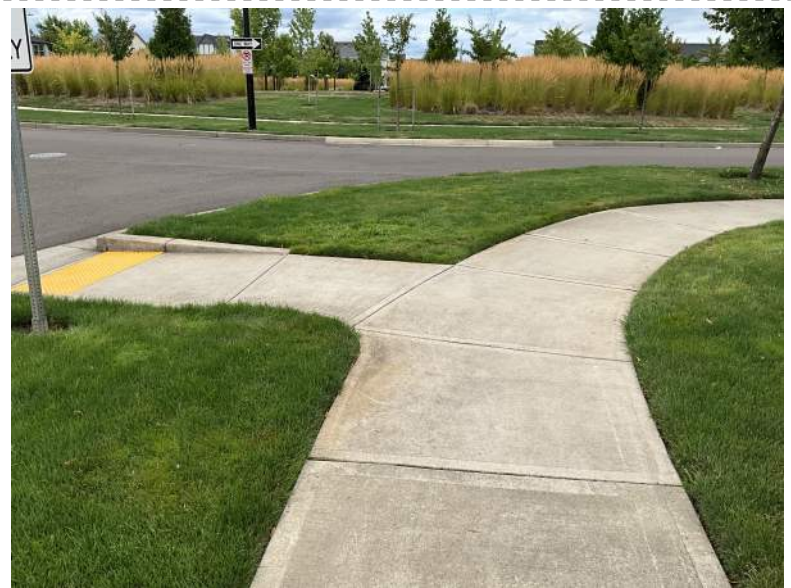
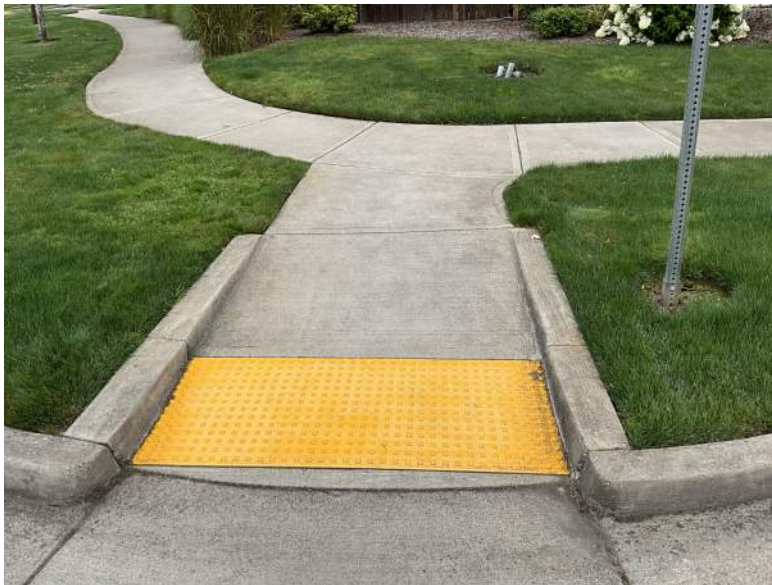
ADA Curb Ramp Images

RR1 ICRR, IITD
