# ADA Curb Ramp New Construction Inspection Form (Parallel)

Nw. Glencoe rd

24952.54

Nw. Pacific st.

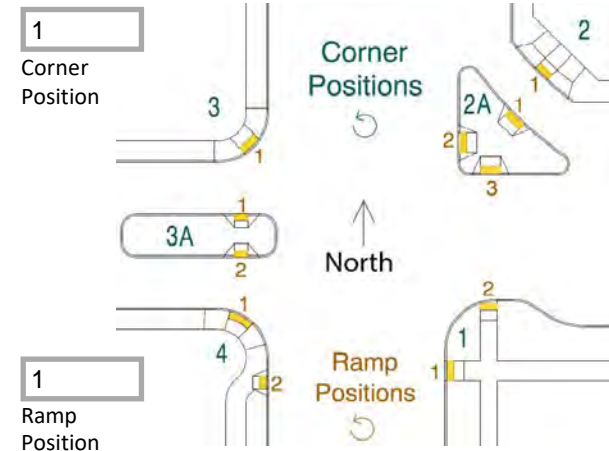
PARALLEL RAMP (PL)

- Pedestrian Access Route (to measure Clear Width)
- Detectable Warning Surface
- Cross Slope (2.0% max.)
- Running Slope (8.3% max.)
- Counter Slope (5.0% max.)
- Turning Space (X & Y) (2.0% max. / 4' x 4' min.)\*  
\* If constrained at back of walk, min. Y length is 5'.
- Gutter Flow Slope (as directed)

☐  $\leq 2.0\%$  ☐  $> 2.0\%$  ☒

Comments:  
IITD, large comm. box in RR2
