ADA Curb Ramp New Construction Inspection Form (Blended Transition)

NW. EMPRESS PL.

24953

NW. NORTH AVE.

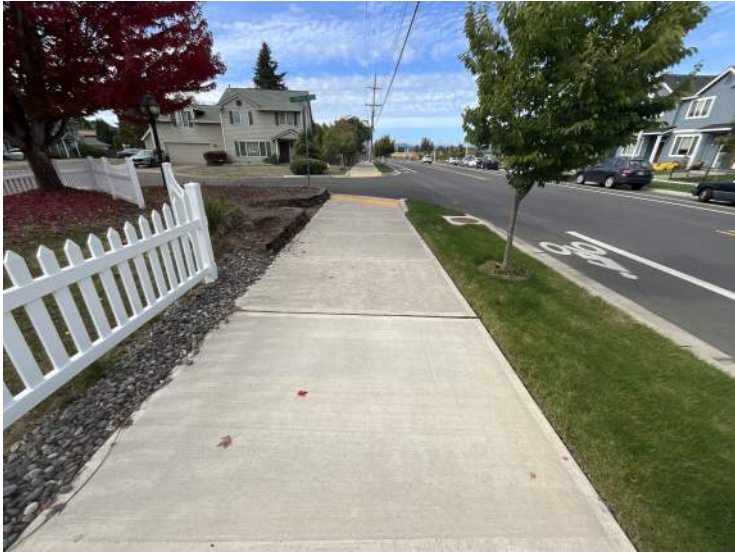
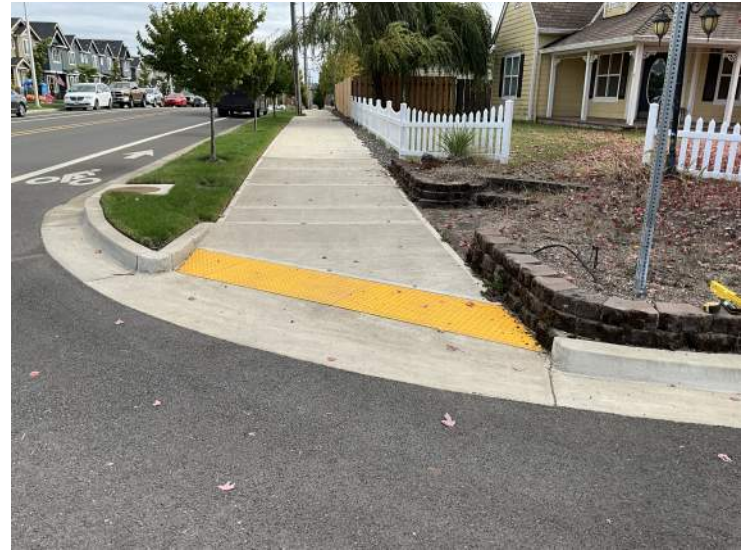
ADA Curb Ramp Images

Blended Transitions are locations where the pedestrian walkway (which has one direction of travel) and the street crossing intersect at the same plane without the need of a ramp. If the Running Slope is 5.0% or more, the ramp is not a Blended Transition and should be inspected using a different inspection form.
