ADA Curb Ramp New Construction Inspection Form (Perpendicular)

Nw King

23885.56

Nw 292nd

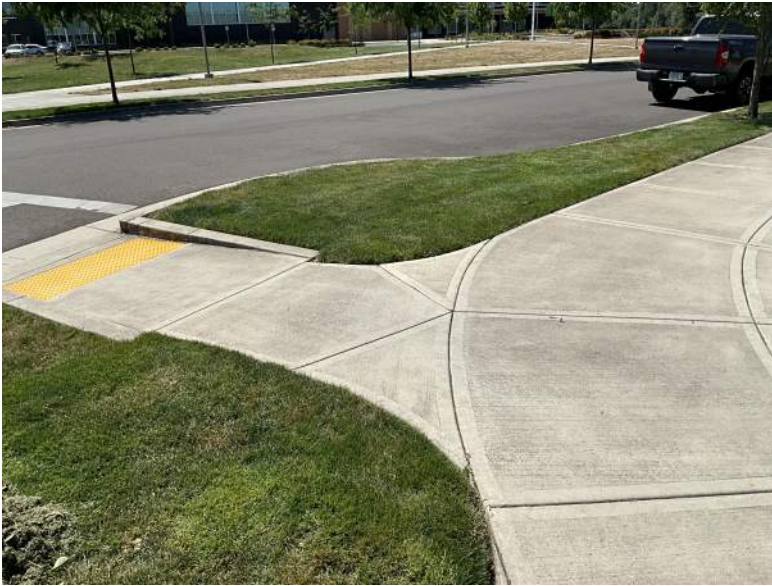
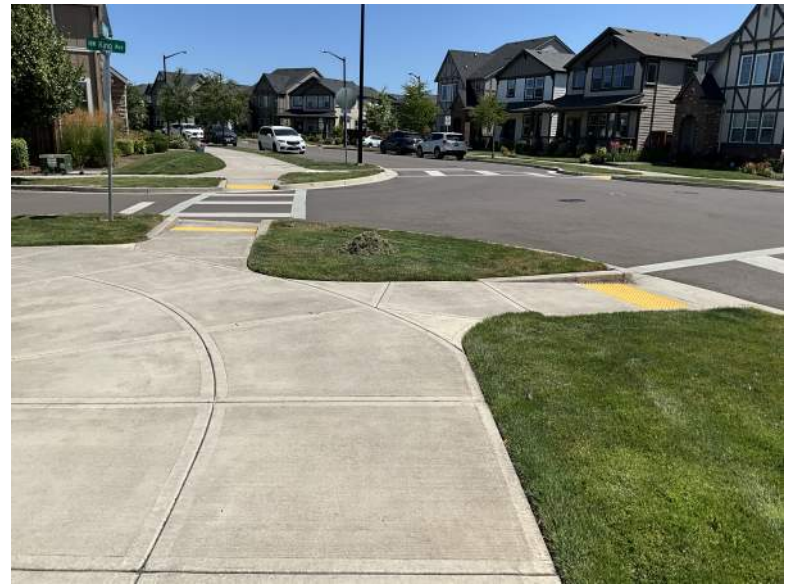
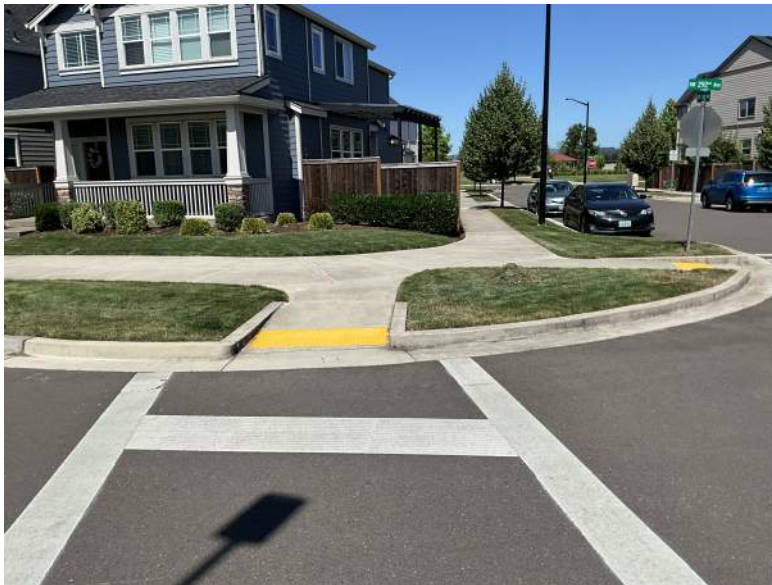
ADA Curb Ramp Images

Tool joins in TS
