ADA Curb Ramp New Construction Inspection Form (Blended Transition)

NW MAIN ST

29453

NW NORTH AVE

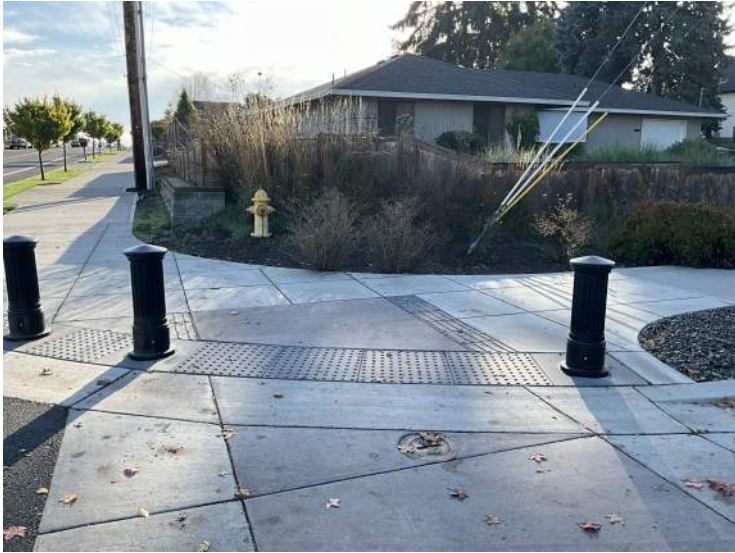
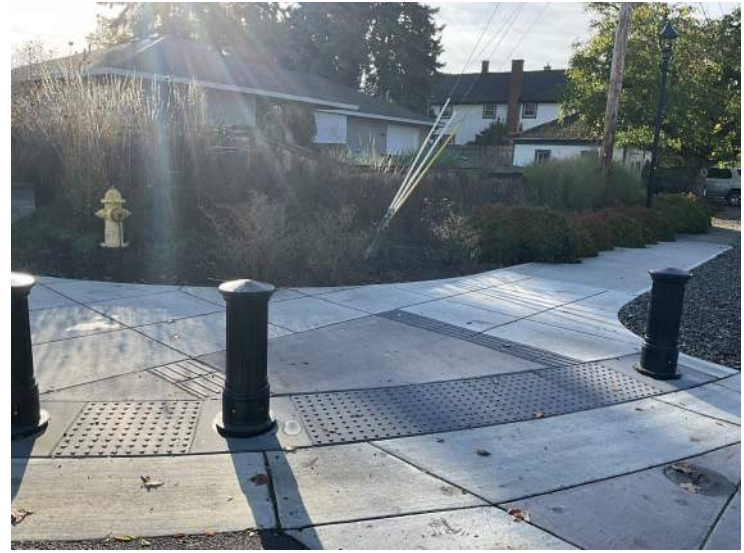
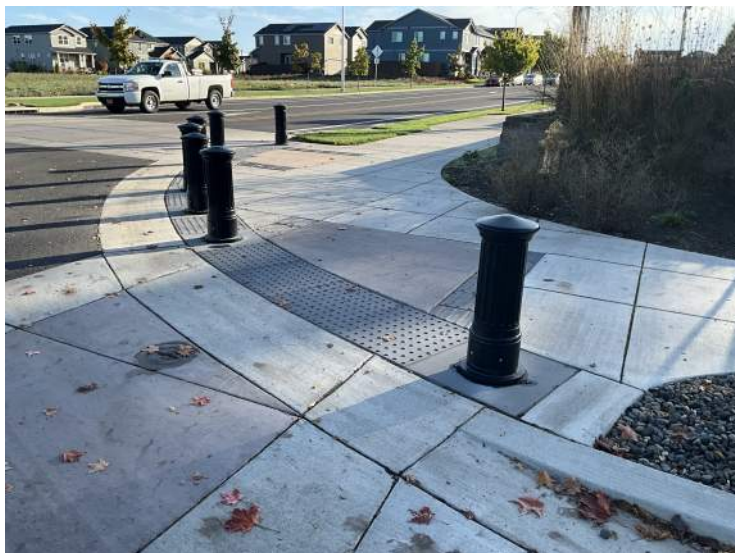
ADA Curb Ramp Images

Blended Transitions are locations where the pedestrian walkway (which has one direction of travel) and the street crossing intersect at the same plane without the need of a ramp. If the Running Slope is 5.0% or more, the ramp is not a Blended Transition and should be inspected using a different inspection form.
