ADA Curb Ramp New Construction Inspection Form (Blended Transition)

NW MAIN ST

24953

NW NORTH AVE

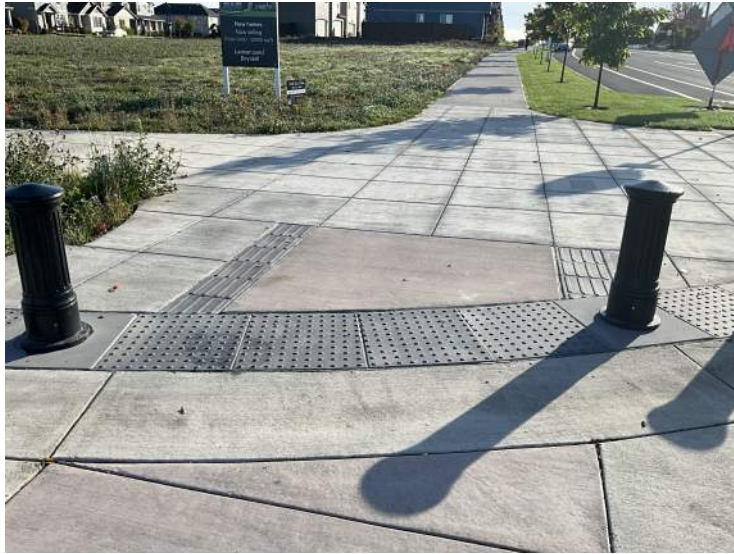
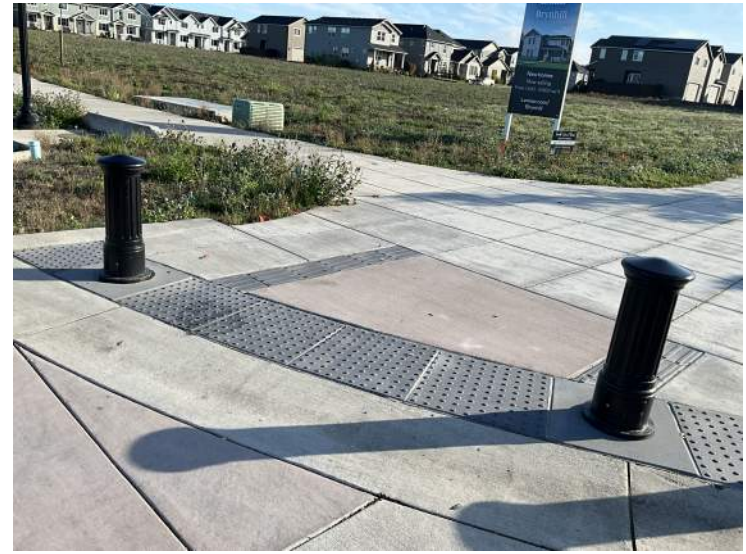
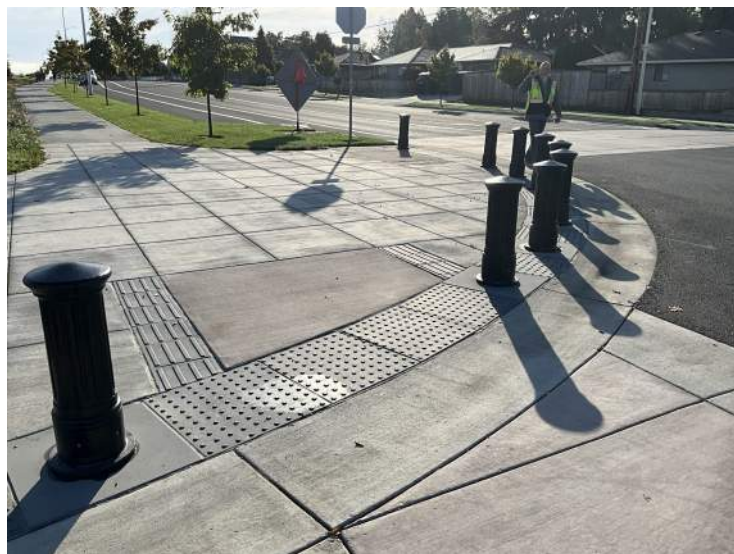
ADA Curb Ramp Images

Blended Transitions are locations where the pedestrian walkway (which has one direction of travel) and the street crossing intersect at the same plane without the need of a ramp. If the Running Slope is 5.0% or more, the ramp is not a Blended Transition and should be inspected using a different inspection form.
