ADA Curb Ramp New Construction Inspection Form (Perpendicular)

Nw 311th ave

24952.54

Nw Yorkshire st

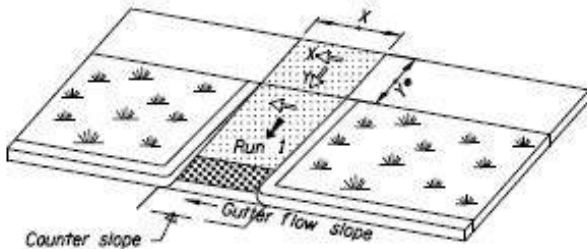
PERPENDICULAR RAMP (PR)

Pedestrian Access Route (to measure Clear Width)

Detectable Warning Surface

Cross Slope (2.0% max.)

Running Slope (8.3% max.)

Counter Slope (5.0% max.)

Turning Space (X & Y) (2.0% max. / 4' x 4' min.)*
* If constrained at back of walk, min. Y length is 5'.

Gutter Flow Slope (as directed)
