ADA Curb Ramp New Construction Inspection Form (Perpendicular)

Nw 289 ave

24952.54

Nw Keenon st

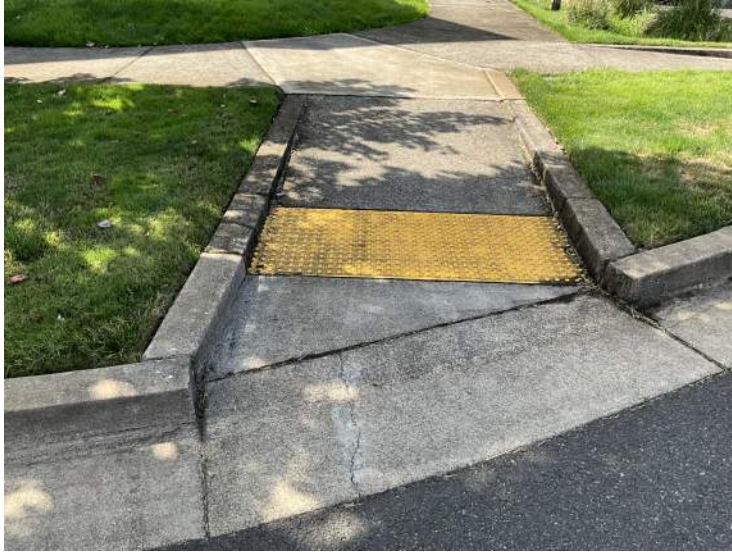
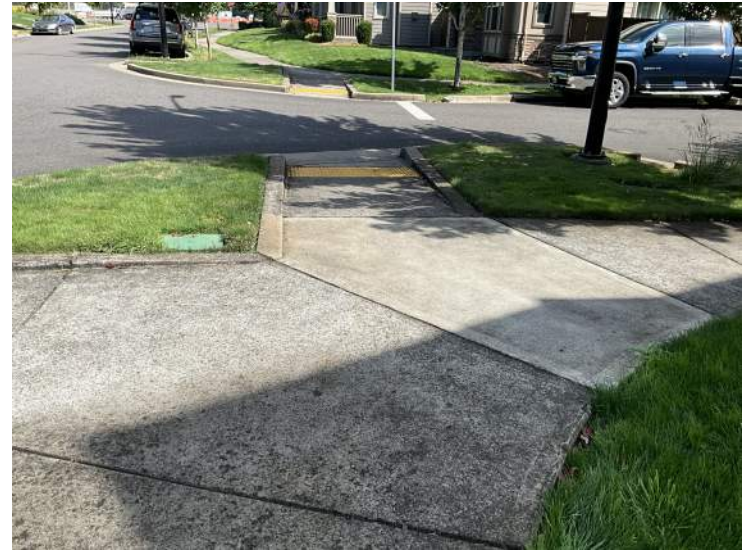
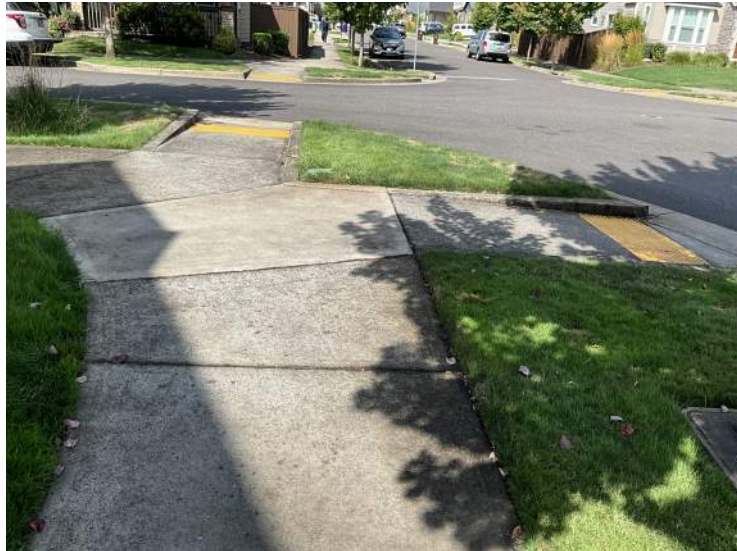
ADA Curb Ramp Images

Large longitudinal crack
