ADA Curb Ramp New Construction Inspection Form (Perpendicular)

Nw 291st

Project No.

NW Keenon

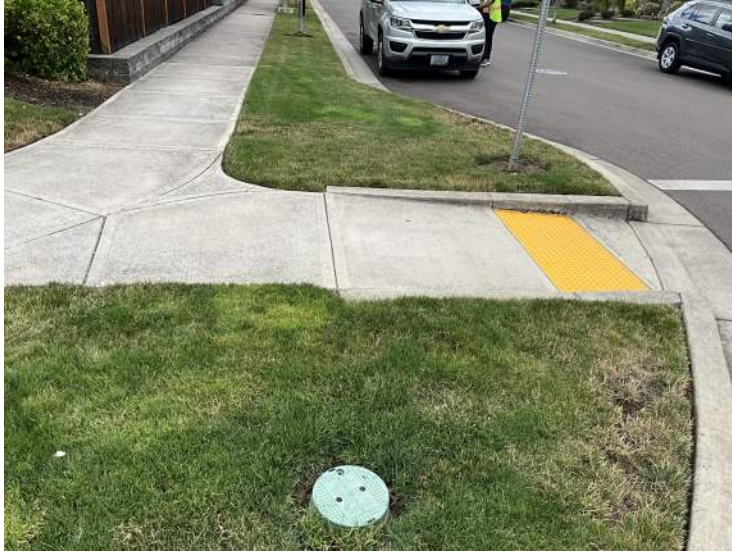
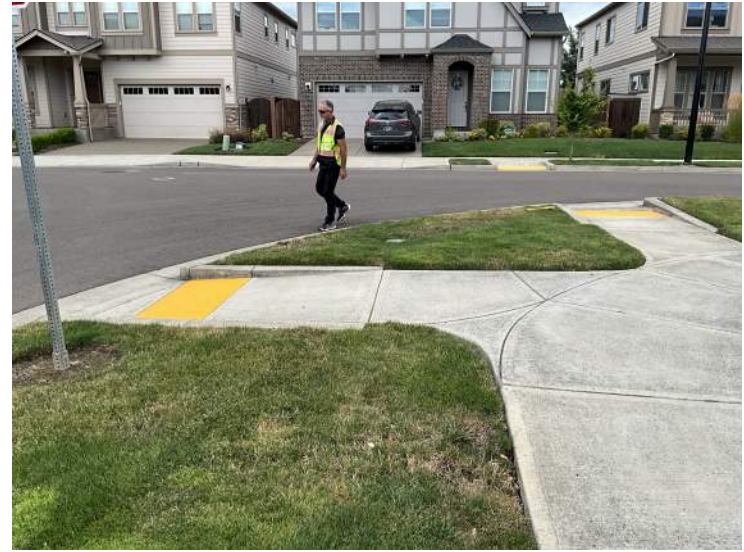
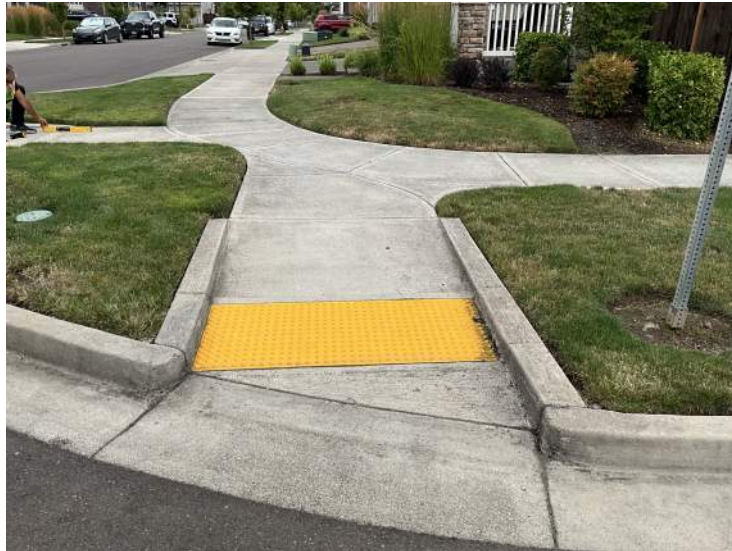
ADA Curb Ramp Images

RR1 ICRR
